**GEOTECHNICAL REPORT  
SLOPE REPAIR RECOMMENDATIONS  
HUNTINGTON BEACH DOG BEACH  
19341 PACIFIC COAST HWY  
HUNTINGTON BEACH, CALIFORNIA 92648  
AESCO PROJECT NO. 20240155-H3925**

**June 4, 2024**

**Subject: GEOTECHNICAL REPORT  
SLOPE REPAIR RECOMMENDATIONS  
HUNTINGTON BEACH DOG BEACH  
19341 PACIFIC COAST HIGHWAY  
HUNTINGTON BEACH, CALIFORNIA 92648  
AESCO PROJECT NO. 20240155-H3925**

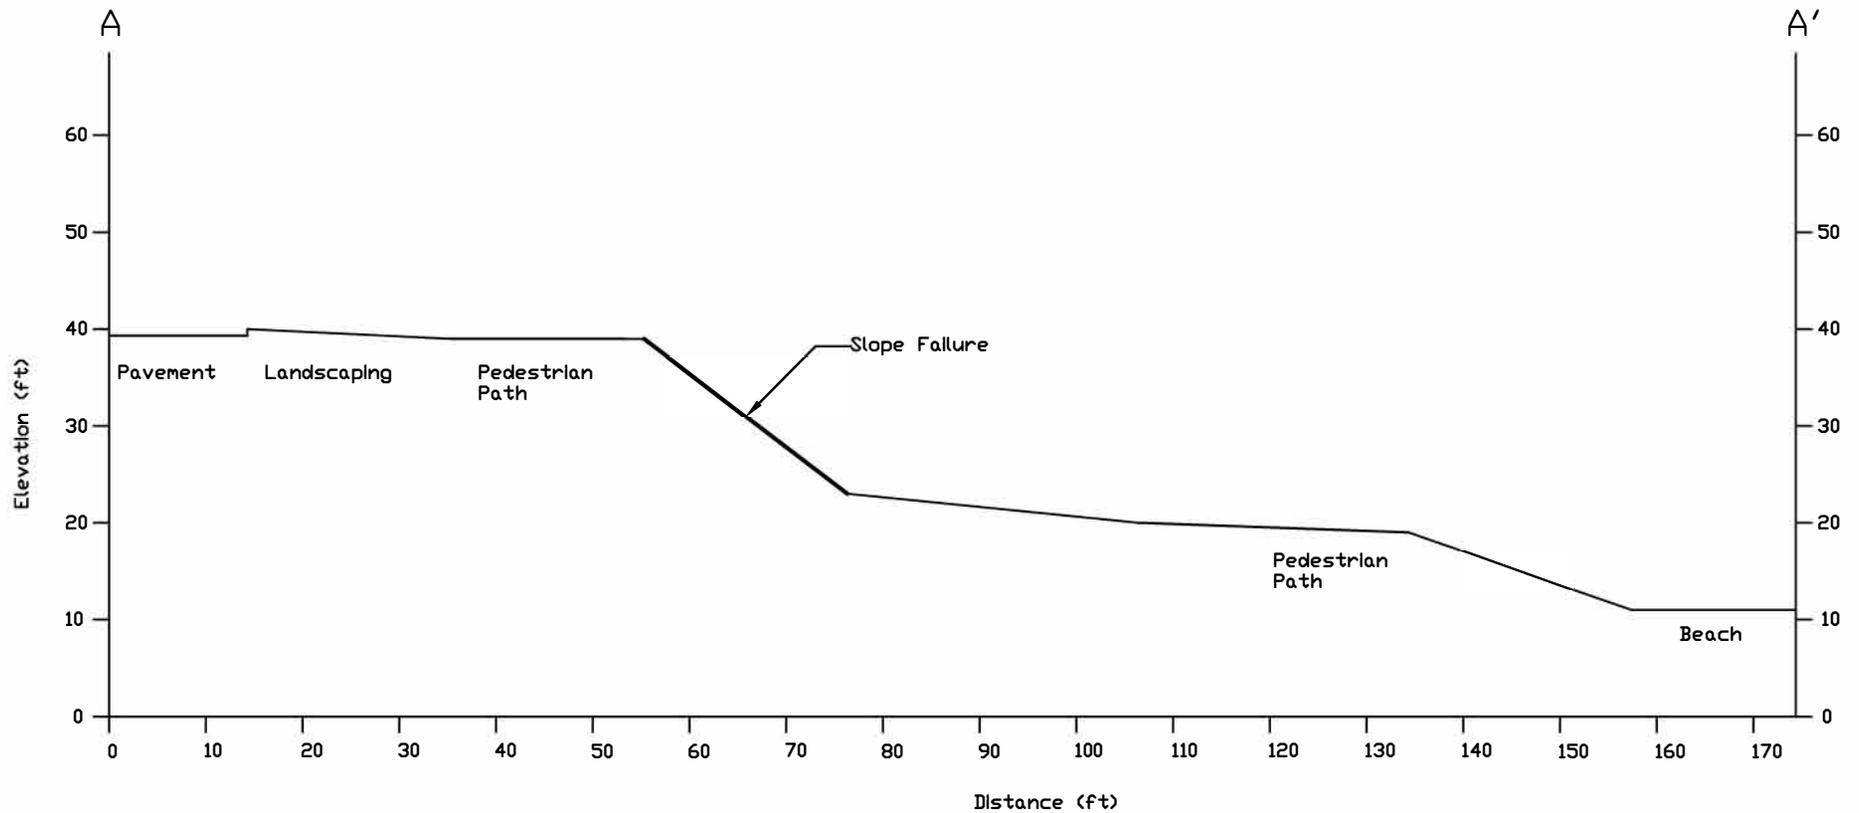
Figure 3

A cross-section of the representative slope (Figure 3) was prepared for analysis purposes, depicting the existing slope prior to failure. We conducted a slope stability analysis, including both static and seismic loading, on Section A-A' using the provided cross-section from the city. The analysis was performed using GEO5 software, which utilizes a two-dimensional limit equilibrium method.

Our analysis utilized shear strength parameters based on field observations, laboratory test data, and our experience with similar materials. The results indicate a minimum safety factor of 1.94 for static loading and 1.36 for seismic loading. In comparison, general geotechnical engineering practice in Southern California recommends minimum acceptable safety factors of 1.5 and 1.1 for static and seismic load cases, respectively. Therefore, the test results indicated that the existing slope safety factors for both seismic load and static conditions are acceptable.
