**Arborist's Report**  
**June 18, 2022**

# **Tree Preservation Plan**

**For Edison Park, City of Huntington Beach**

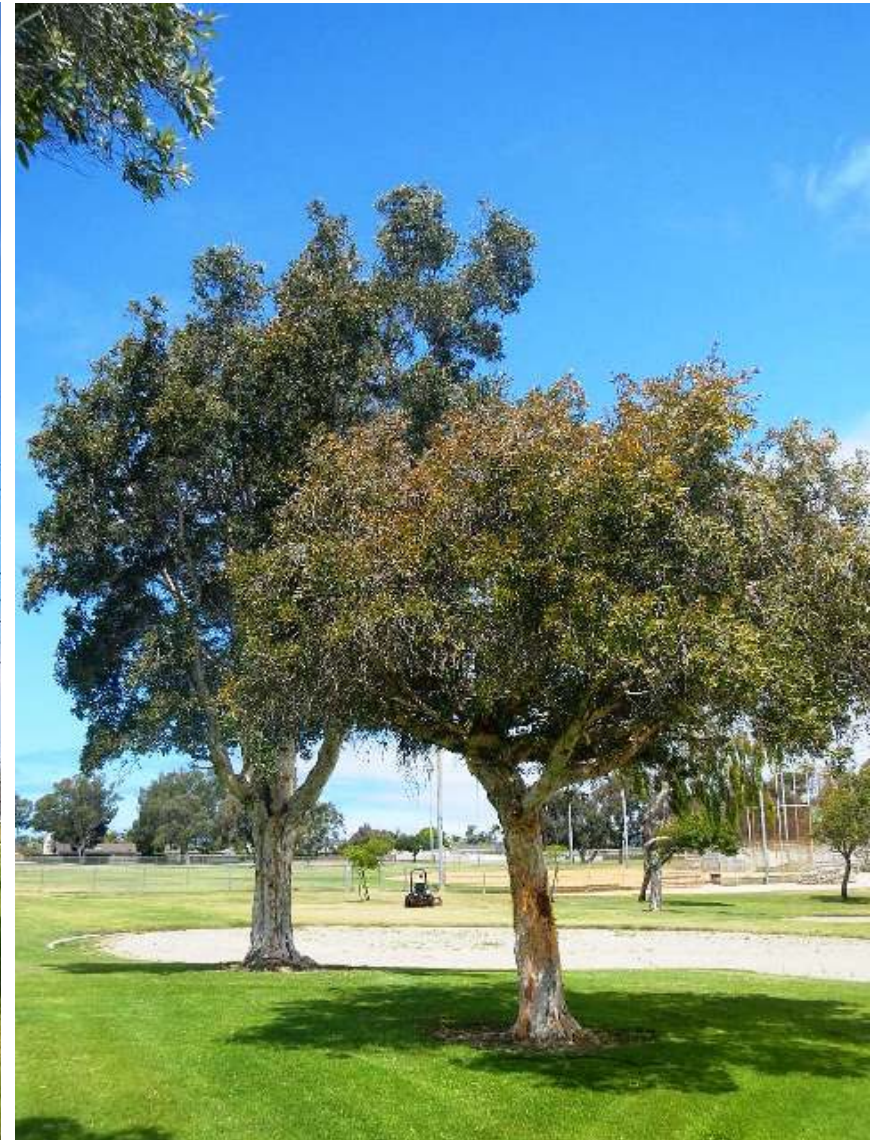
Cajeput or paperbark trees should be a good species for this soil and climate. The most common deterrent to good health are root injuries.

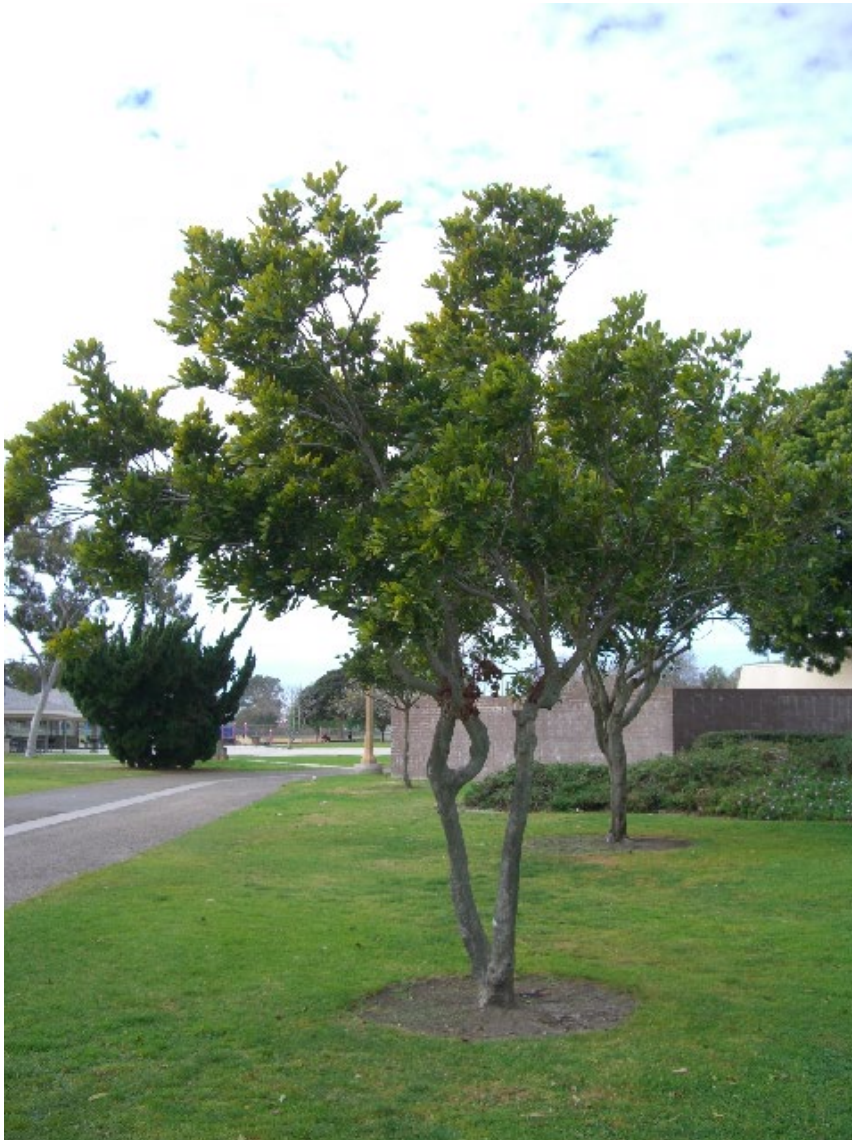
More stunted carrotwoods surround the community building.
