**Arborist's Report
June 18, 2022**

Tree Preservation Plan

For Edison Park, City of Huntington Beach

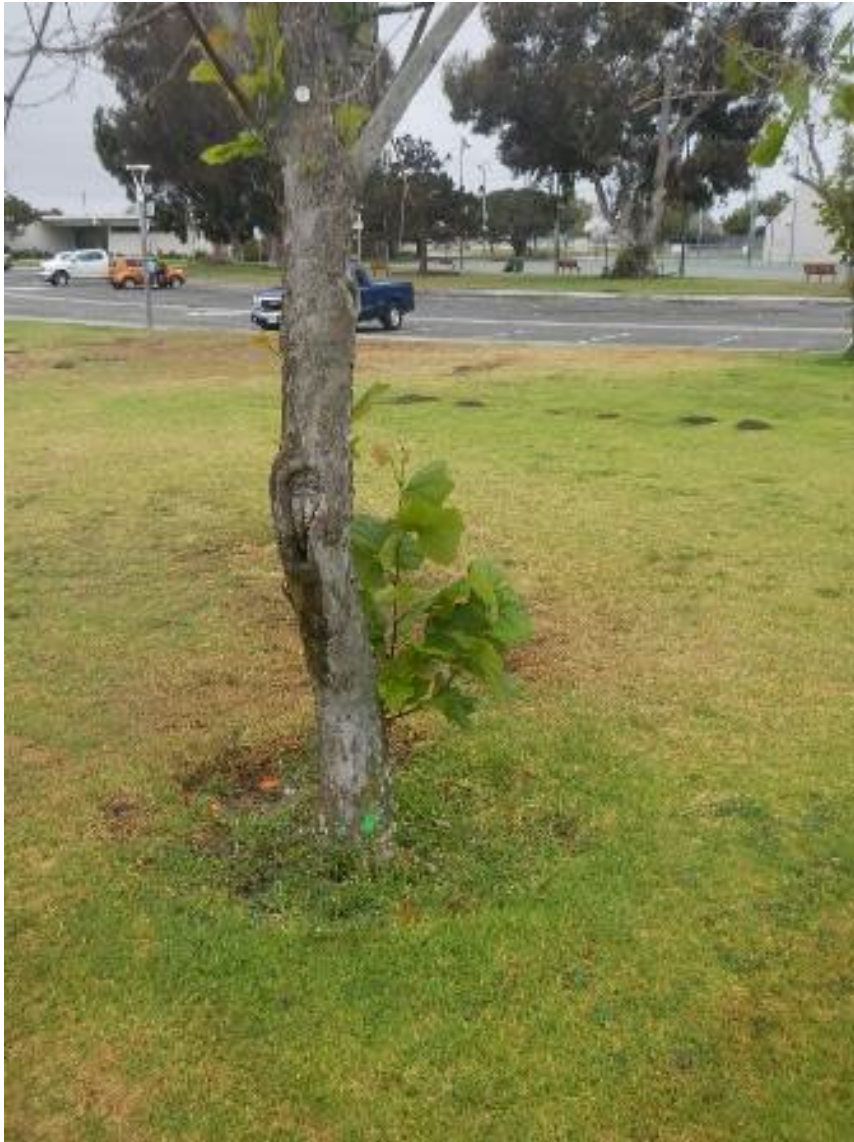
#19 London plane – note limb torn out

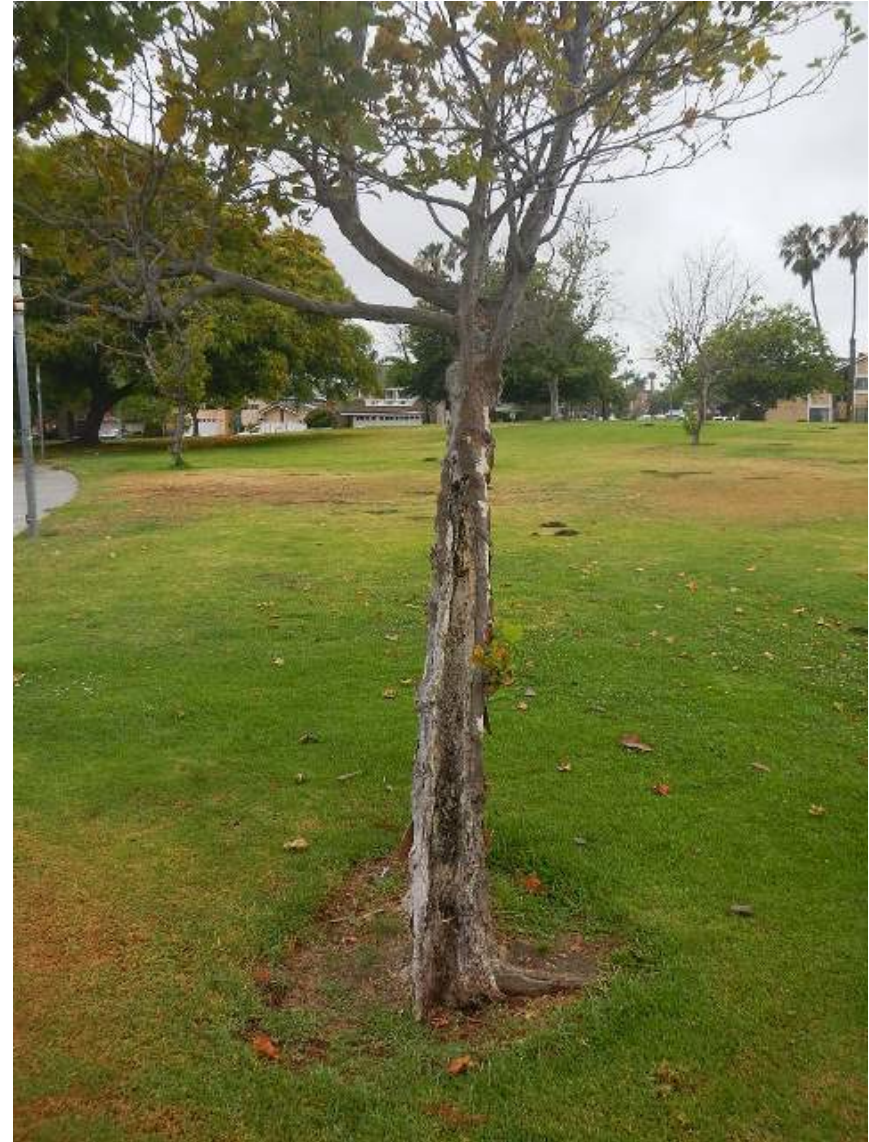
Decay probably started with a basal injury by a lawn mower.

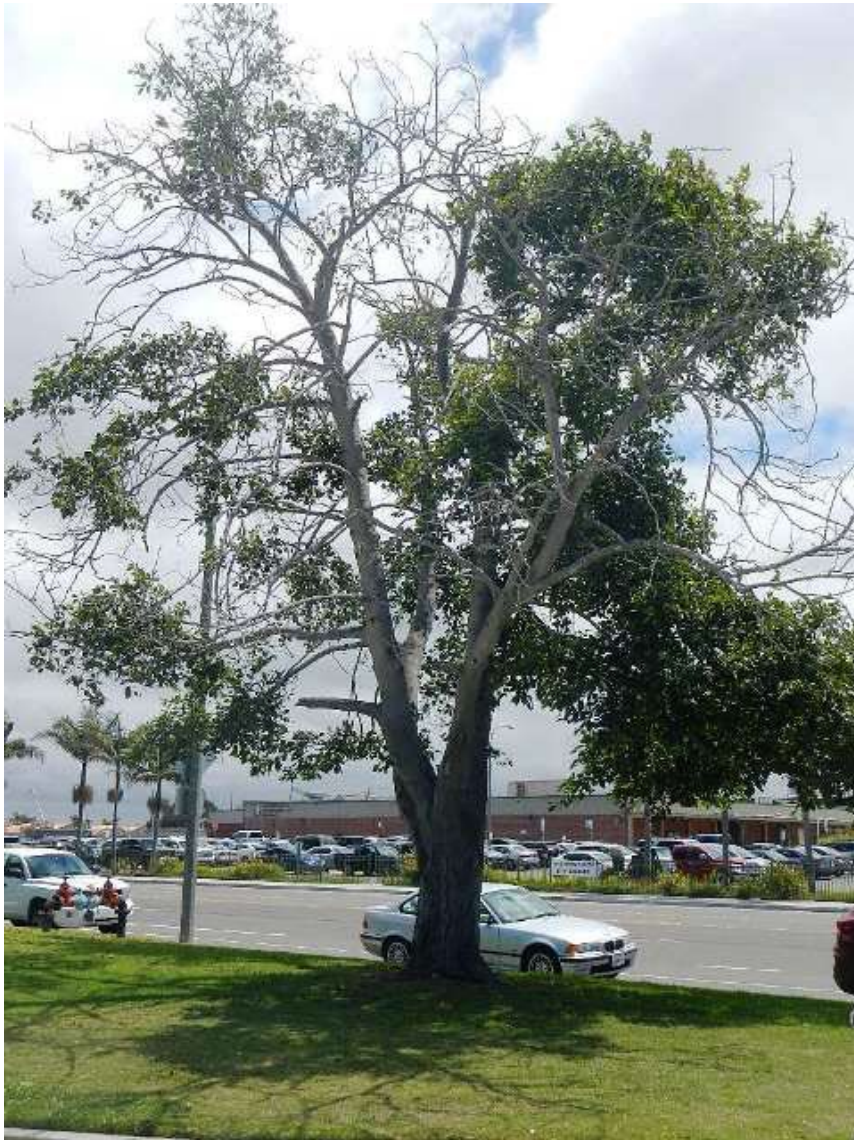
Alders in decline

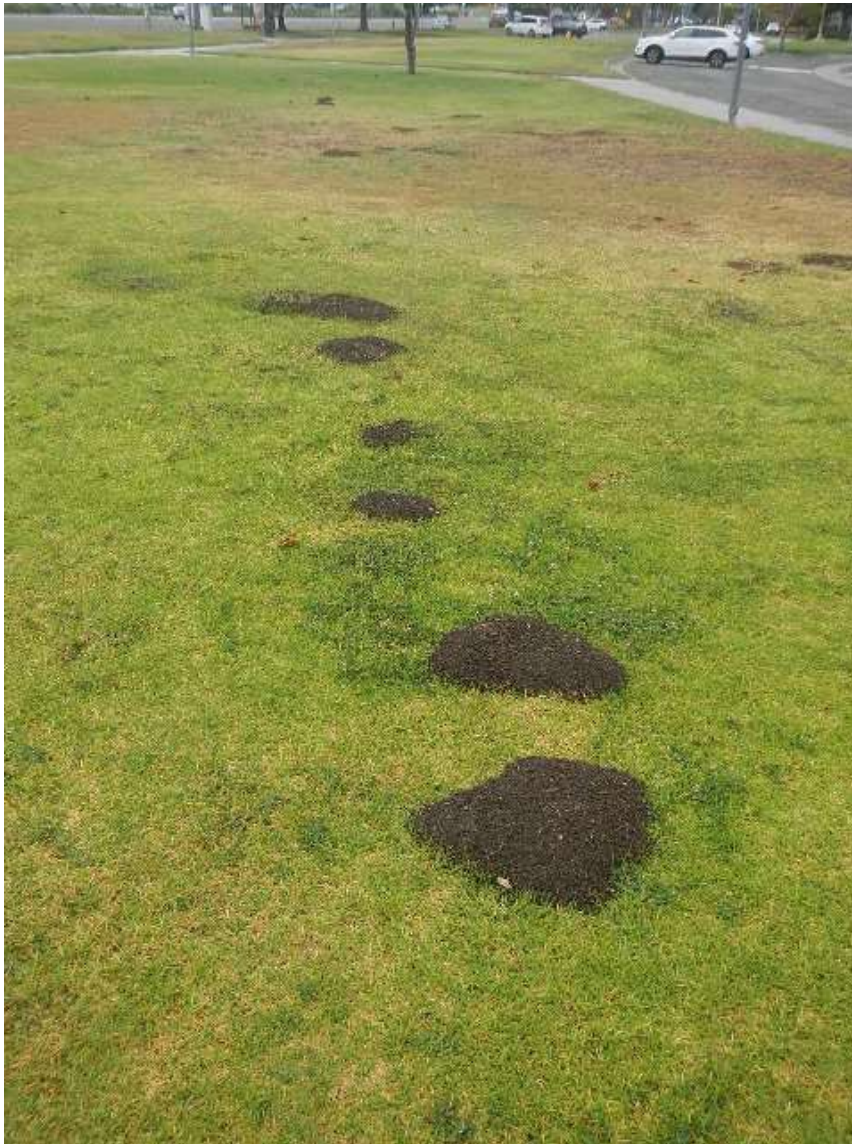
Gophers or ground squirrels abound.

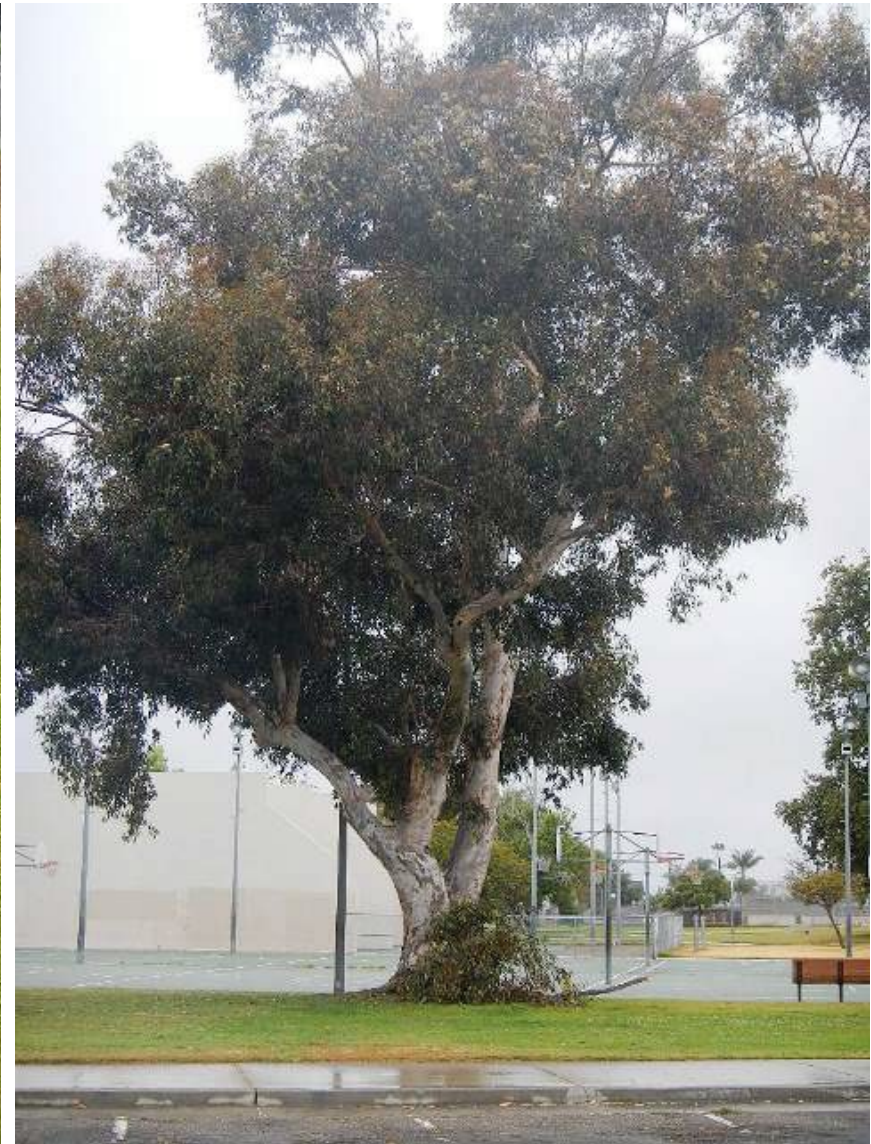
Note a recently fallen branch.

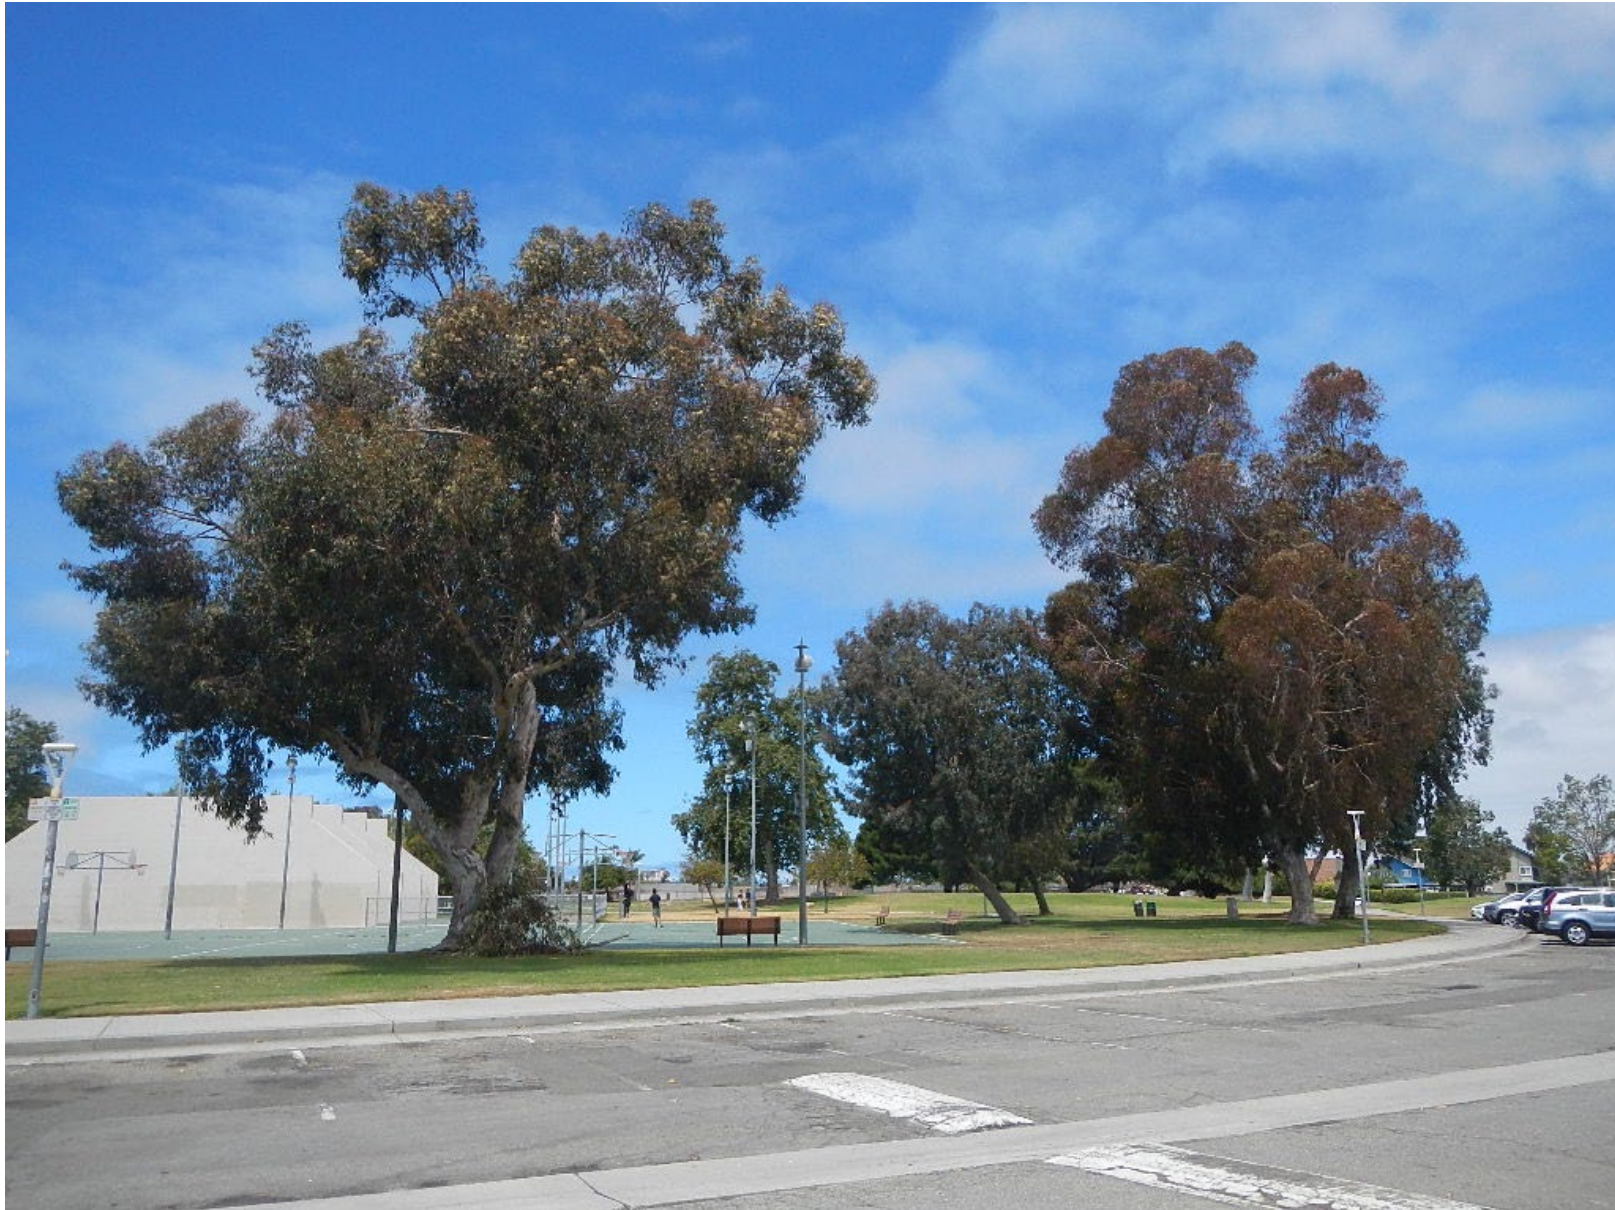
Locals know these trees have dropped limbs, but everyone wanted to make sure they were not removed.

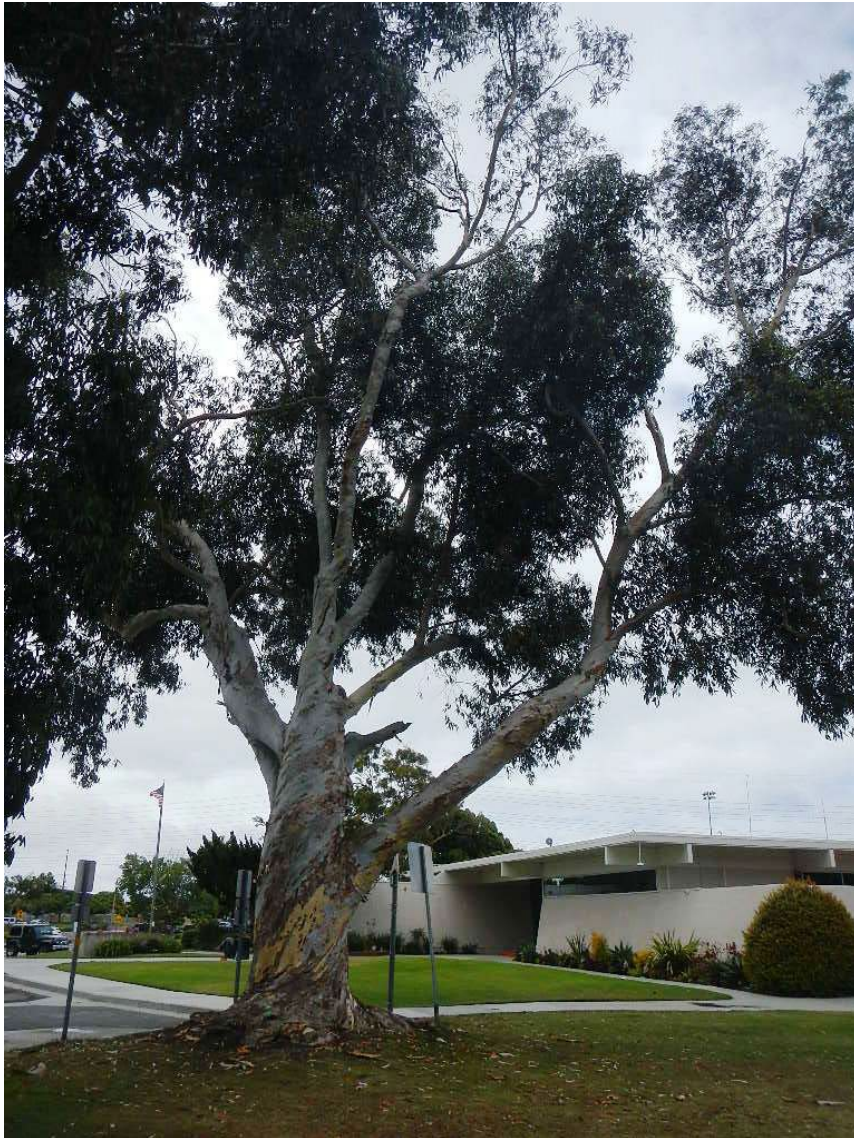
#206 Sugar gum is one-sided and has crossing limbs that fused.

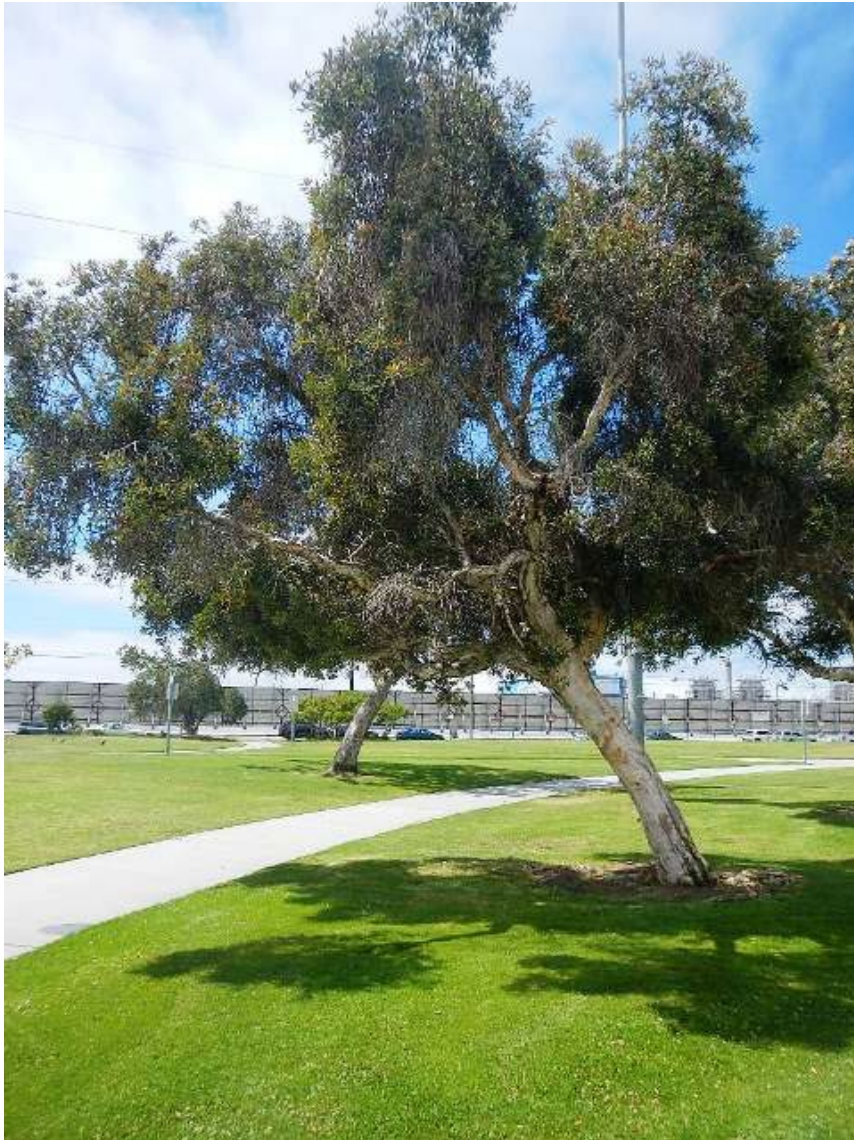
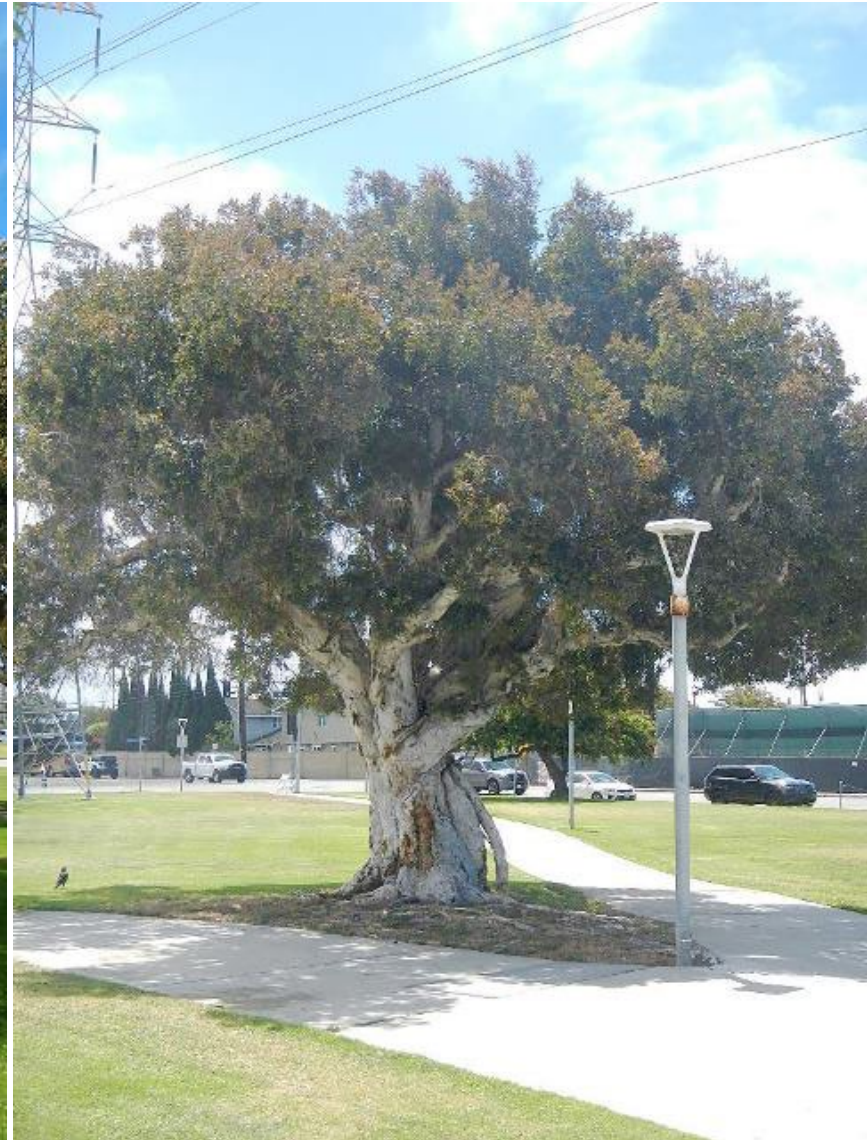
Cajeput or paperbark trees should be a good species for this soil and climate. Some are declining though.

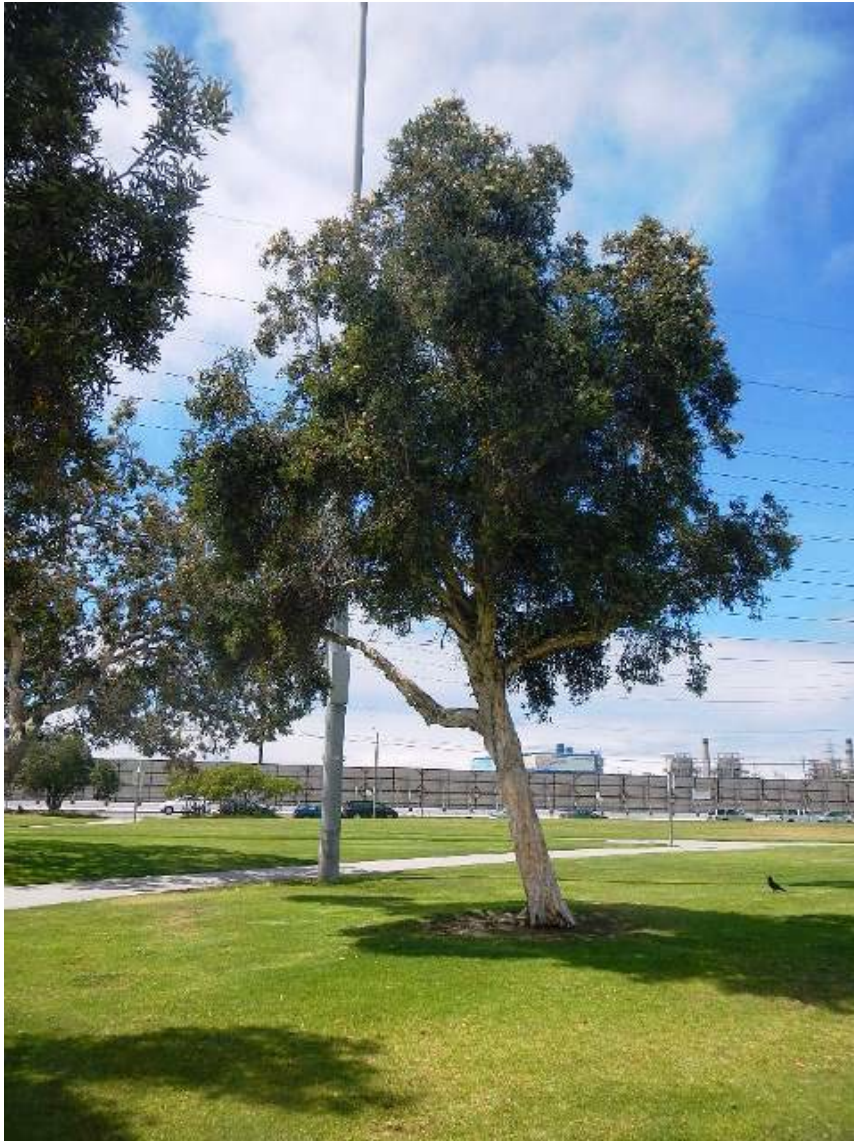
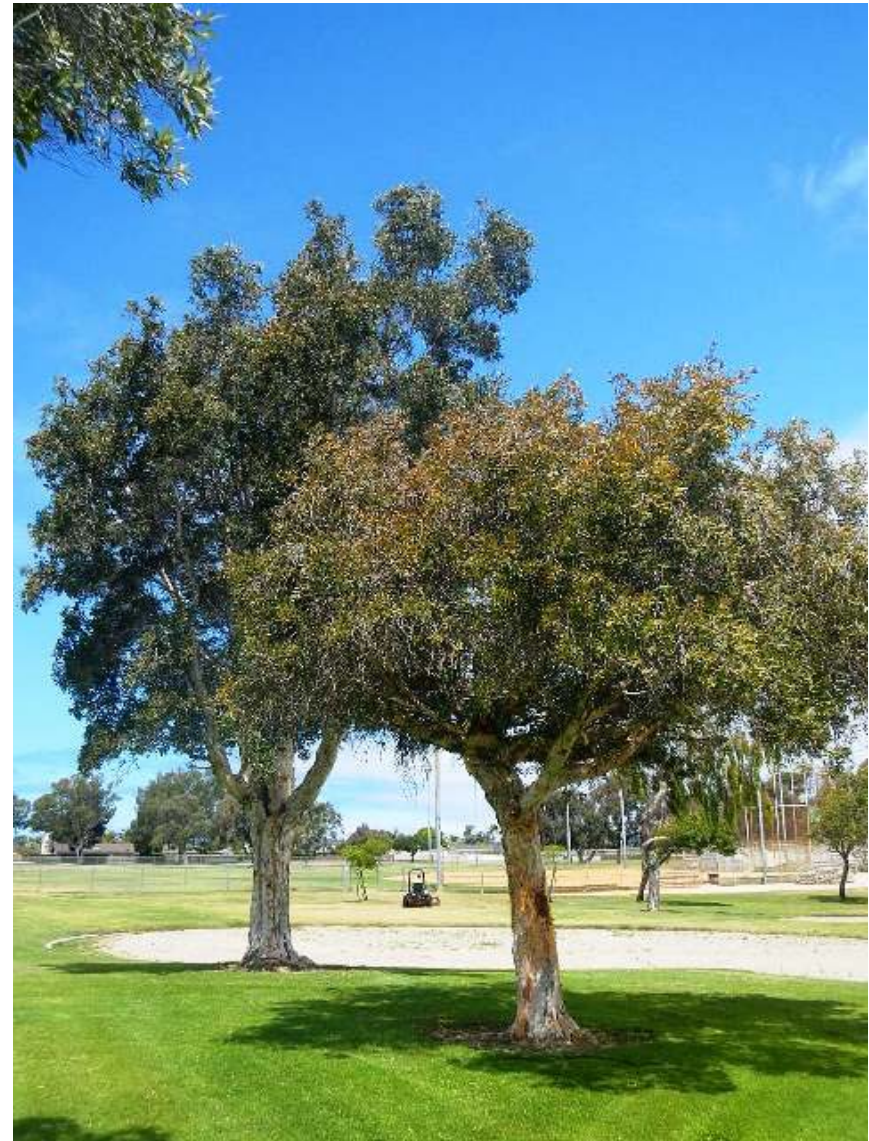
Cajeput or paperbark trees should be a good species for this soil and climate. The most common deterrent to good health are root injuries.

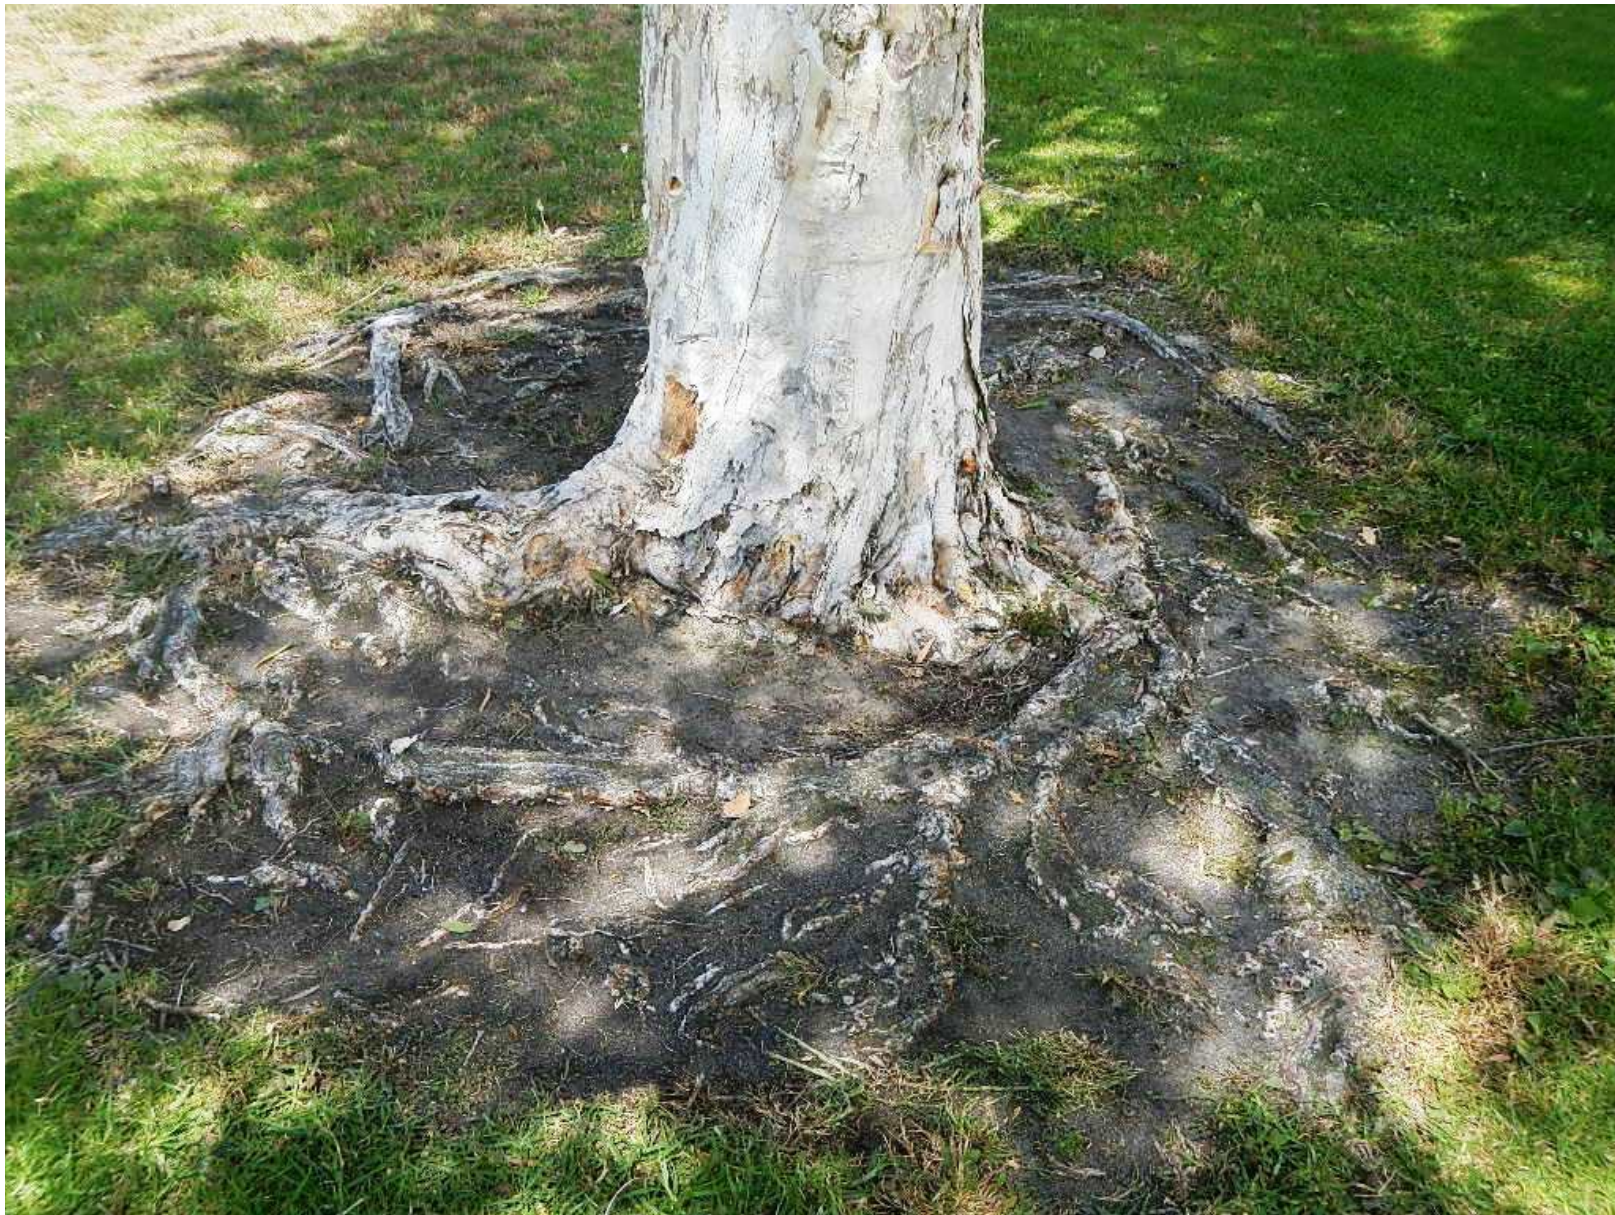
Note the planed down surface roots common around their basess.

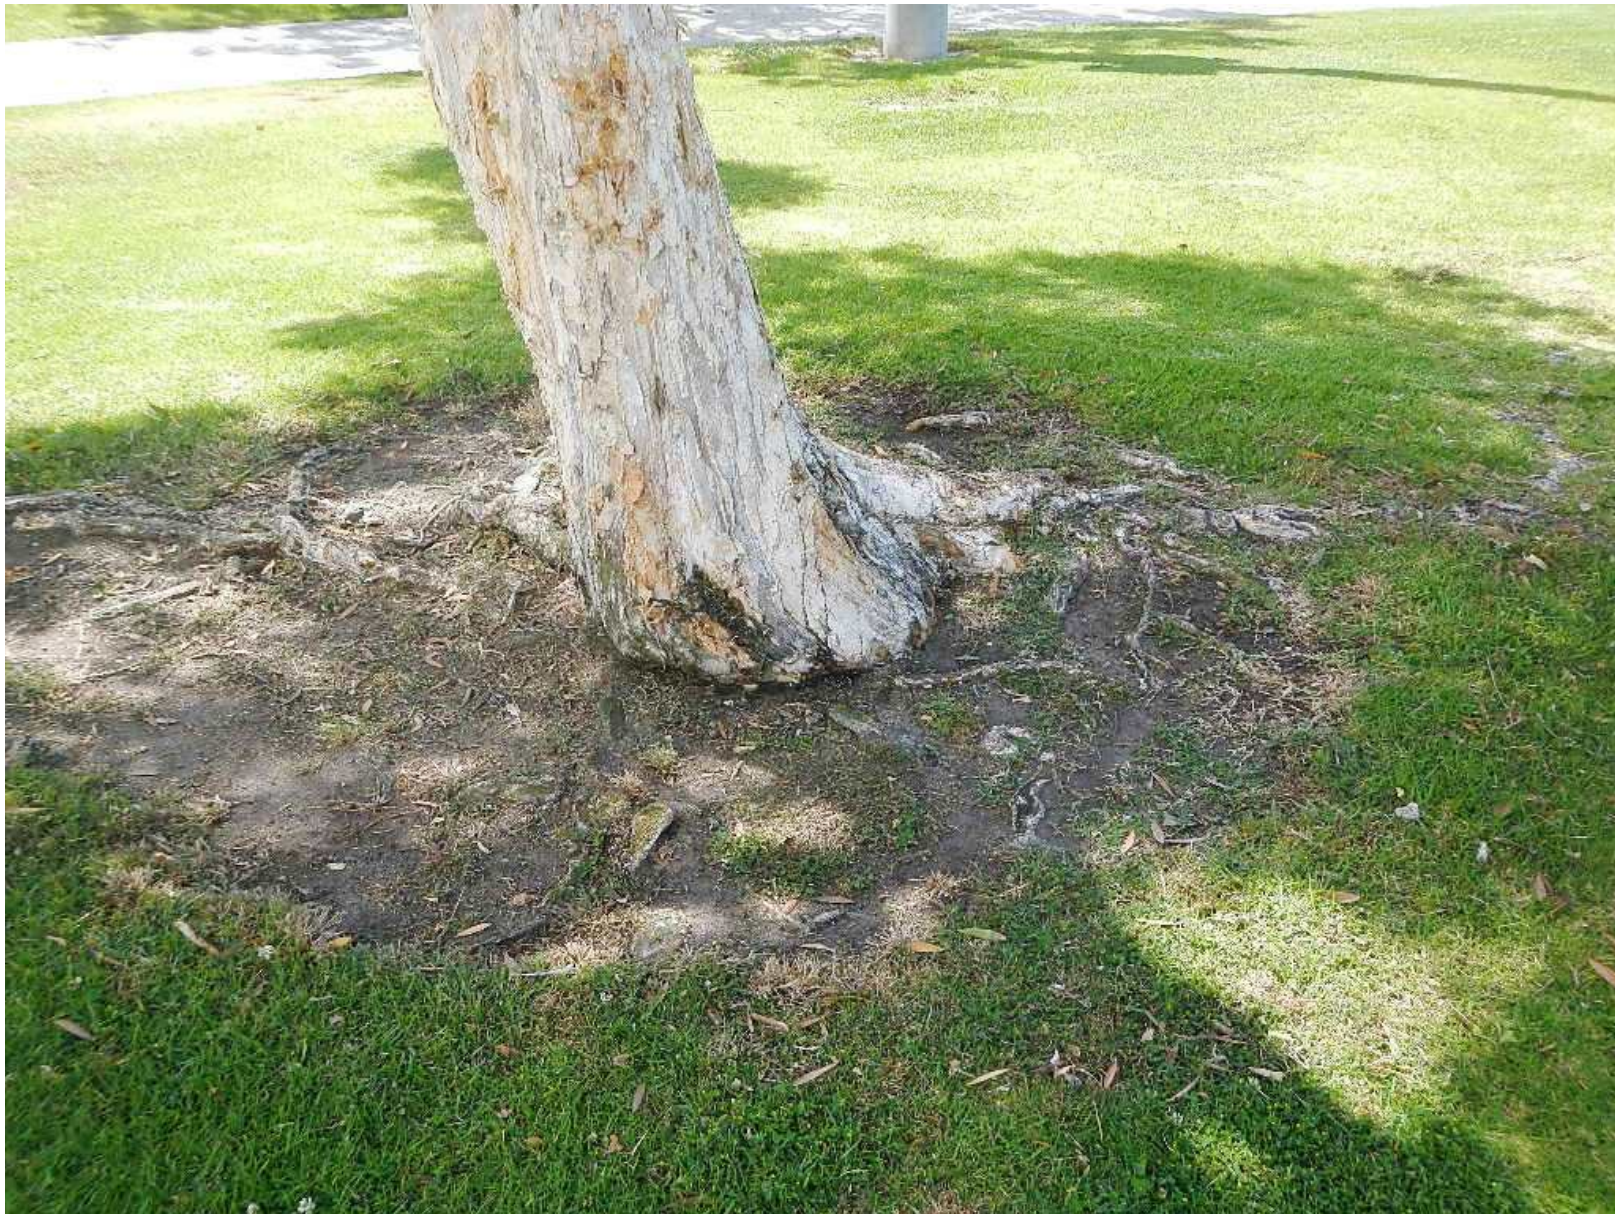
Note the planed down surface roots common around their bases. This one is also girdled

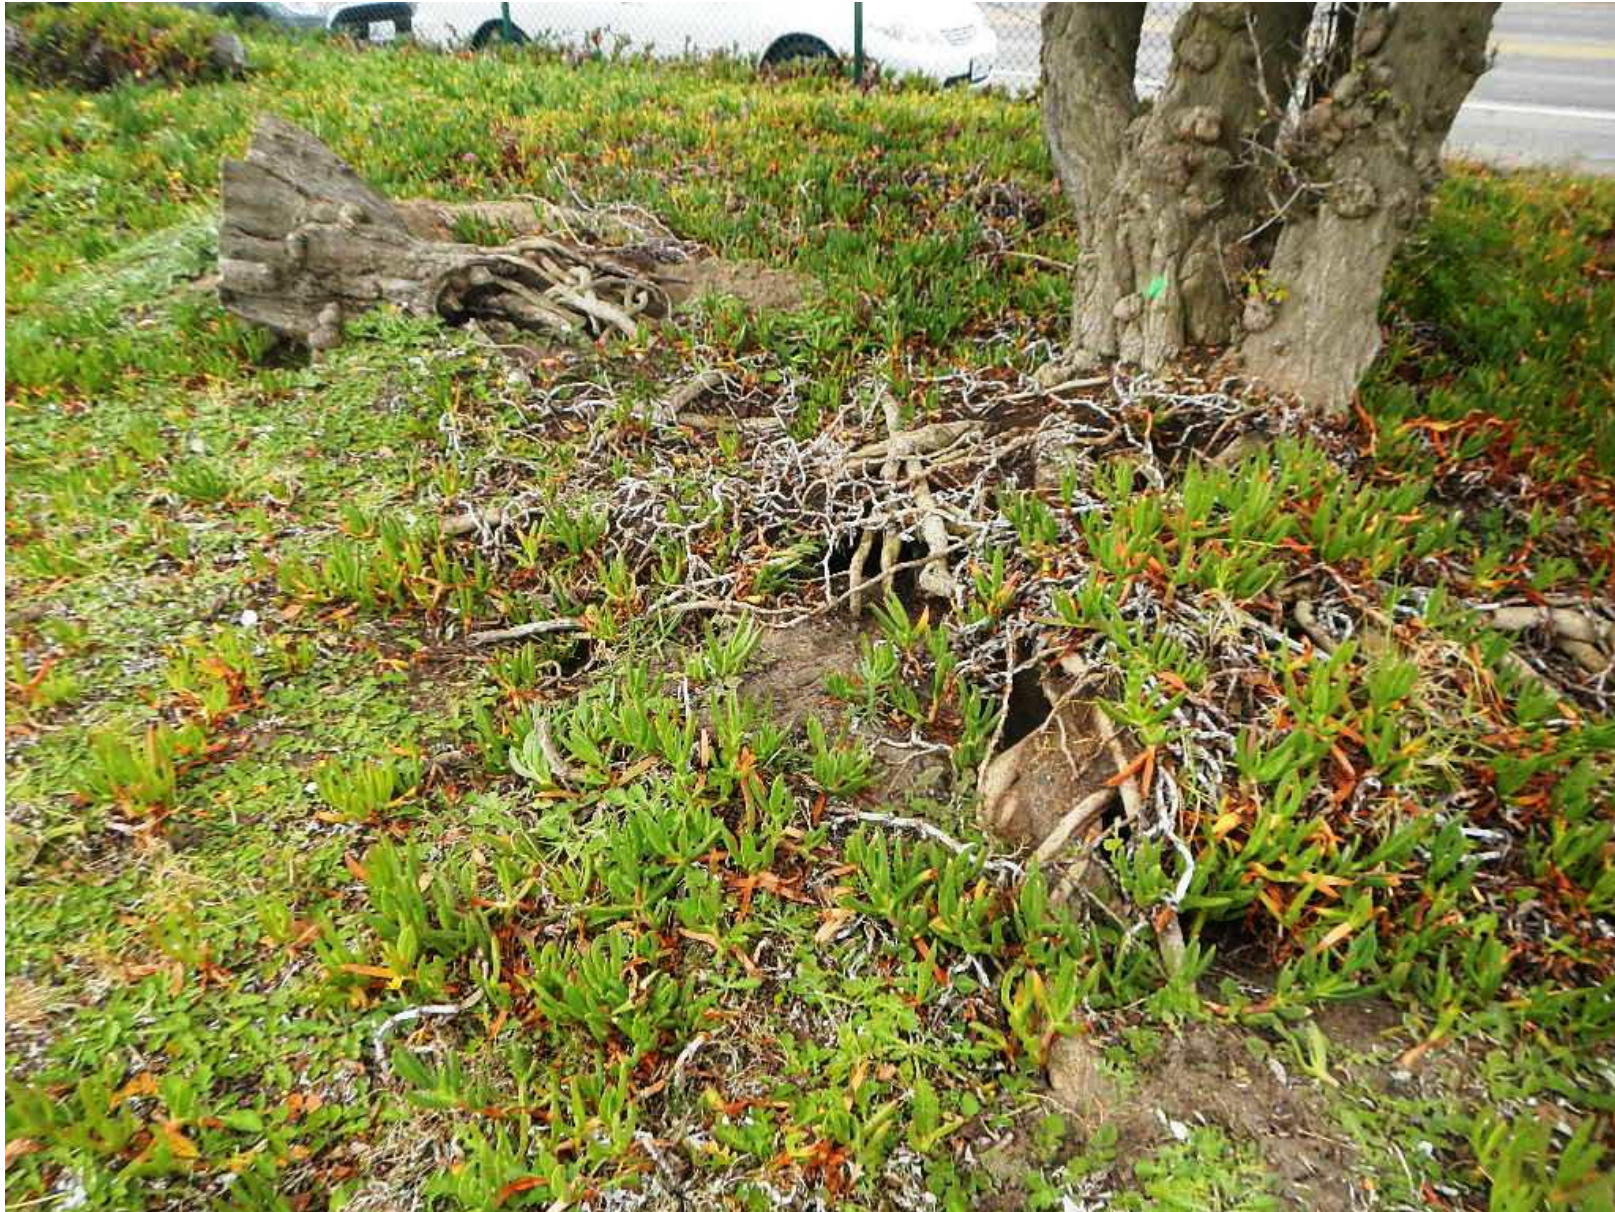
Many myoporums are root sprung.

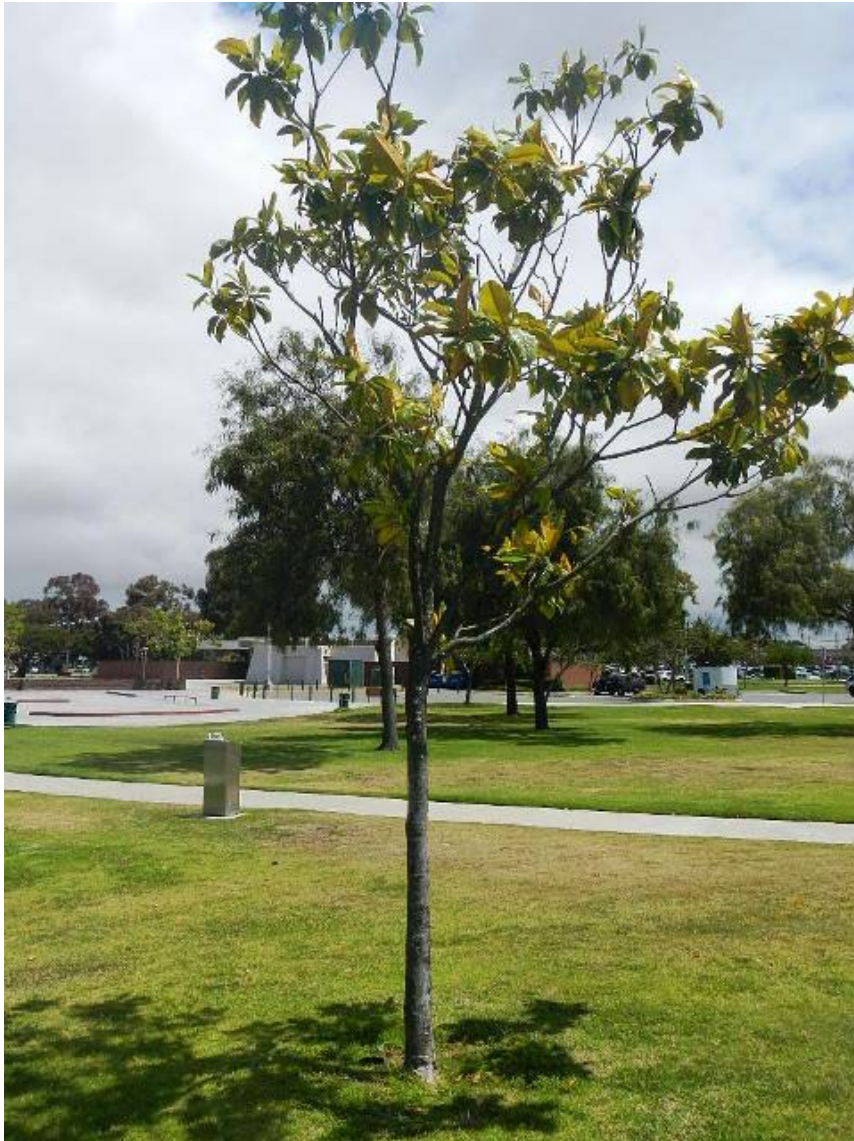
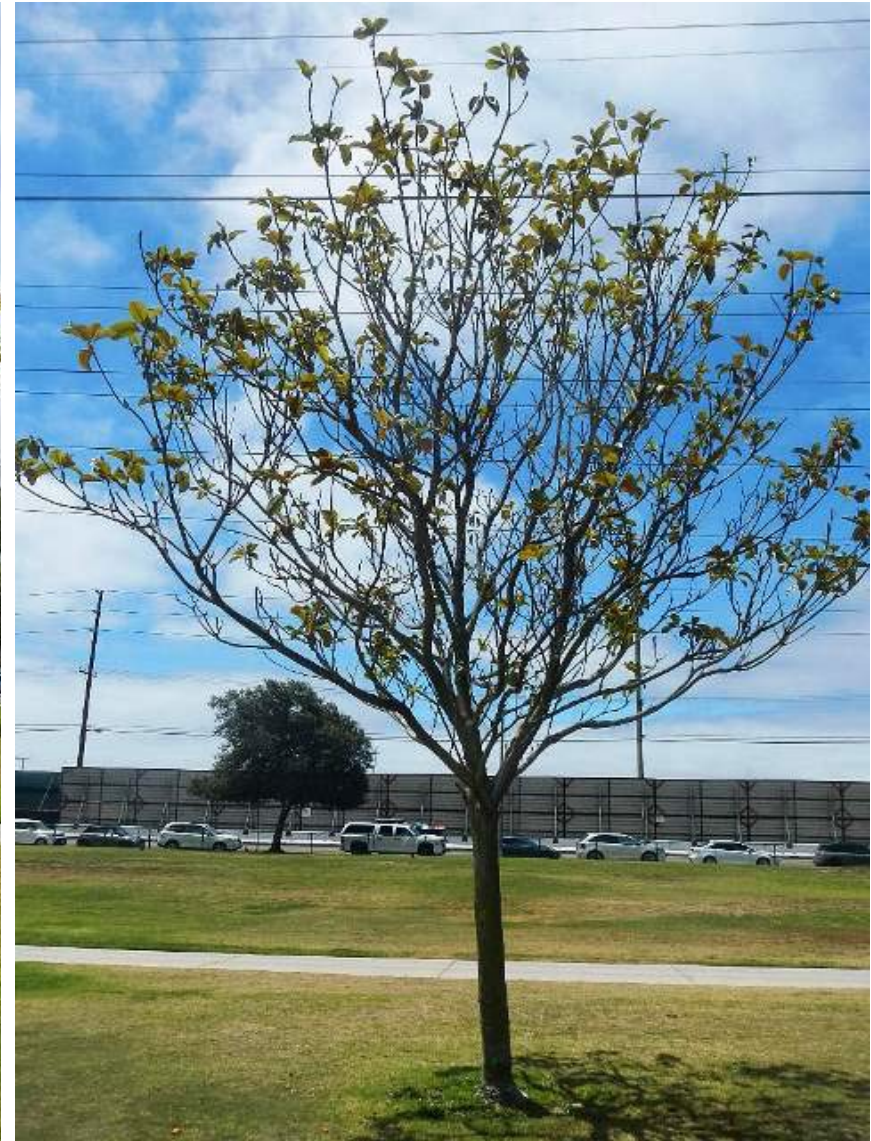
Magnolias are usually a good lawn tree, but need better soil. Note the unhealthy turf surrounding these trees.

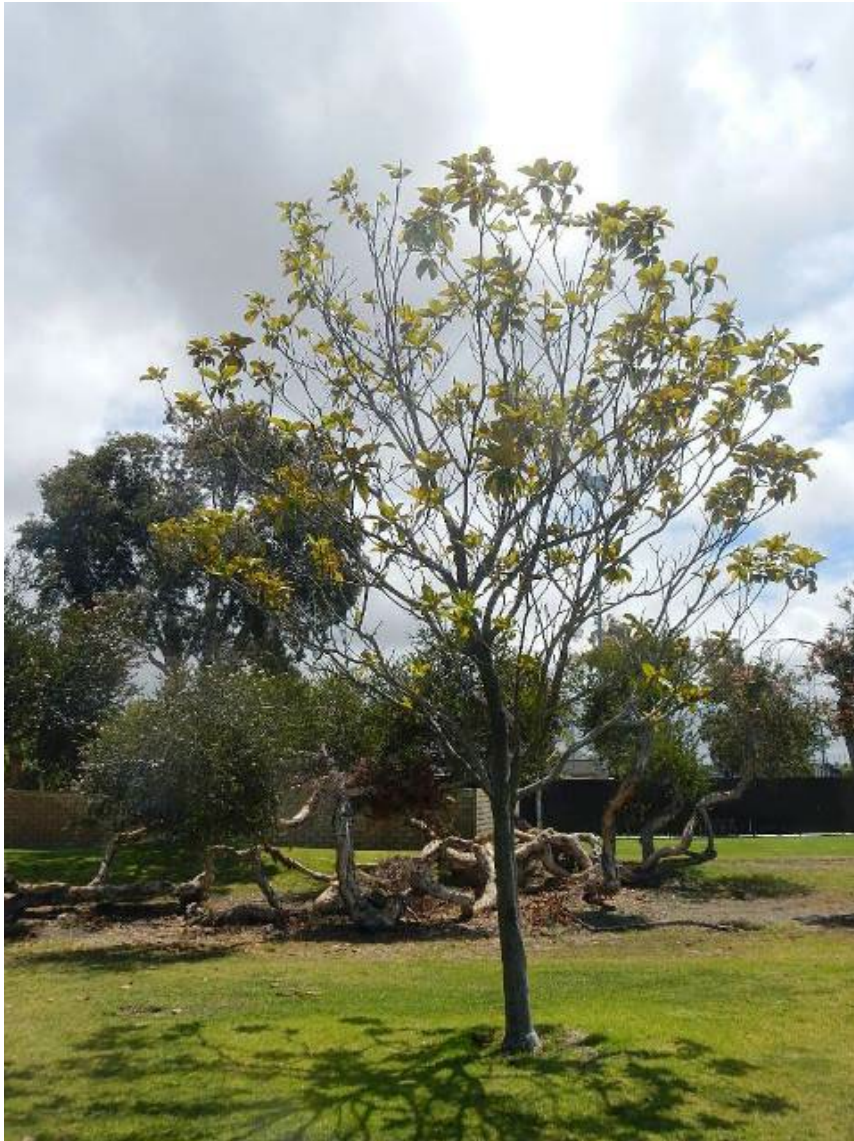
Note the unhealthy turf surrounding these trees.

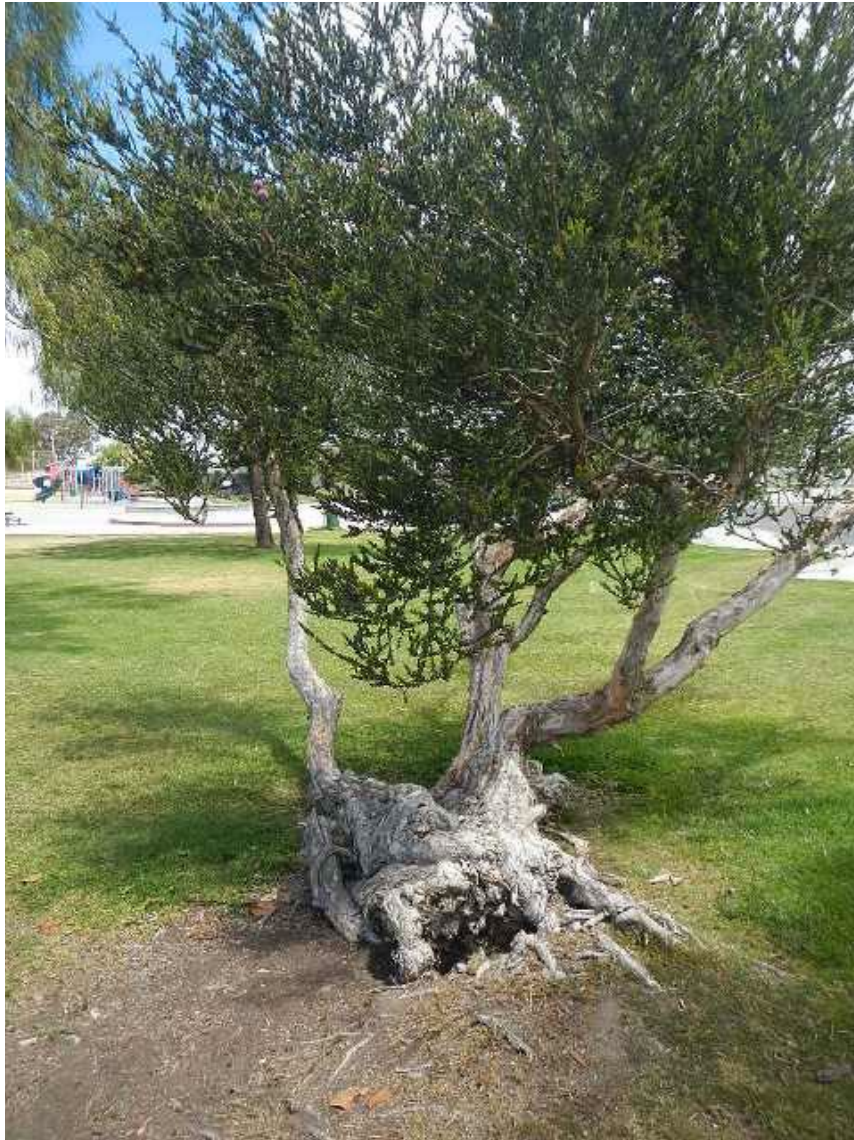
A root sprung pink melaleuca.

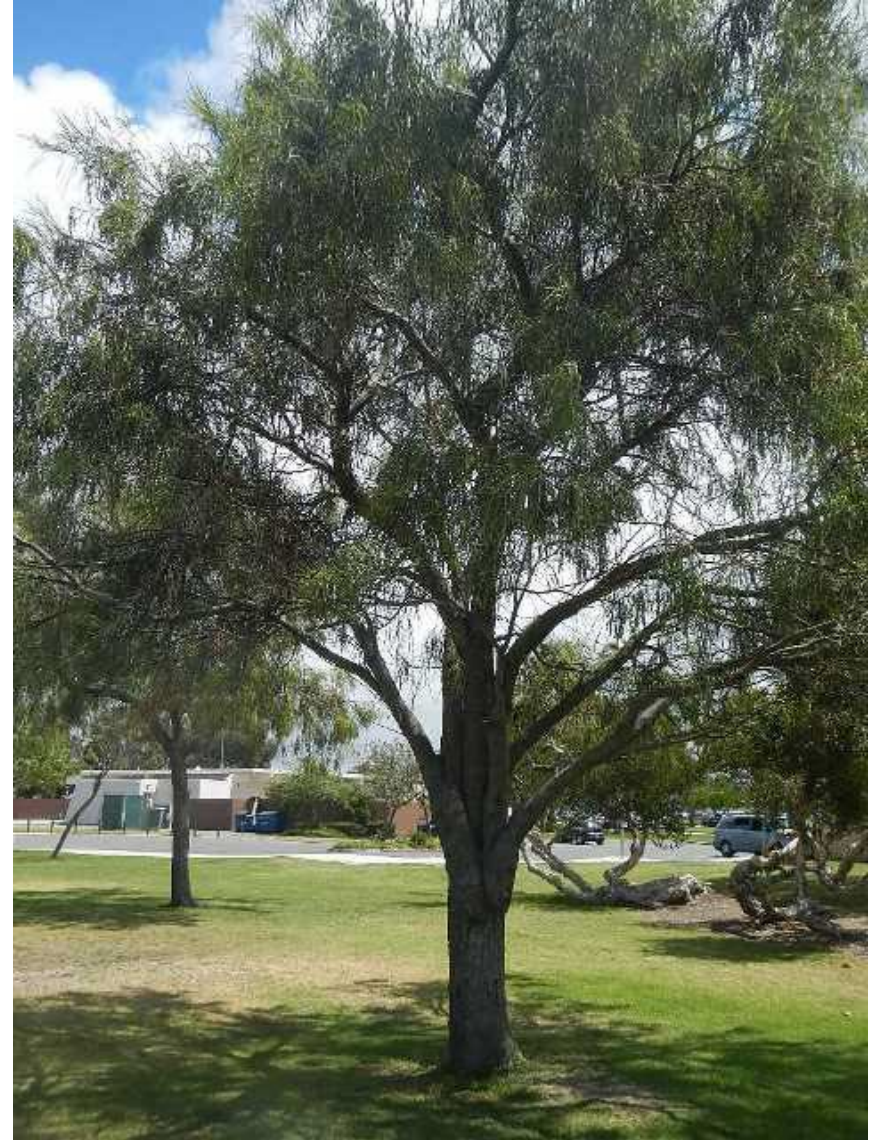
#67 Willow pittosporum with a braided trunk.
