**Arborist's Report
June 18, 2022**

Tree Preservation Plan

For Edison Park, City of Huntington Beach

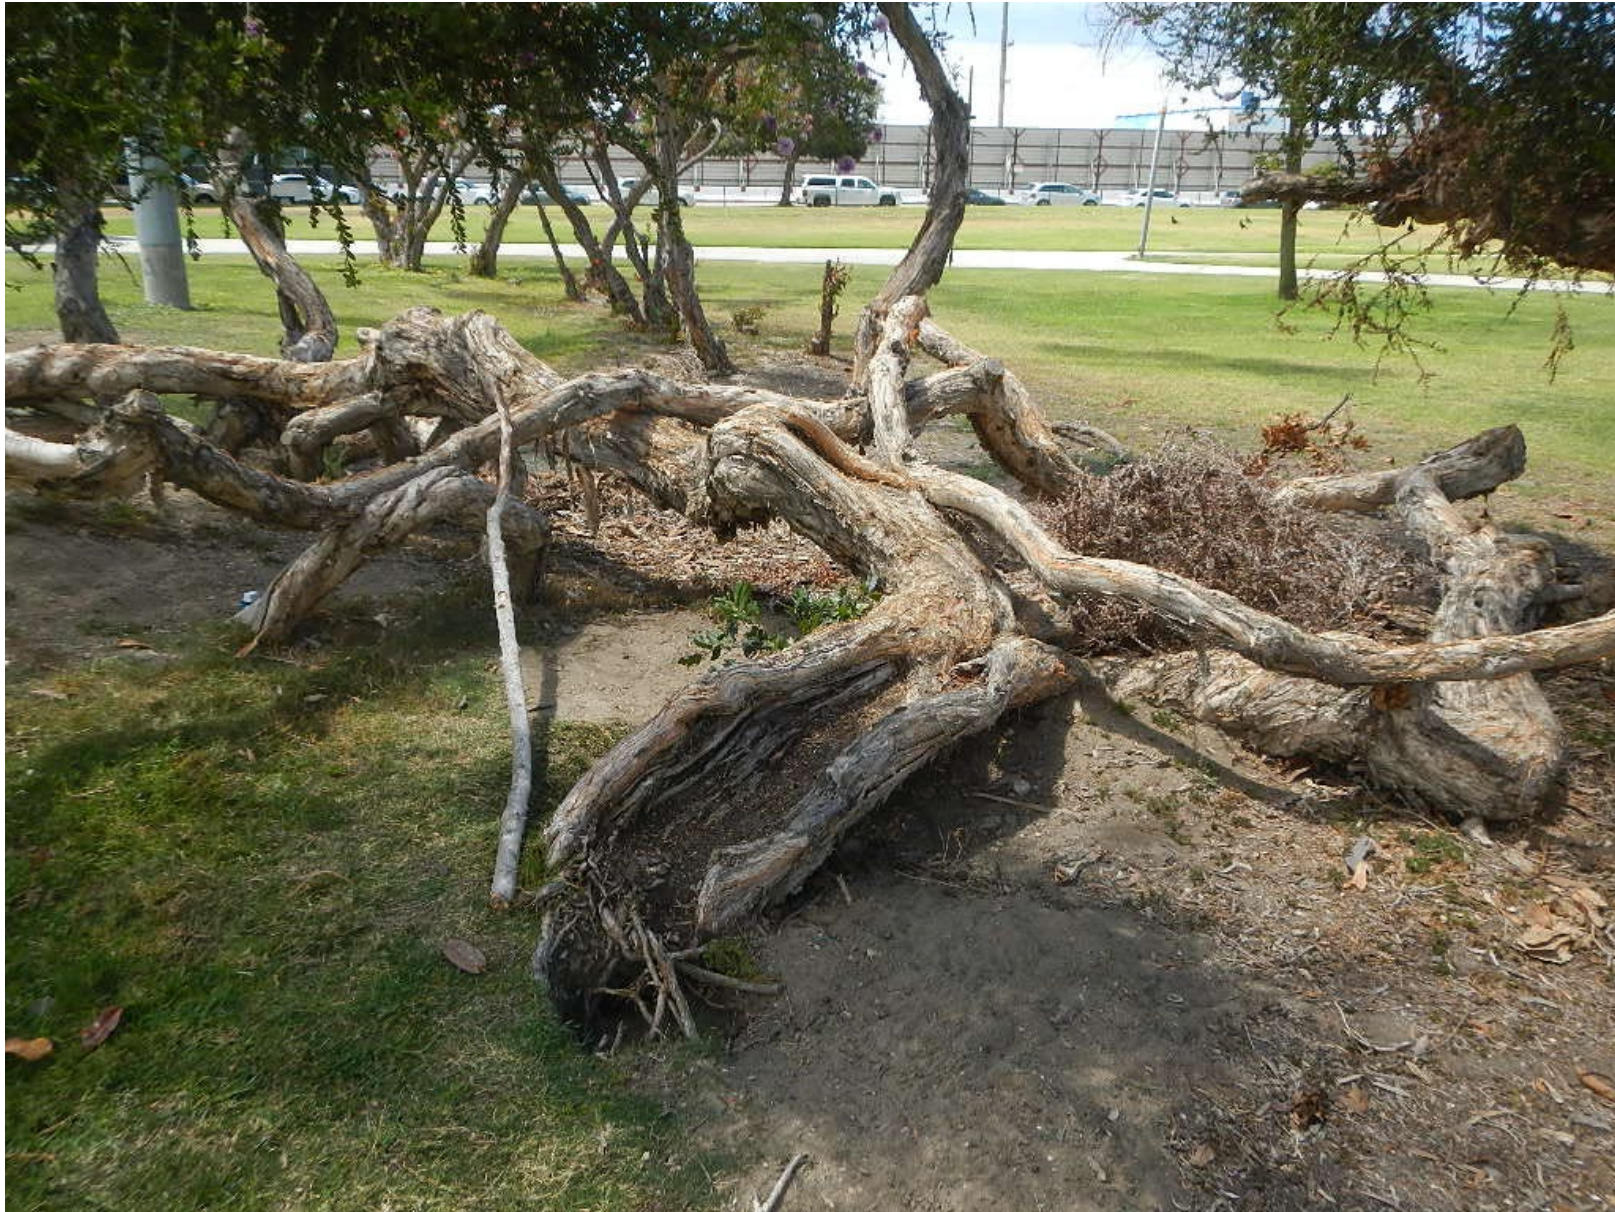
A root-sprung, decayed and headed pink melaleuca, but not dead.

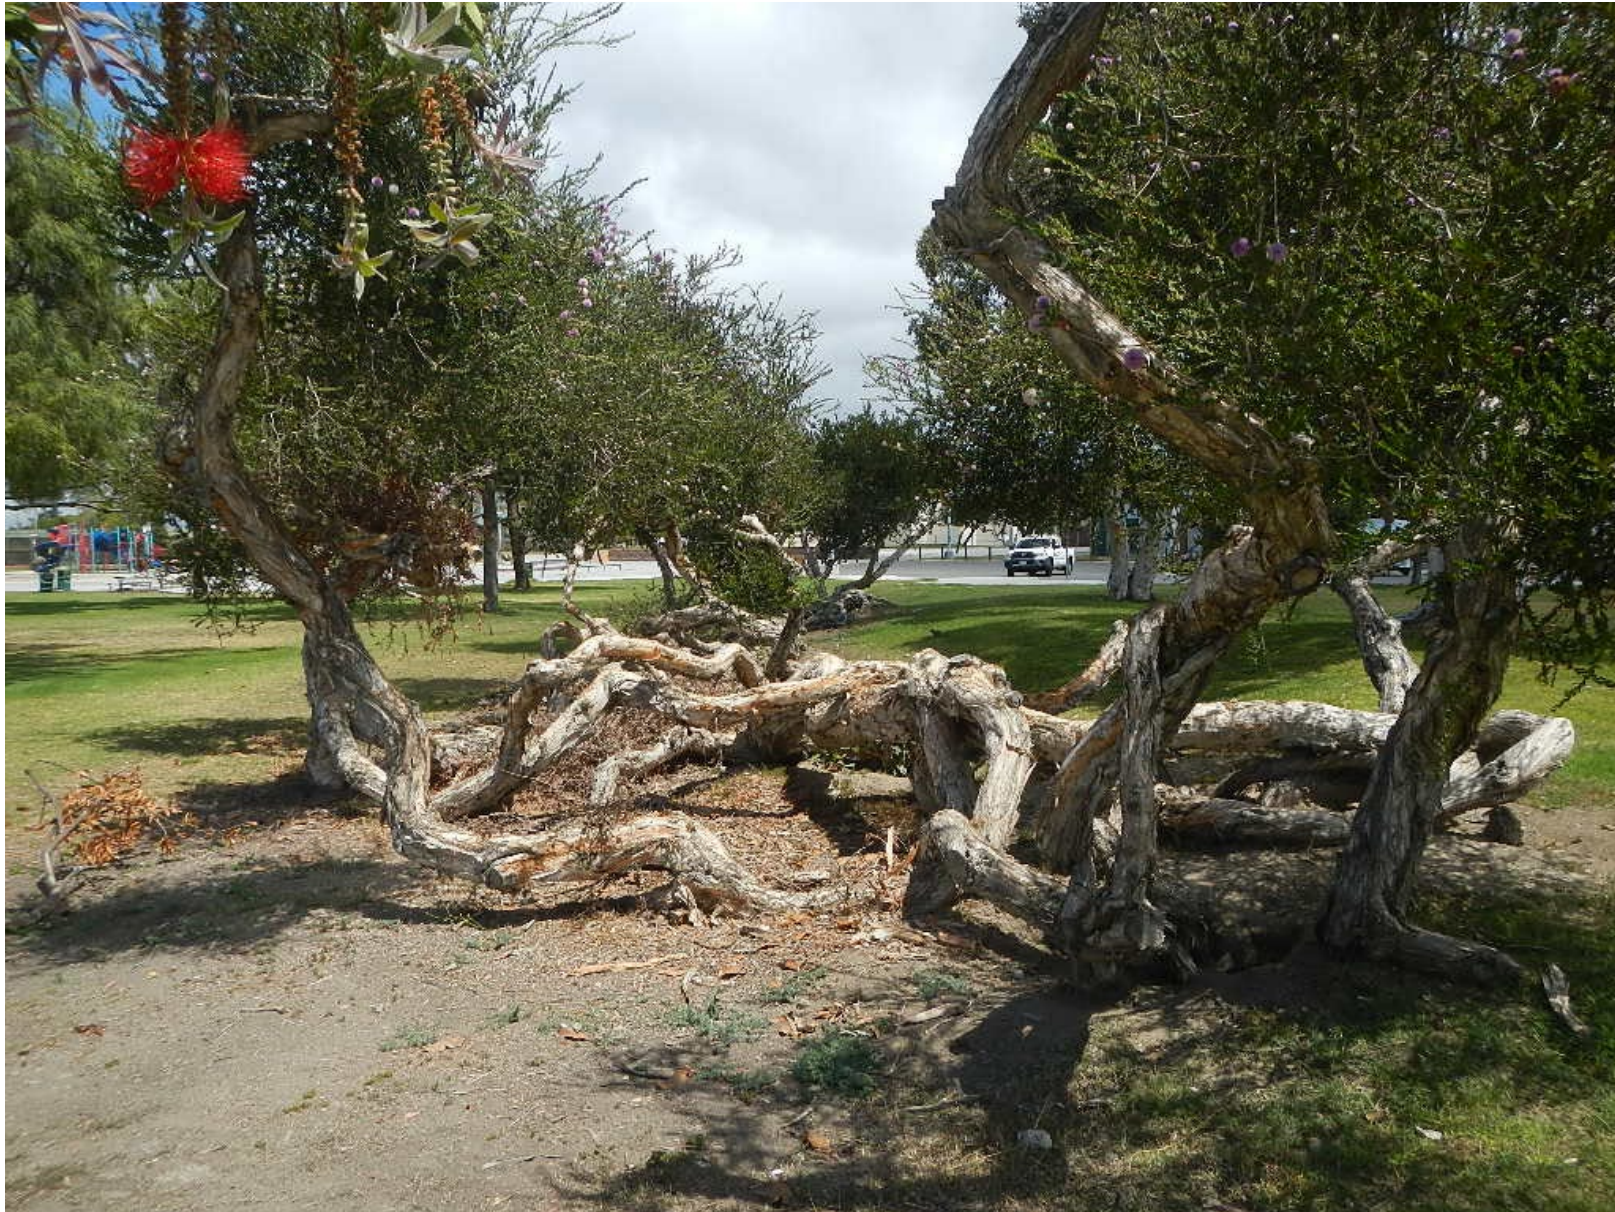
A root-sprung, decayed and headed pink melaleuca, but interesting.

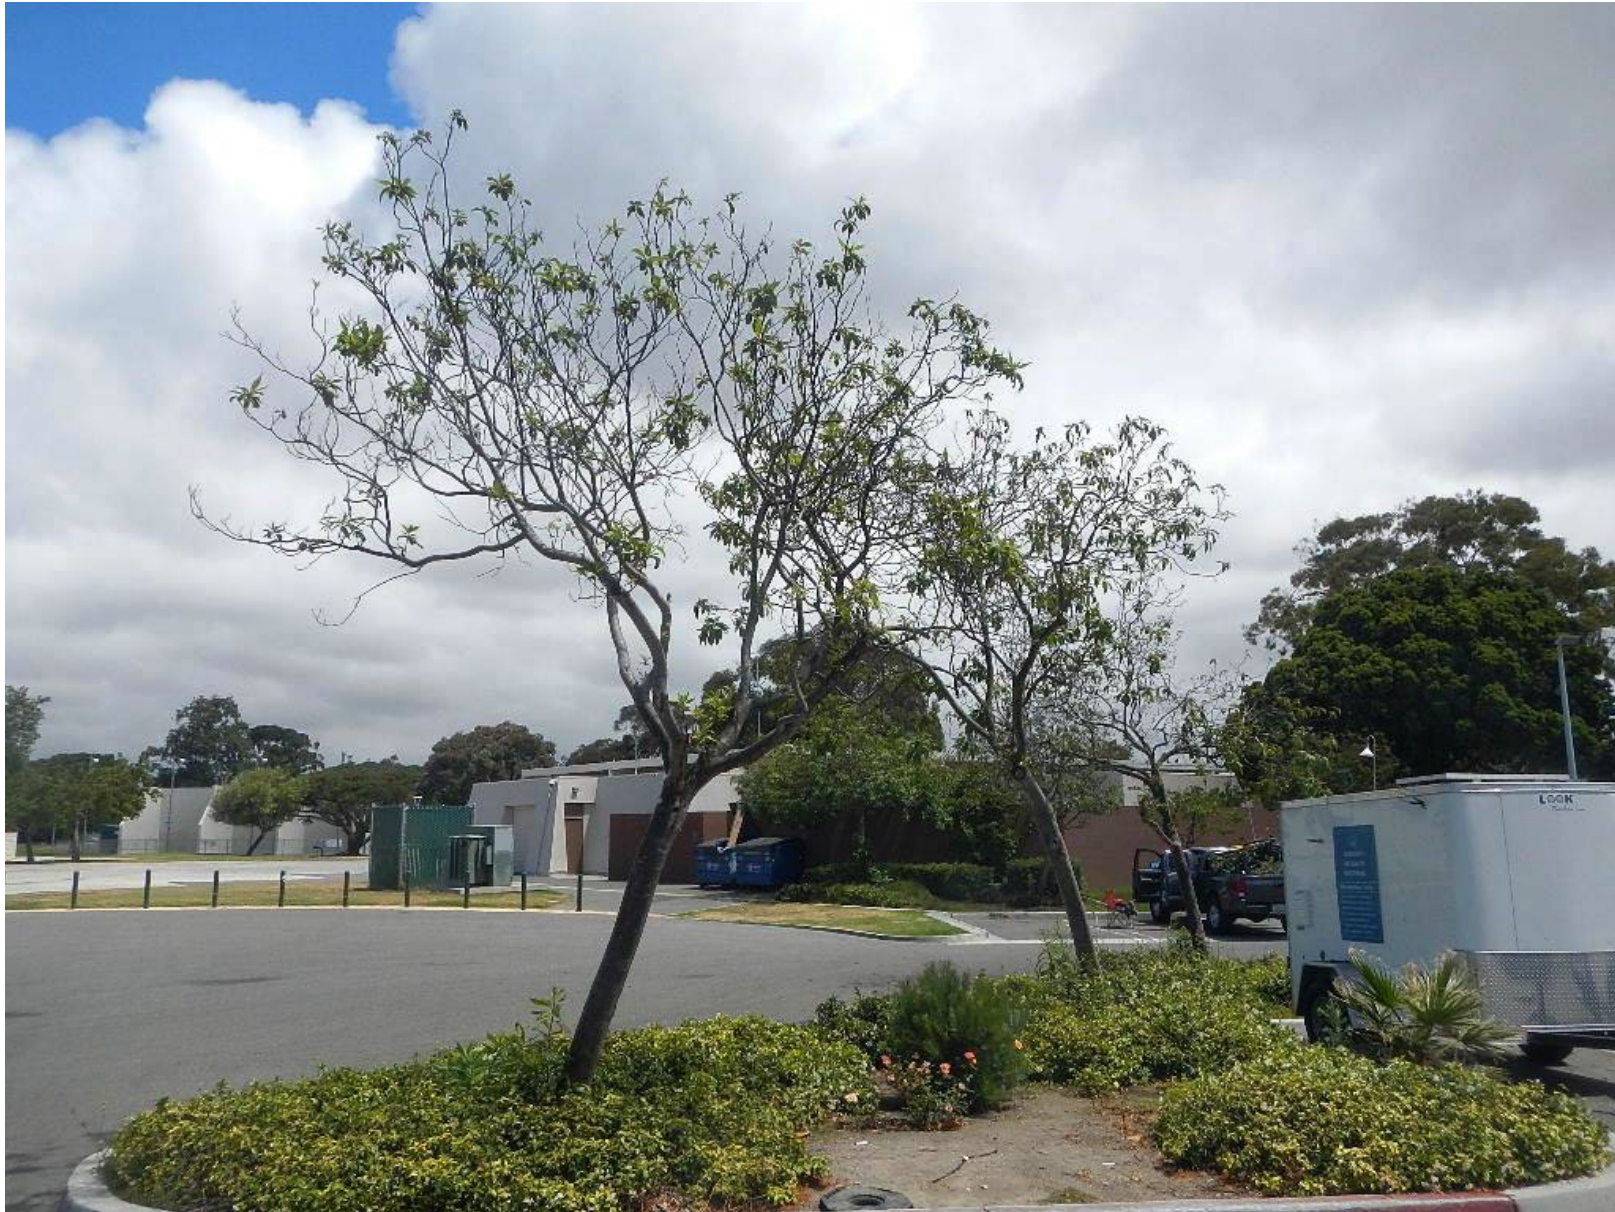
It may be only a seasonal problem, but the Chitalpas are sparse and heavily infested by aphids. Aphids can infest many different species when they have soft new leaves in spring. However, this is the only species noted with a significant aphid infestation.

Chitalpa are a recently planted desert loving hybrid. They are sparse, have poor structure and lots of aphids.

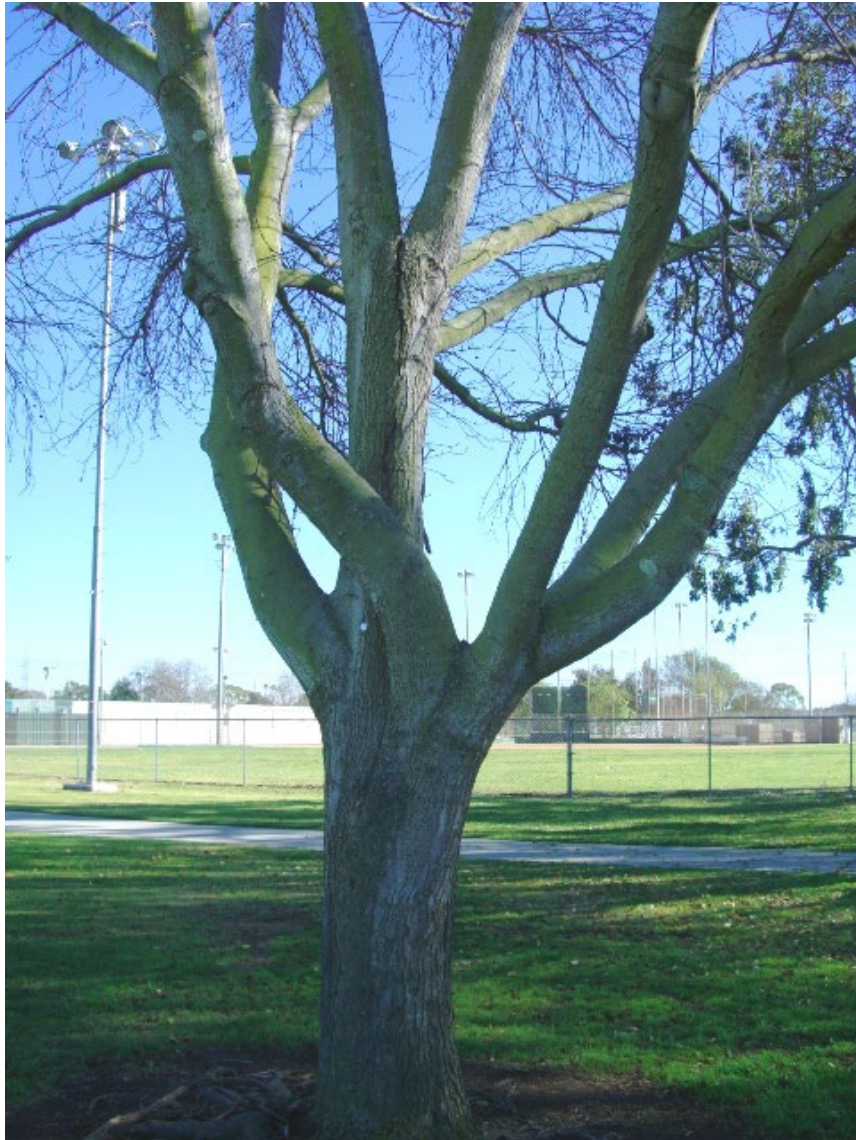
Tag #145, *Liquidambar styraciflua* with crowded codominant limbs

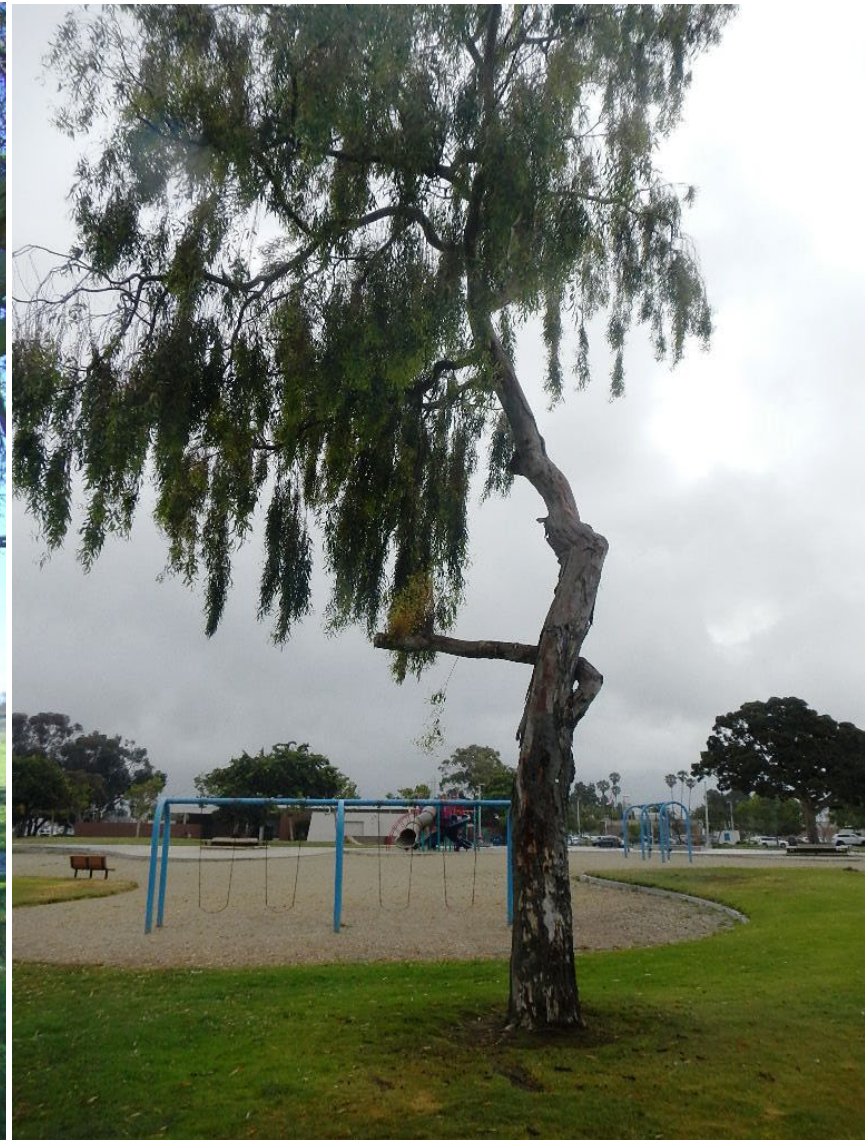
#71 *Eucalyptus camaldulensis* – note headed lower limb wraps around

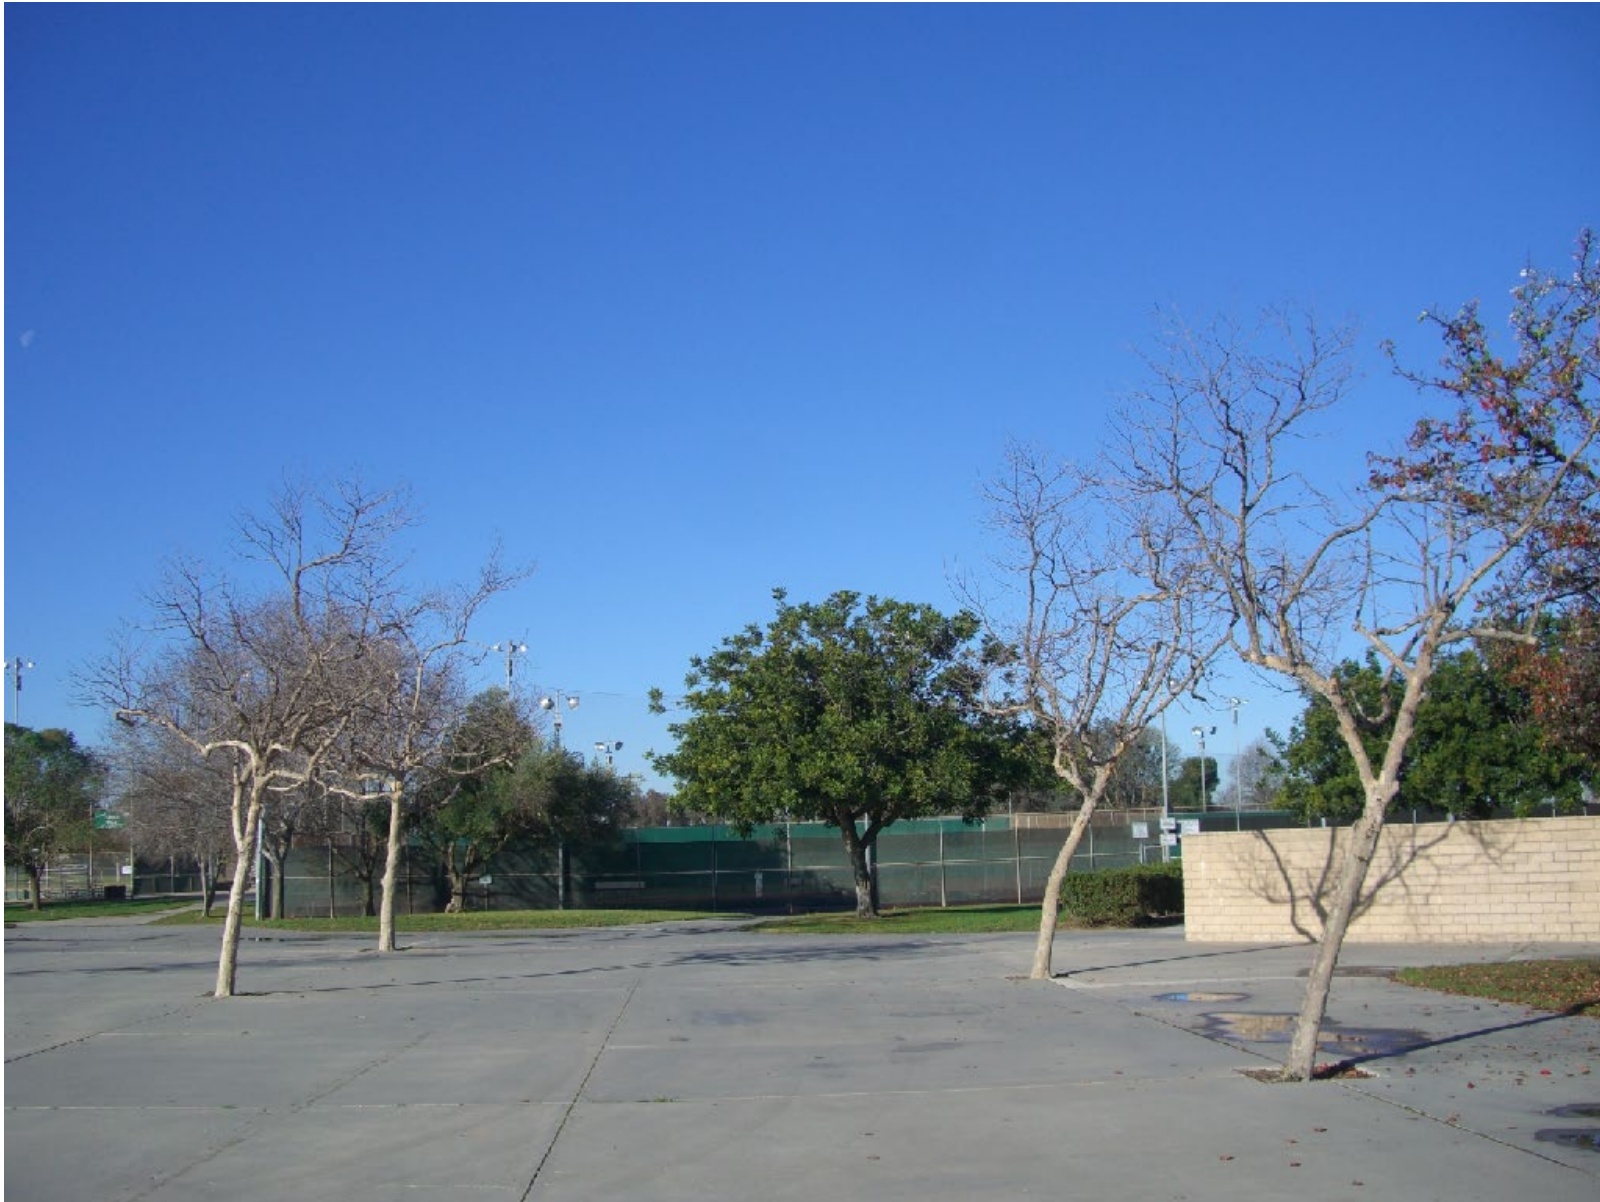
The whole group of London planes in the plaza are in tiny cut-outs and in poor health.>

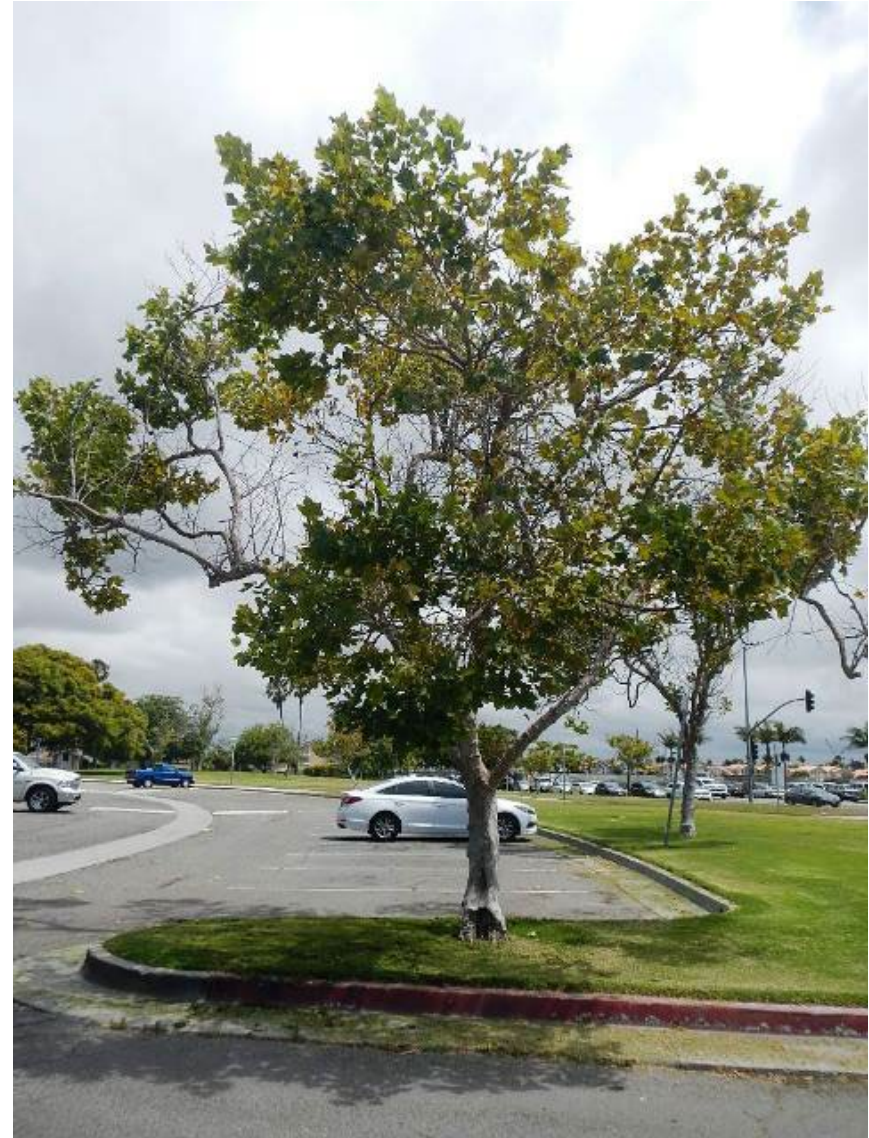
London planes just to the north are in poor health. Soil or water?

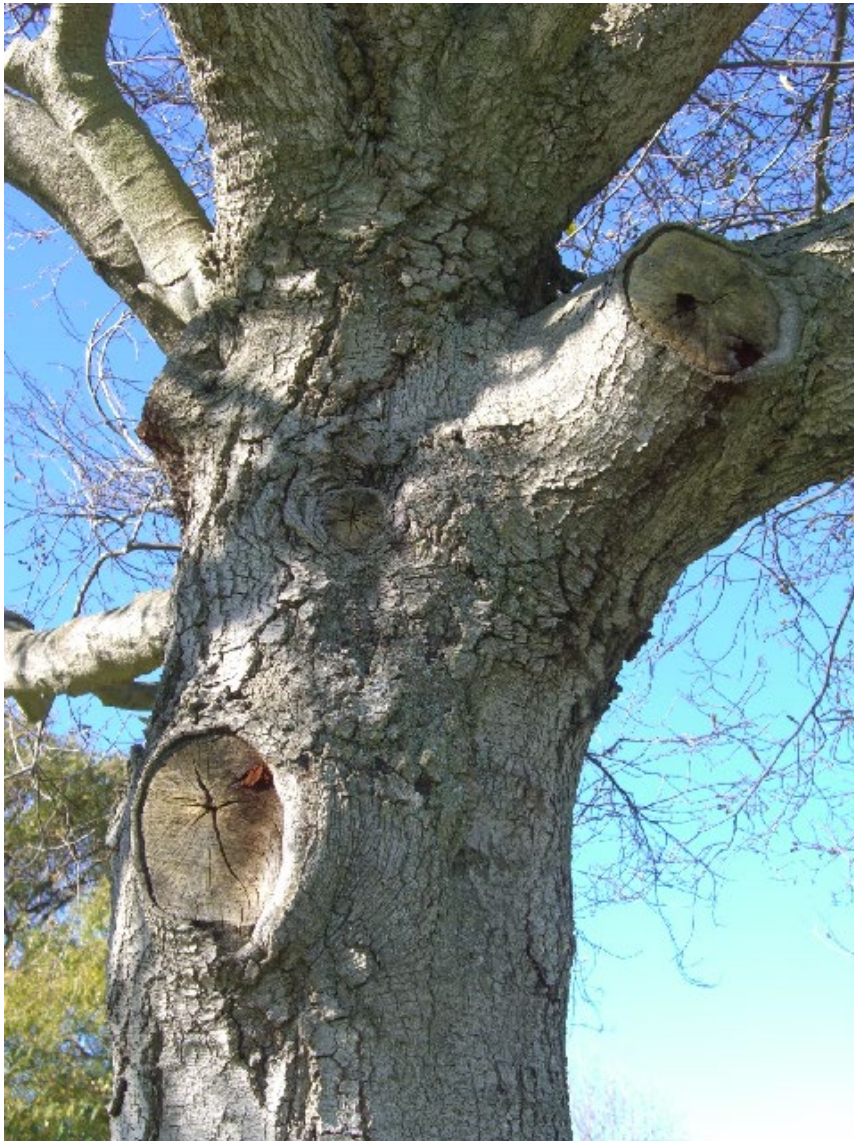
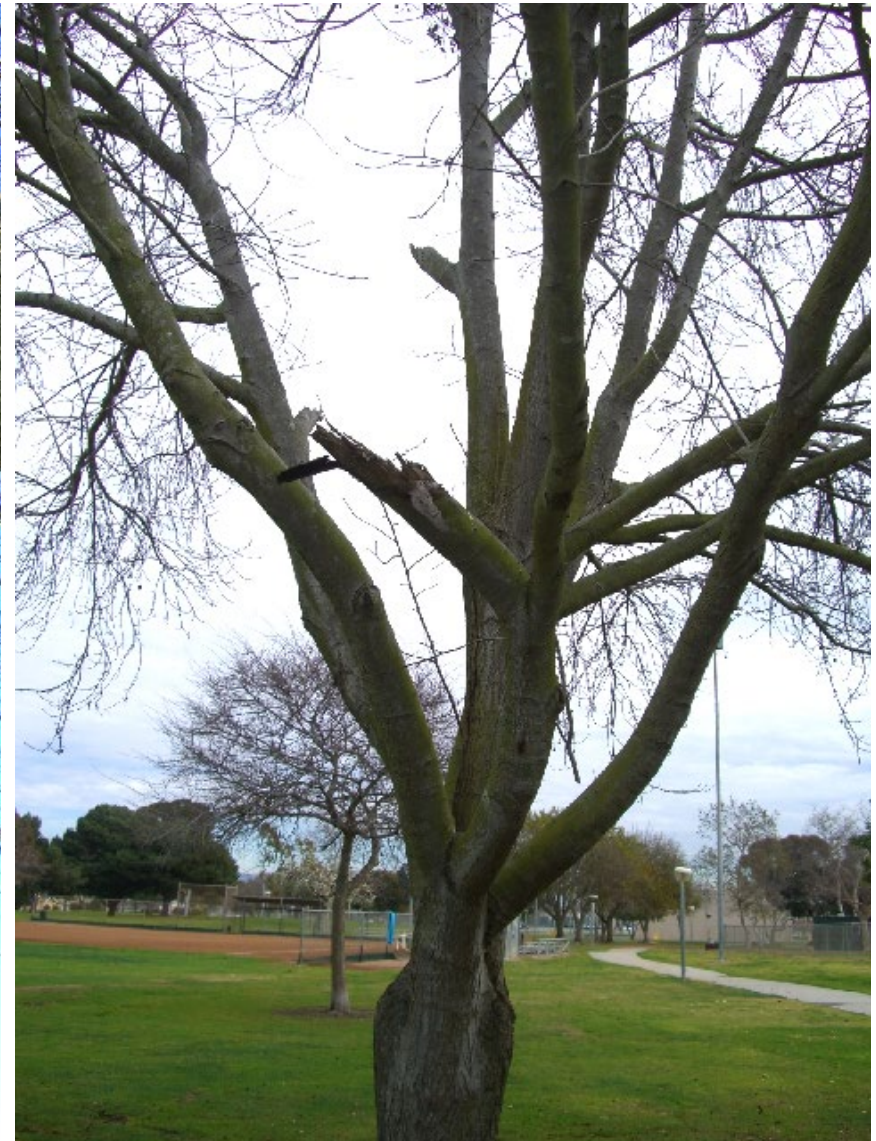
Flush cuts on trunk resulted in velvet stem (*Flammulina velutipes*) decay. #145, Liquidambar with included bark, codominant, broken limbs

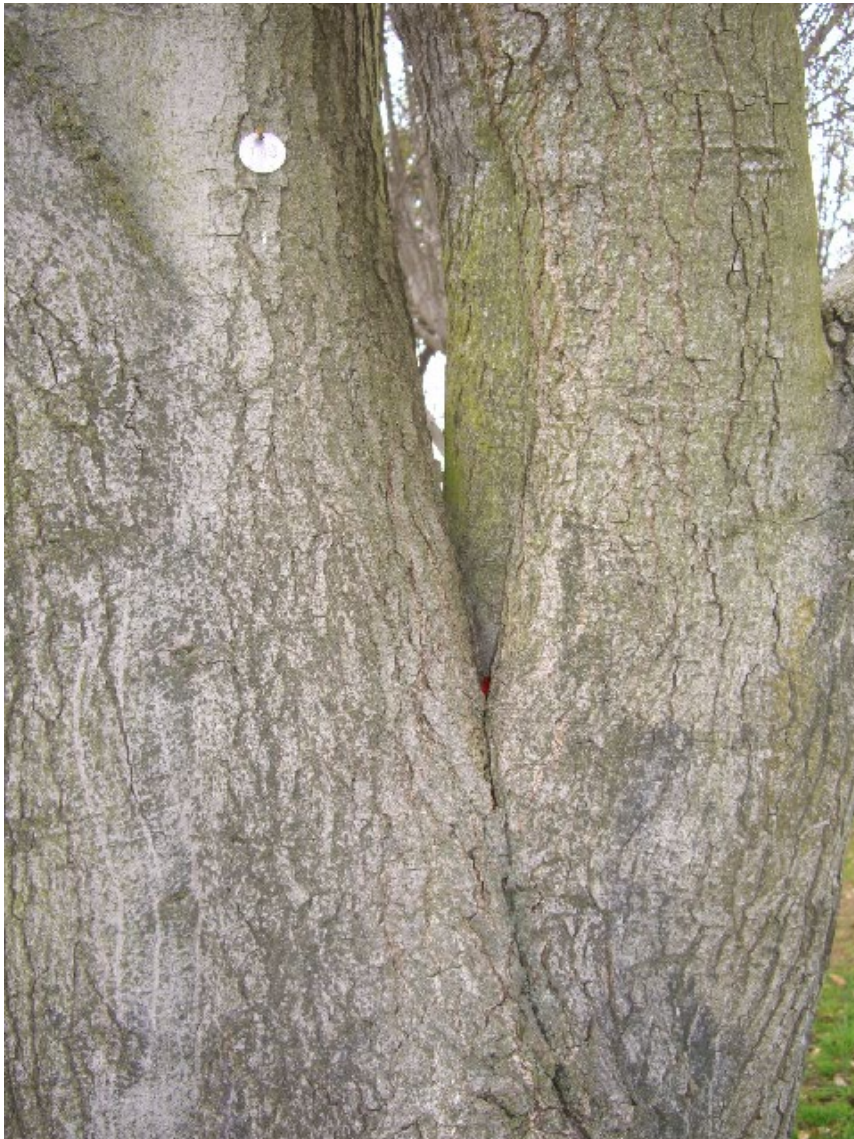
Tag #145, Liquidambar with codominant limbs and included bark.

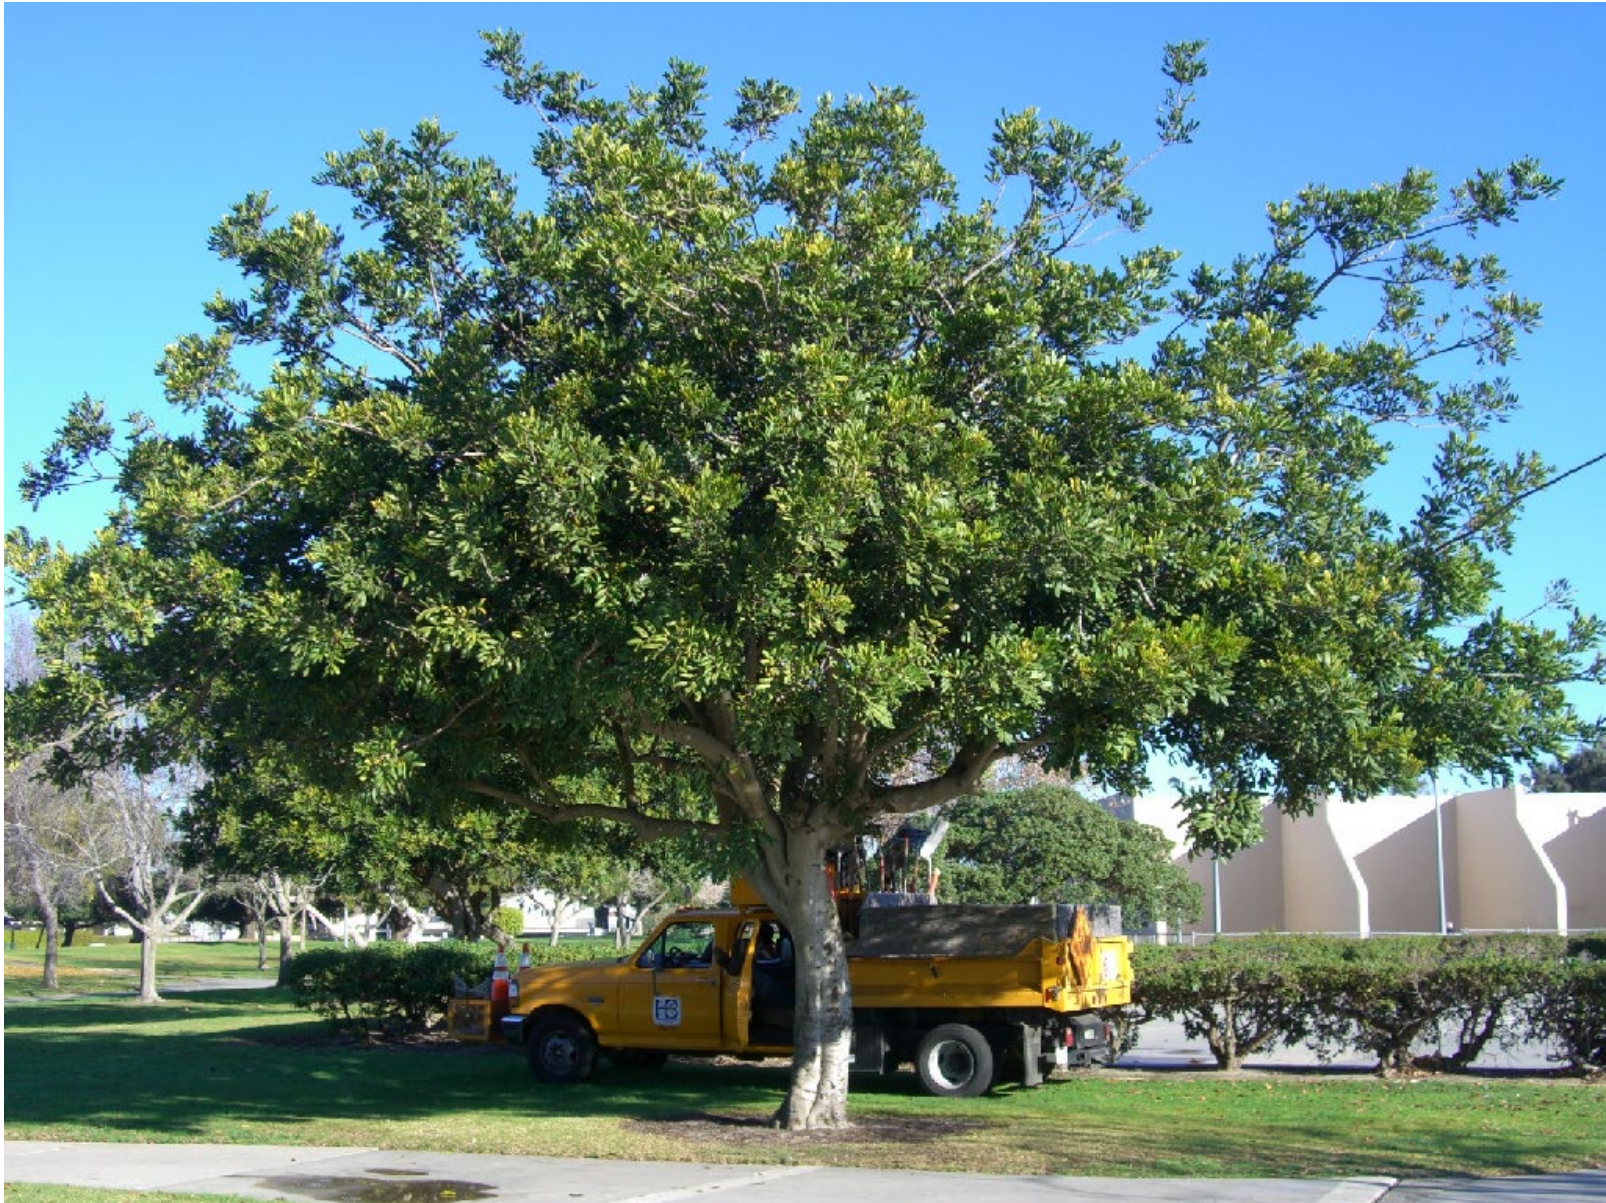
Tag #218, *Cupaniopsis anacardioides* with crowded scaffold limbs and included bark. Also note minor chlorosis.

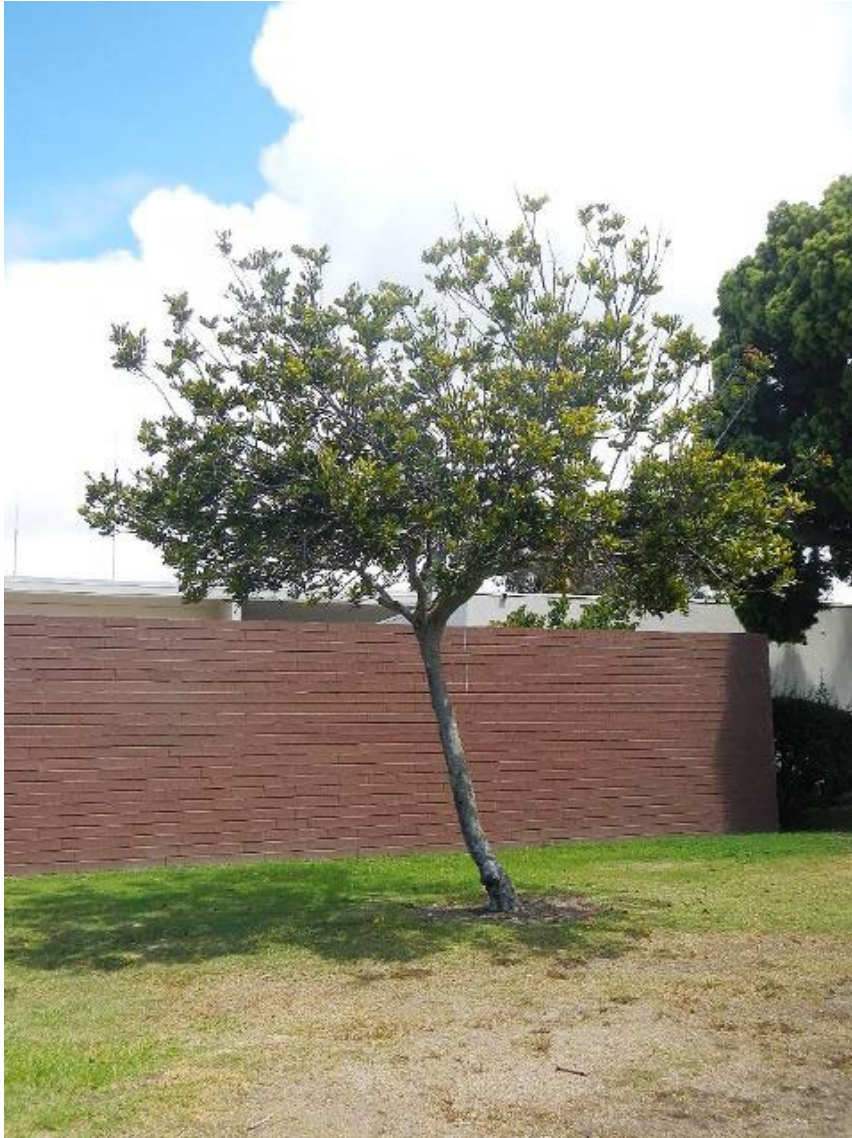
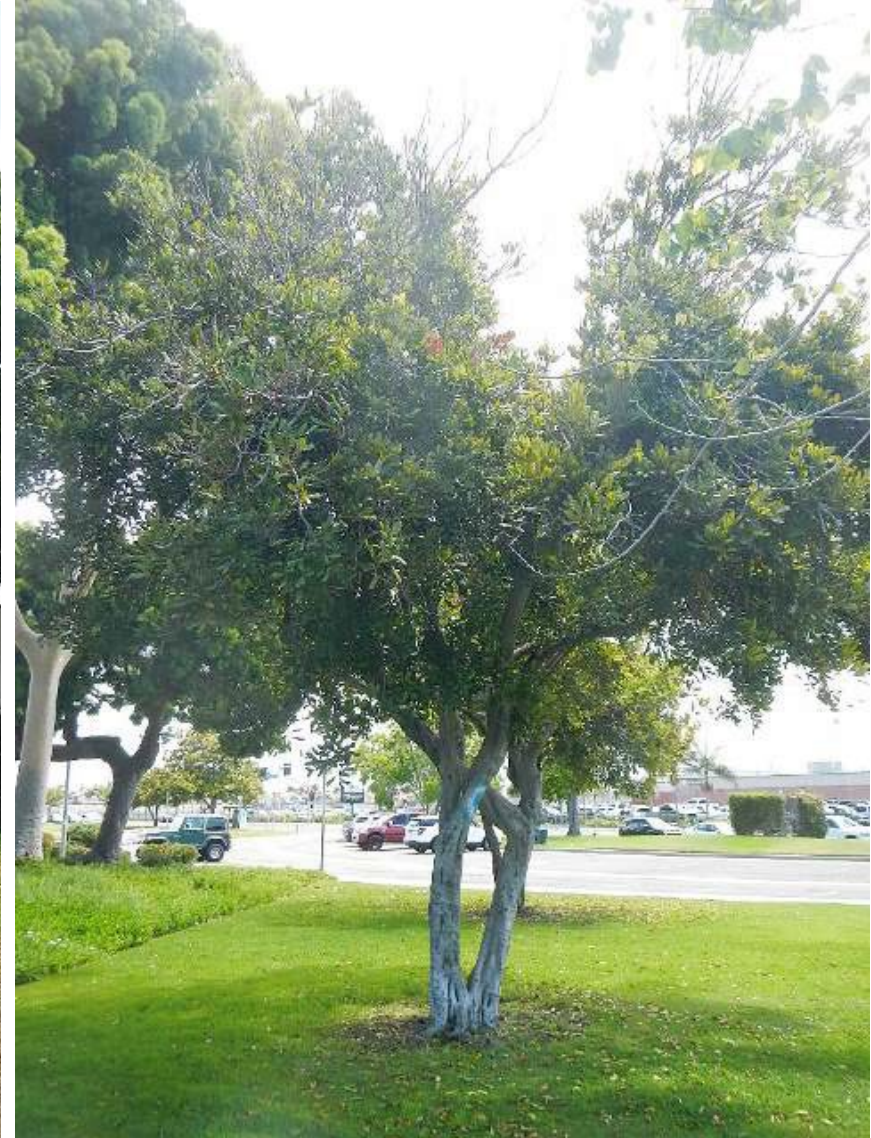
This carrotwood has barely grown at all since 2009. Note the root crown. This carrotwood is also stunted. Note the root crown.

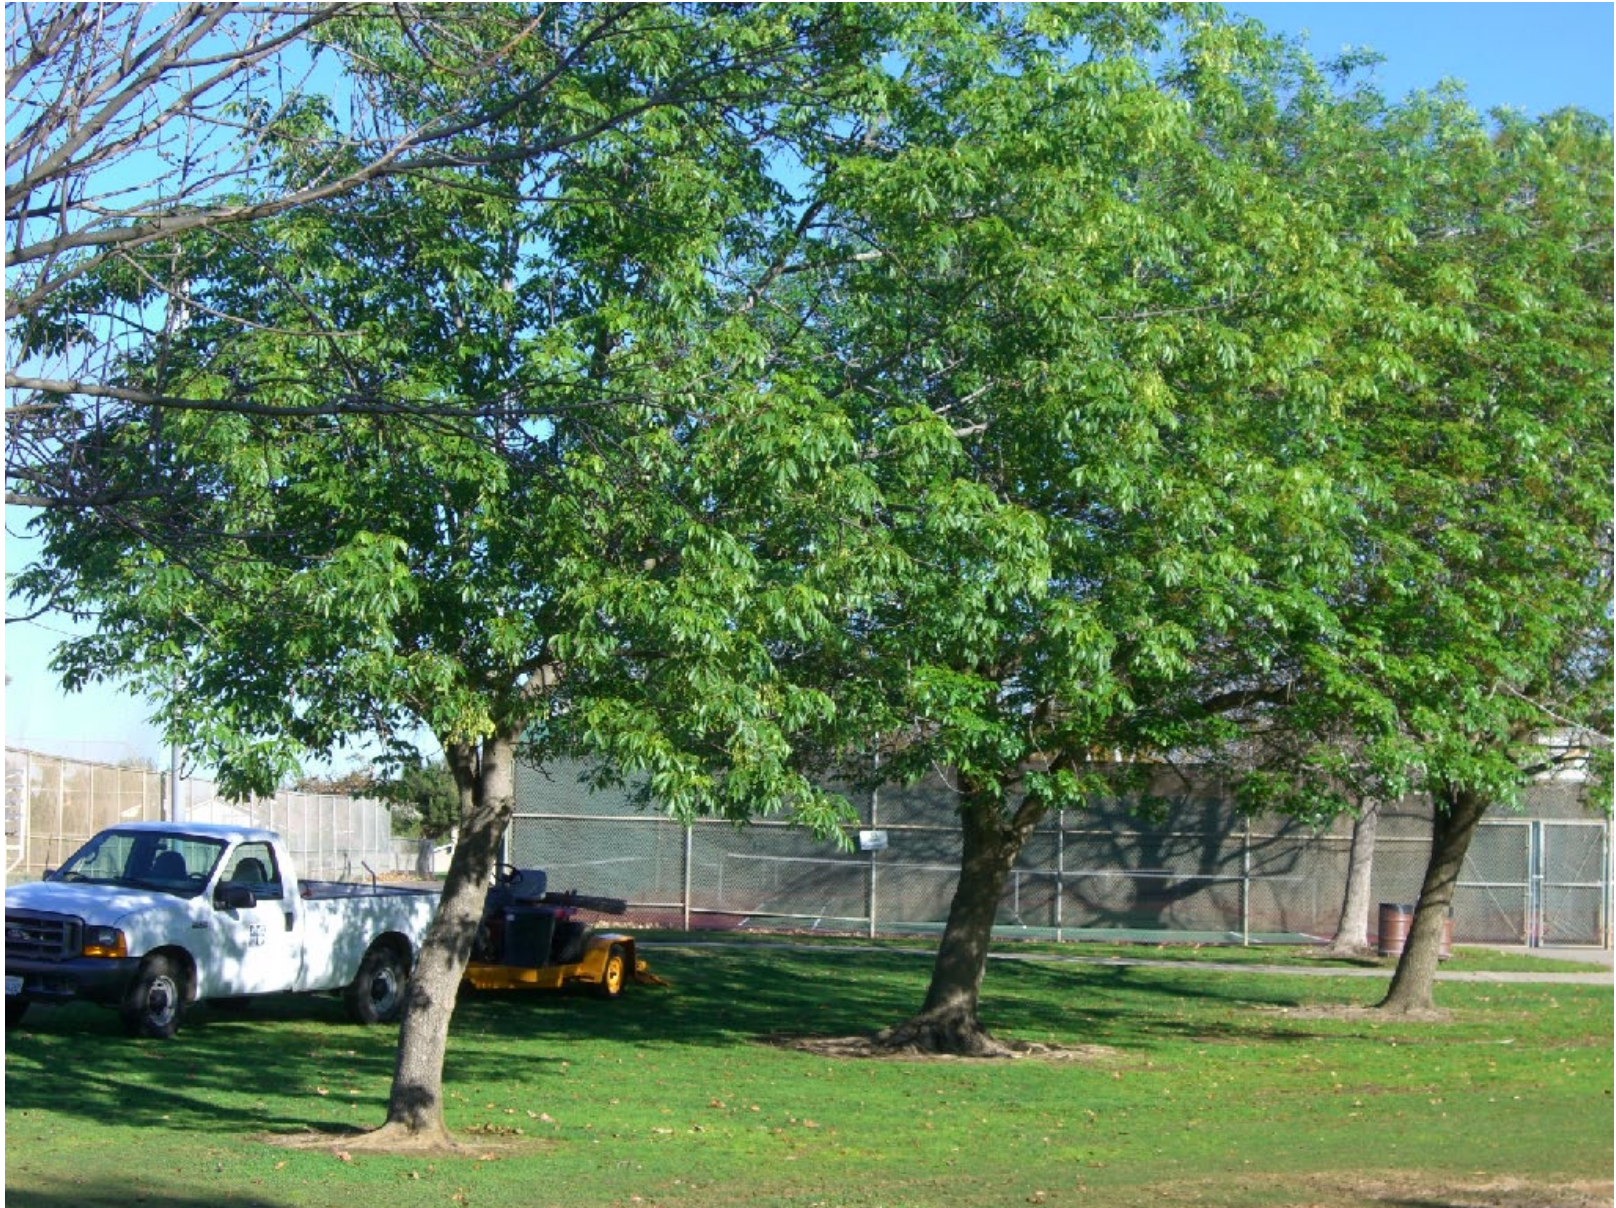
Tag #266, *Fraxinus uhdei* –This damages roots and compacts soil. This picture is from 2009, conditions have deteriorated since then.

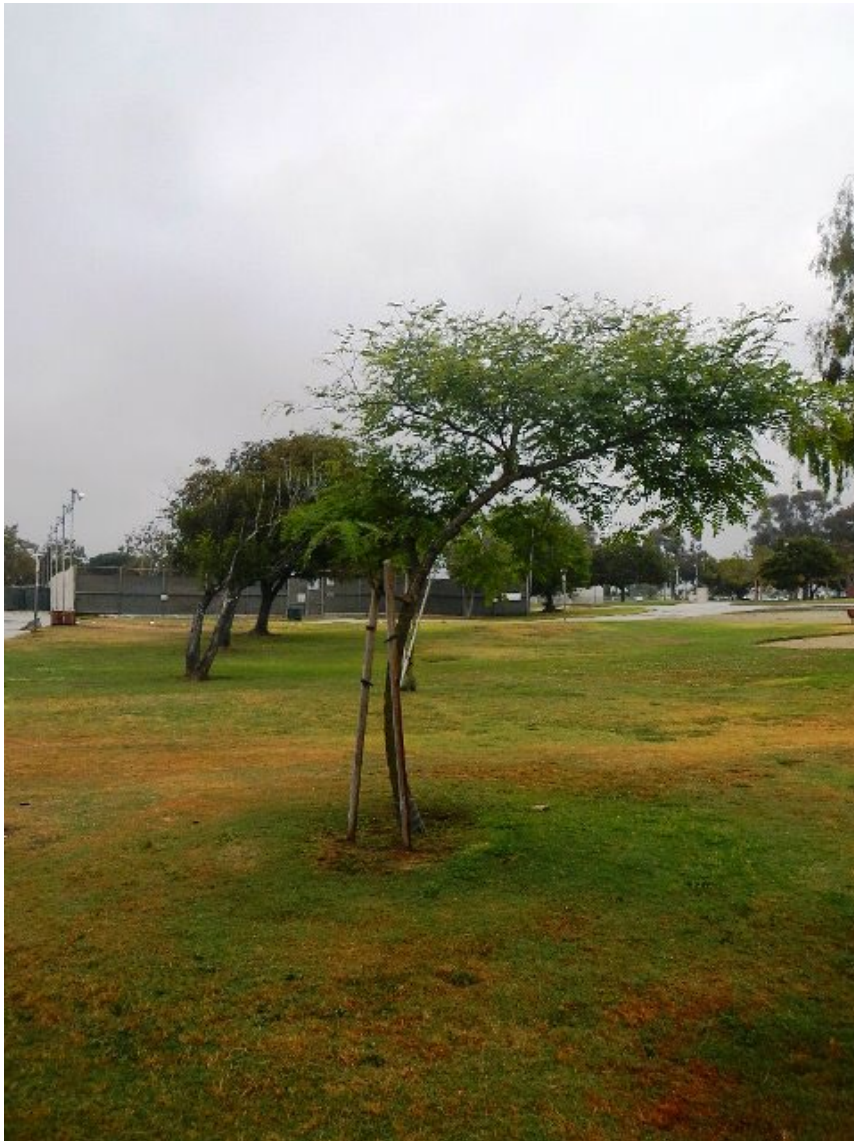
#269 Fraxinus uhdei – wind swept?

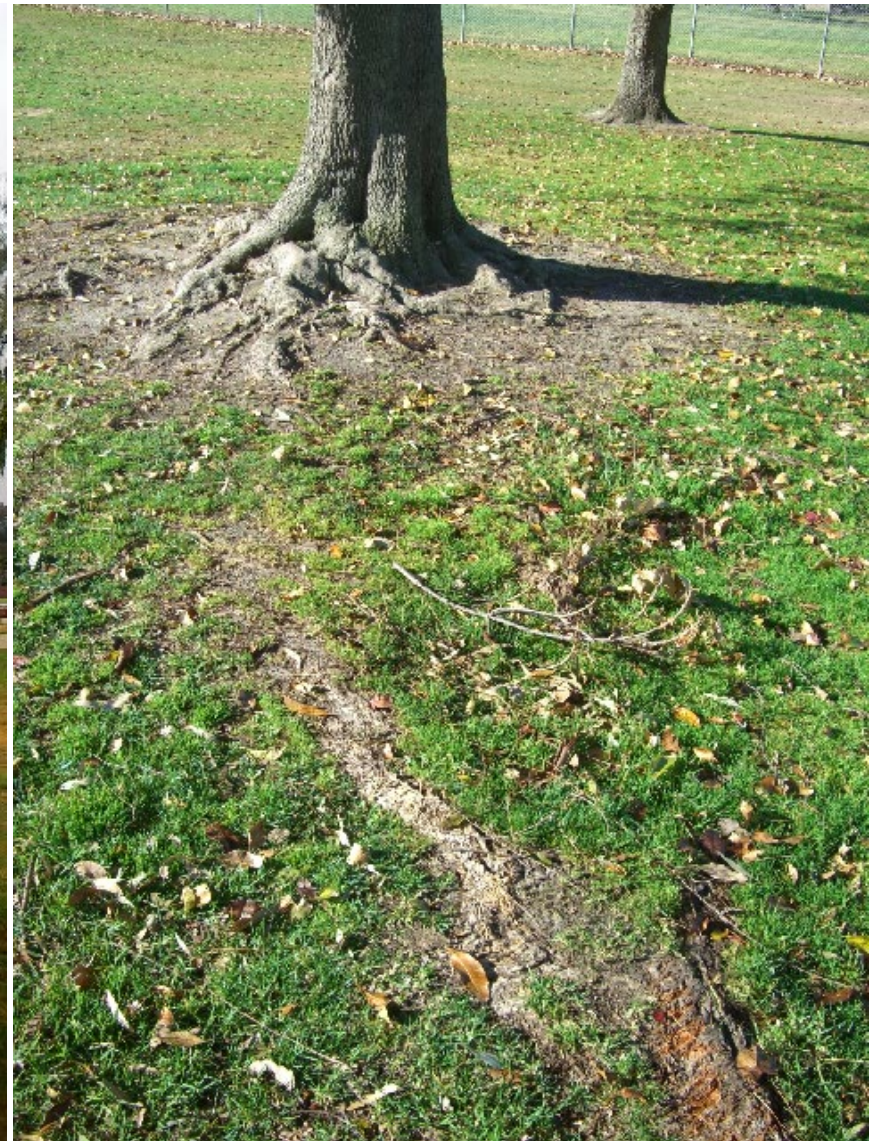
Fraxinus uhdei – note roots shaved by mowers.
