**Arborist's Report
June 18, 2022**

Tree Preservation Plan

For Edison Park, City of Huntington Beach

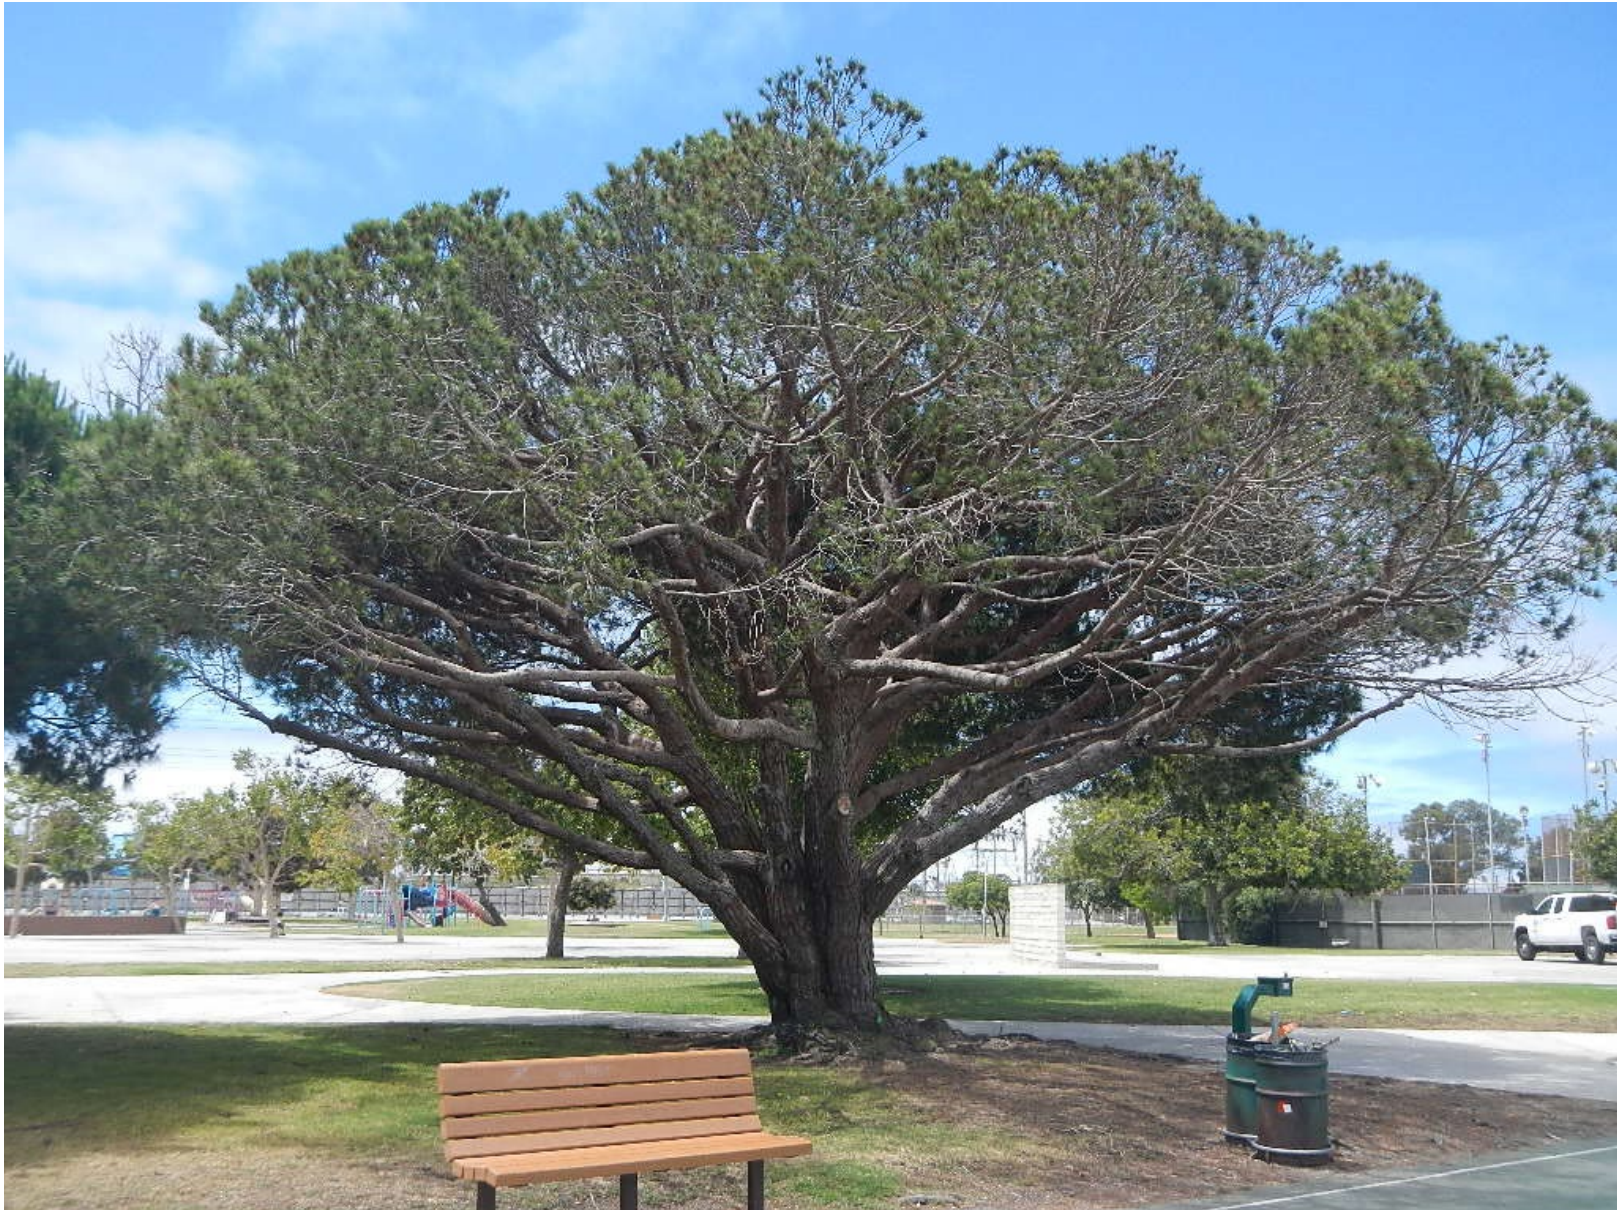
181, *Pinus pinea* with very crowded codominant trunks that are likely to split out. This pine has declined significantly since 2009.

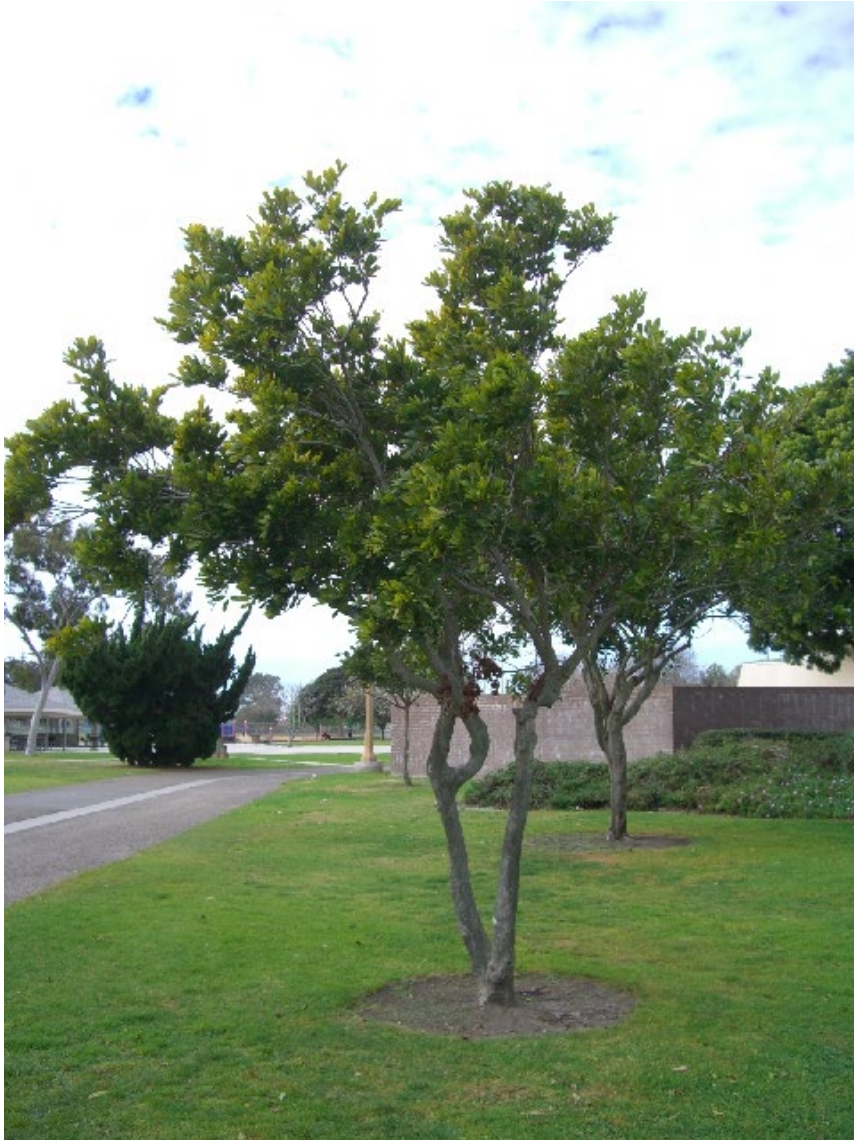
More stunted carrotwoods surround the community building.
