City of Huntington Beach

File #: 18-488

Approve the City's Park Playground Equipment Replacement Priority List

STAFF RECOMMENDED PARK PLAYGROUND & EQUIPMENT REPLACEMENT PRIORITY LIST

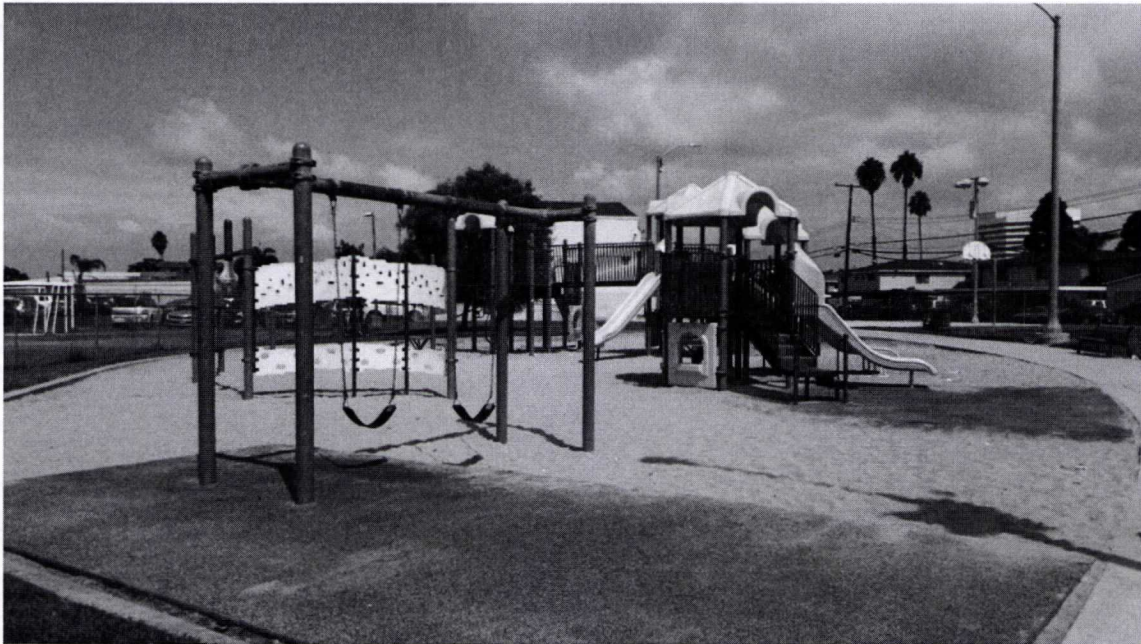
Oak View

17261 Oak Lane
Condition: POOR
High Use: Yes
ADA: Yes

- Rubber surfacing needs patching.
- Approach steps, transfer stations, hand rails, stairs, climbers rusted and corroded beyond repair
- Slides cracked
- Hanger clamps broken
- Multiple missing rivets
- All plastic worn with graffiti/etching

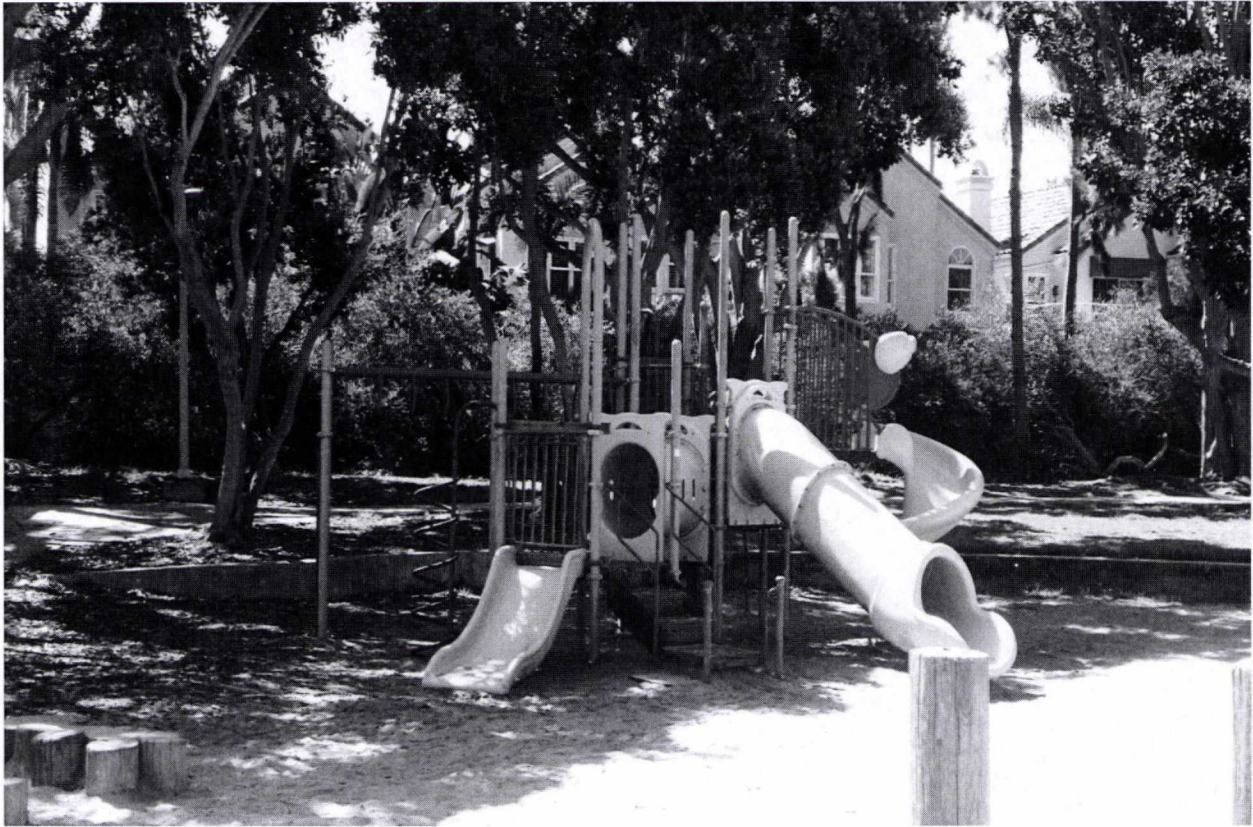
Seabridge

Condition: POOR

- ADA: No. Needs rubber surfacing.
- All play units have been removed

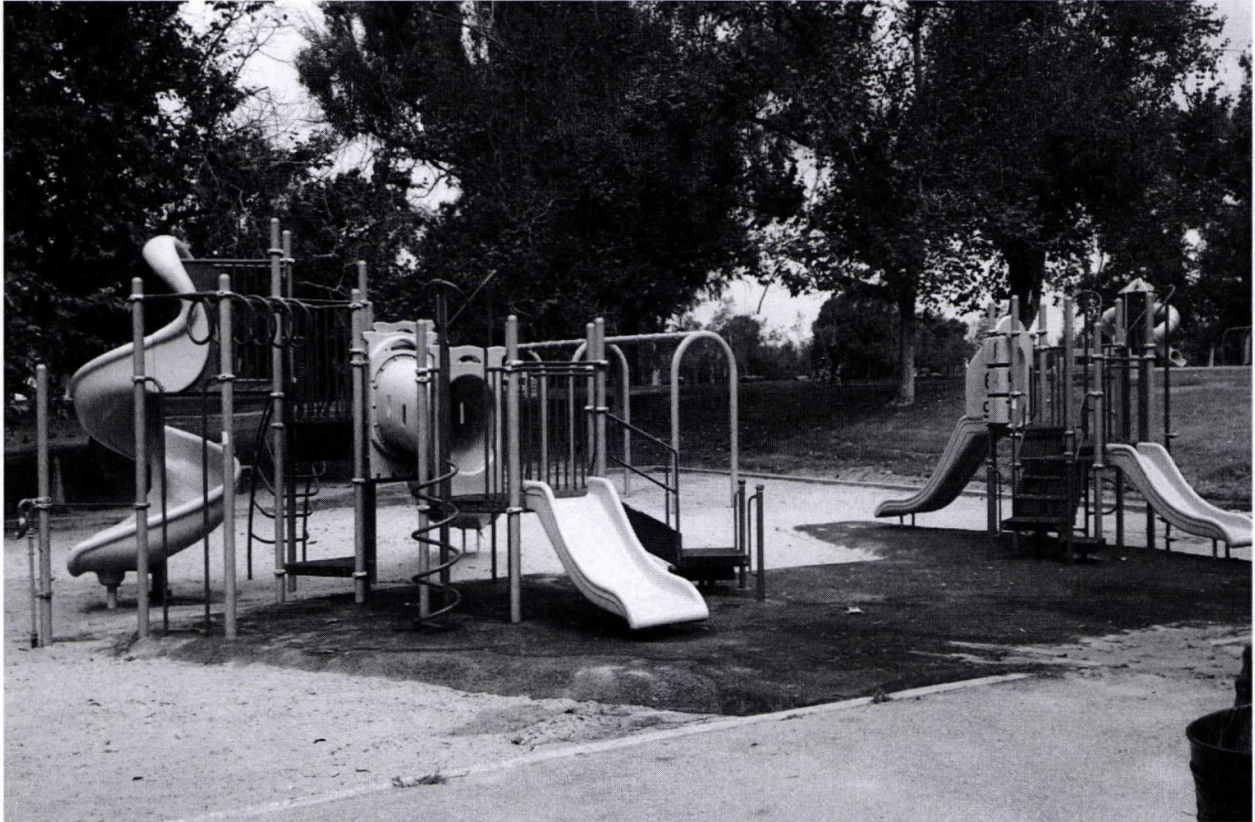
HCP Lower Lake

Condition: POOR

- All play units have been removed

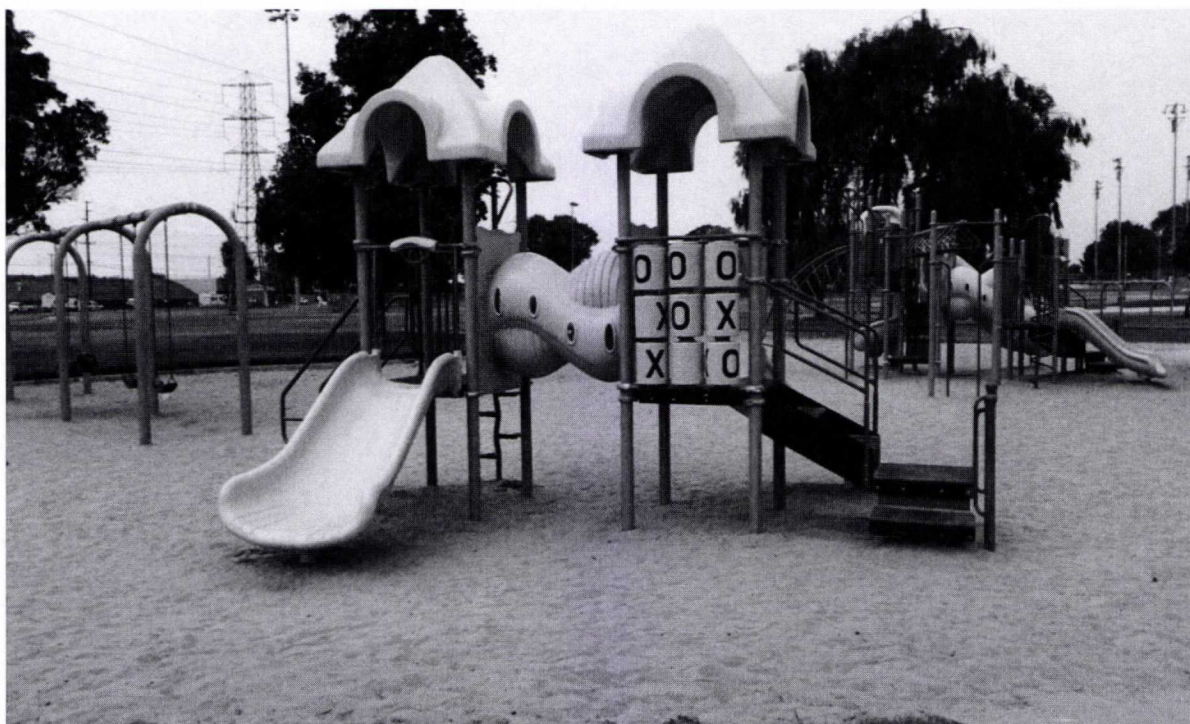
Edison

Condition: POOR

- Rubber surfacing needed for older units.
- Steps and slides rusted and cracked.
- Bucket swings and hardware damaged.
- Crawl tube flange warped.

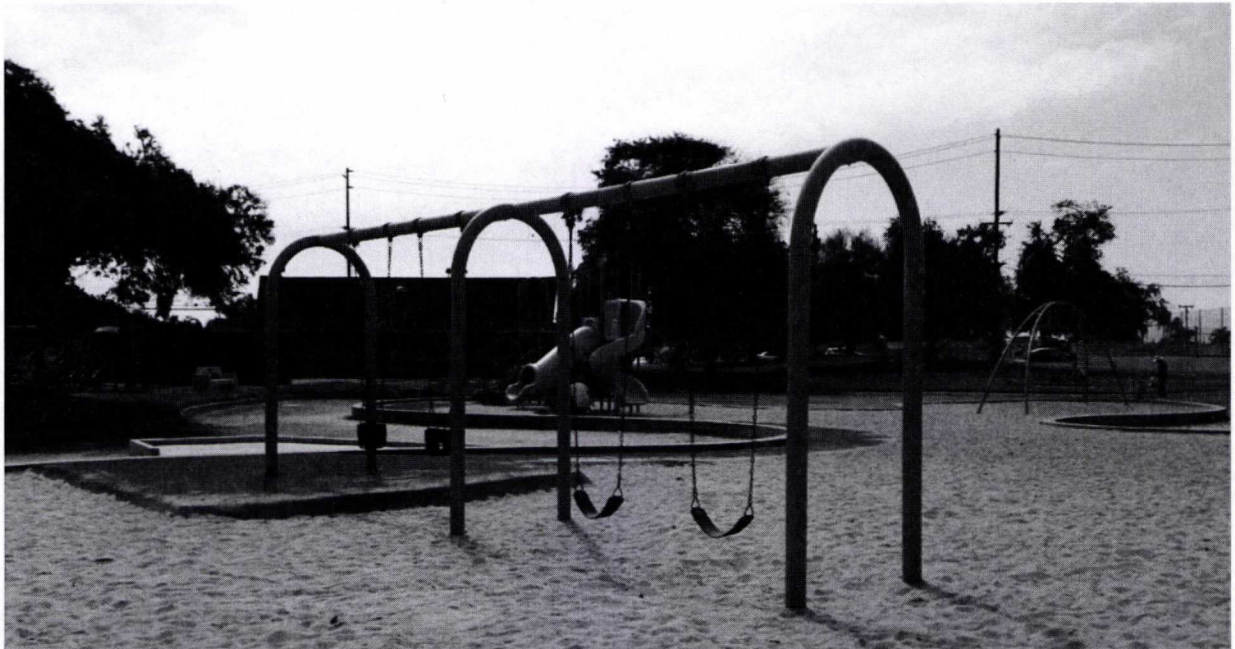
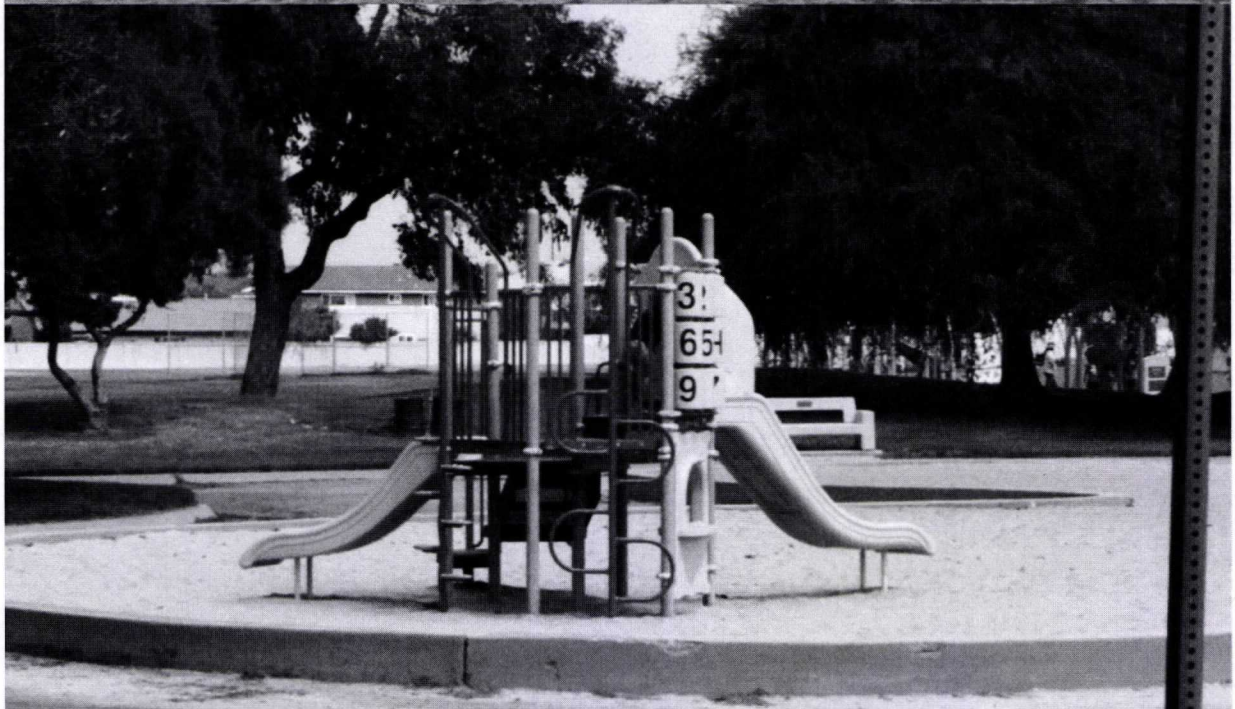
Eader

Condition: POOR

- Rubber Surfacing: Needed at 2-5 unit.
- Railings, steps, platforms rusted.
- Tube slides cracked and vandalized.
- Bucket swings and hardware damaged.

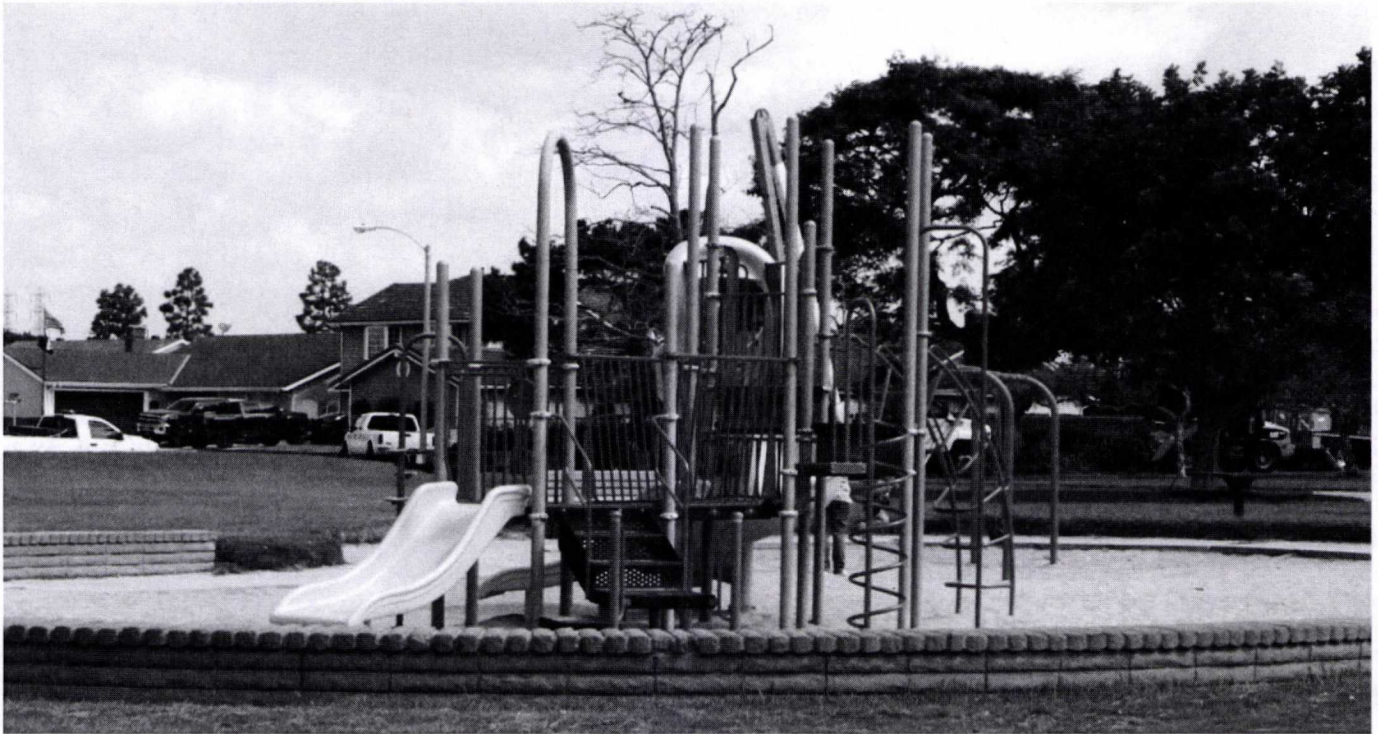
Bushard

Condition: POOR

- ADA: No. Need rubber surfacing.
- All swing hardware need to be replaced.
- Transfer station rusted/corroded.
- 36" wide slide cracked.

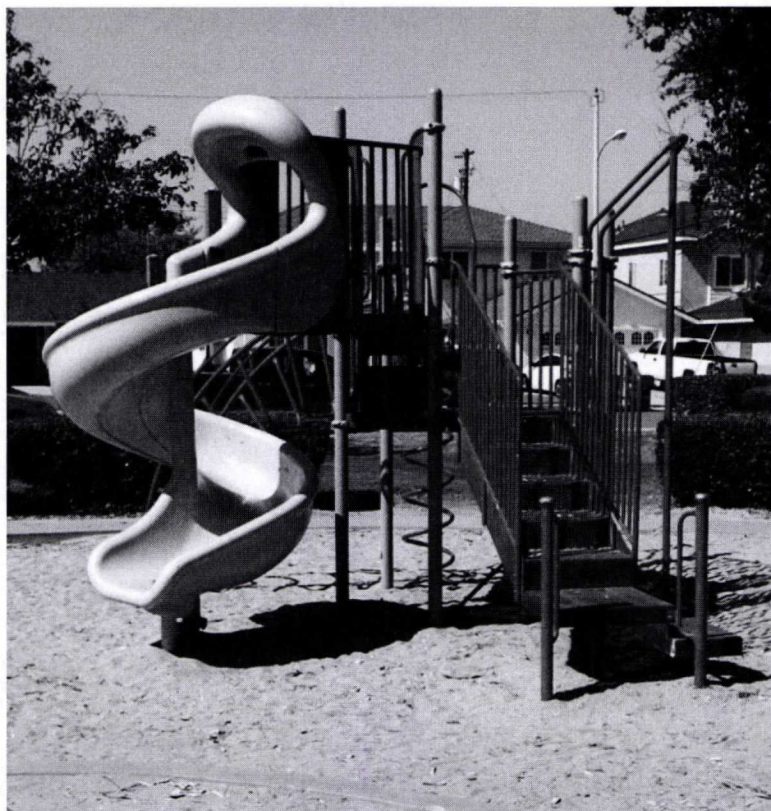
Circle View

Condition: Fair

- ADA: No. Needs rubber surfacing.
- Steps rusted/exposed metal.
- 72" corckscrew exposed footing.

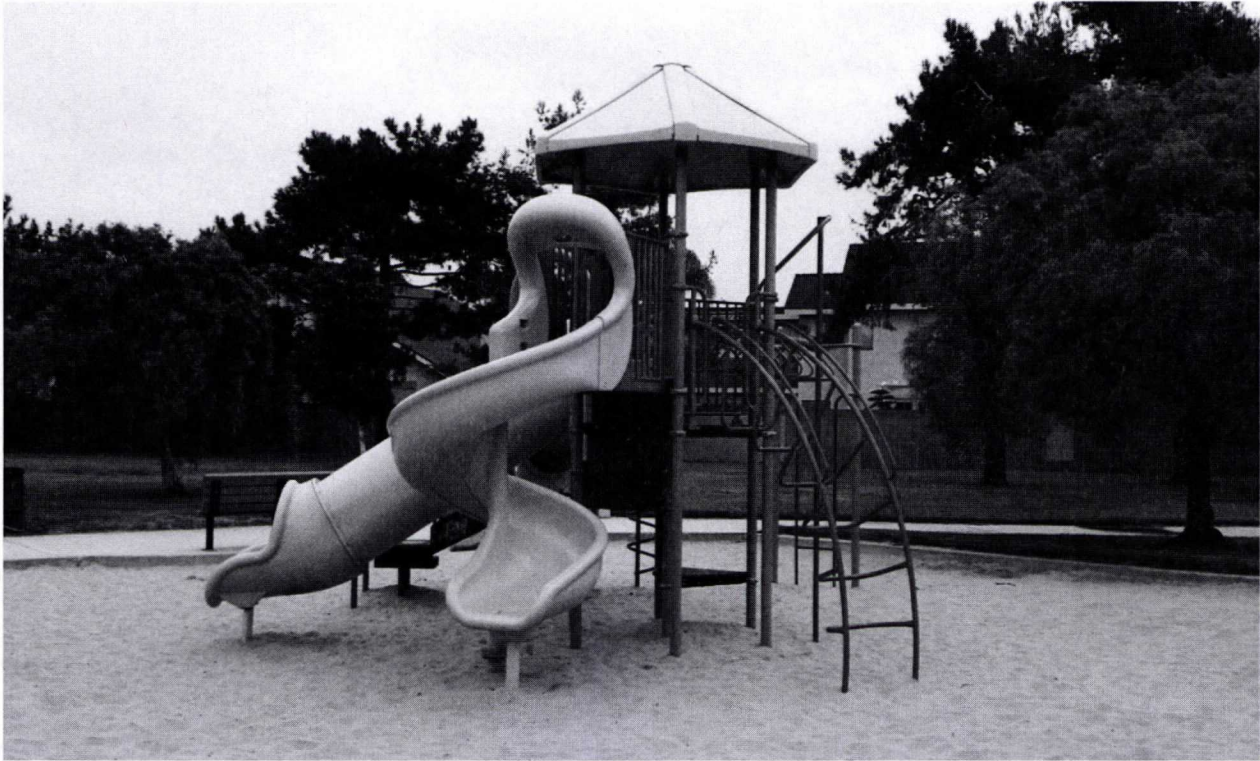
Drew

Condition: Fair

- ADA: No. Needs rubber surfacing.
- Transfer station rusted/corroded.
- 36" wide slide cracked.
- 360 slide exposed footing.

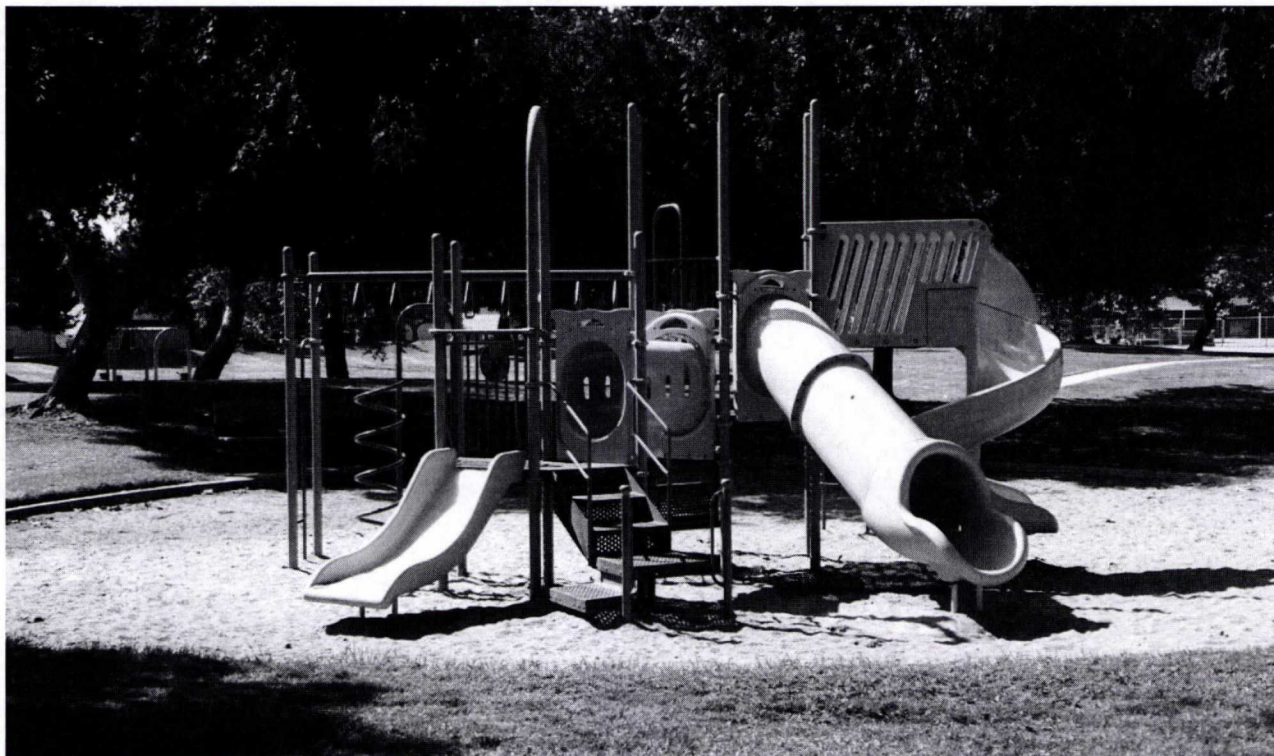
Glen View

Condition: Fair

- ADA: No. Needs rubber surfacing.
- All belt swings and hardware need to be replaced.
- 48" slide missing.

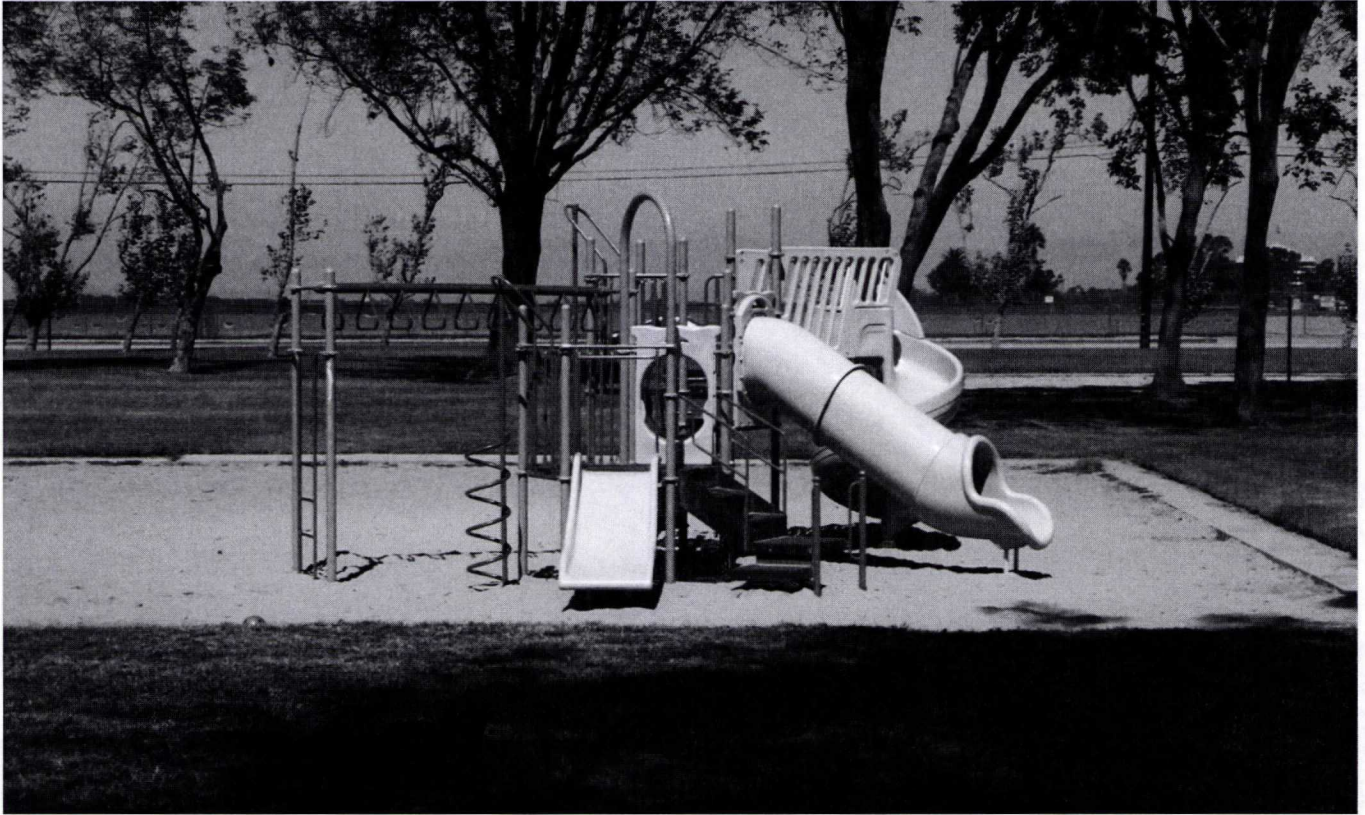
Haven View

Condition: Fair

- ADA: No. Needs rubber surfacing.
- 48" tube slide and 36" wide glide slide needs to be replaced.

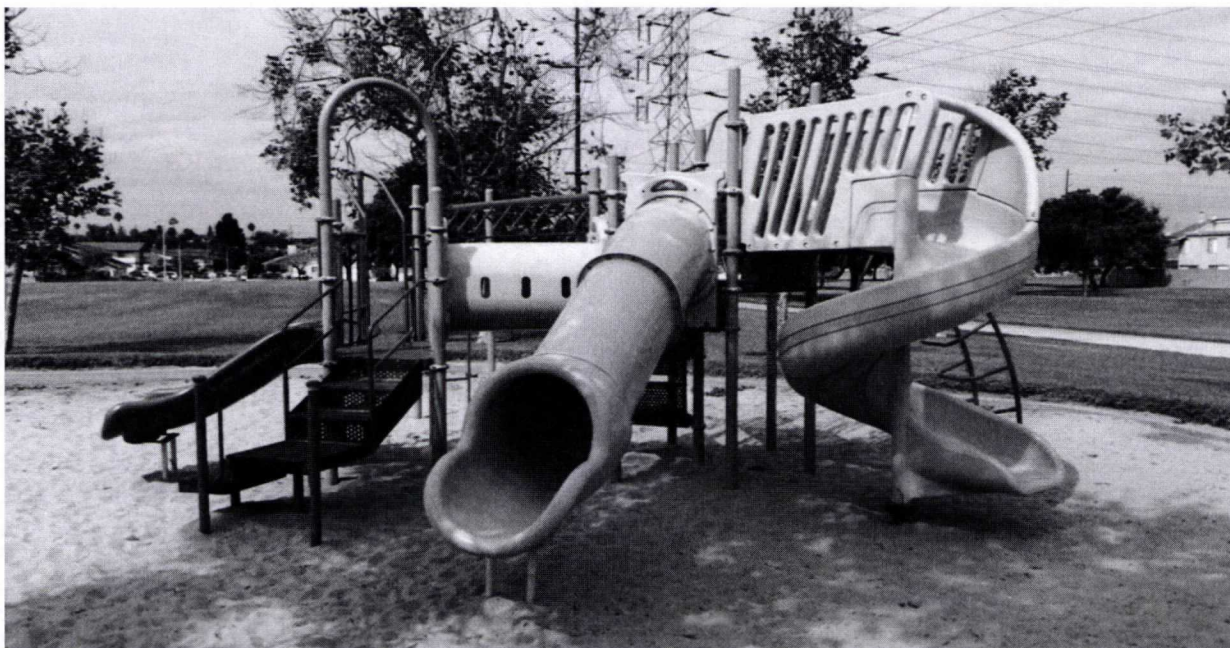
Langenbeck

Condition: Fair

- ADA: No. Needs rubber surfacing.
- 360 slide cracked at base.
- Swings need to be replaced.
- Slide pole railing is rusted.
- 48" tube slide cracked.
- 36" slide bracket is non compliant.

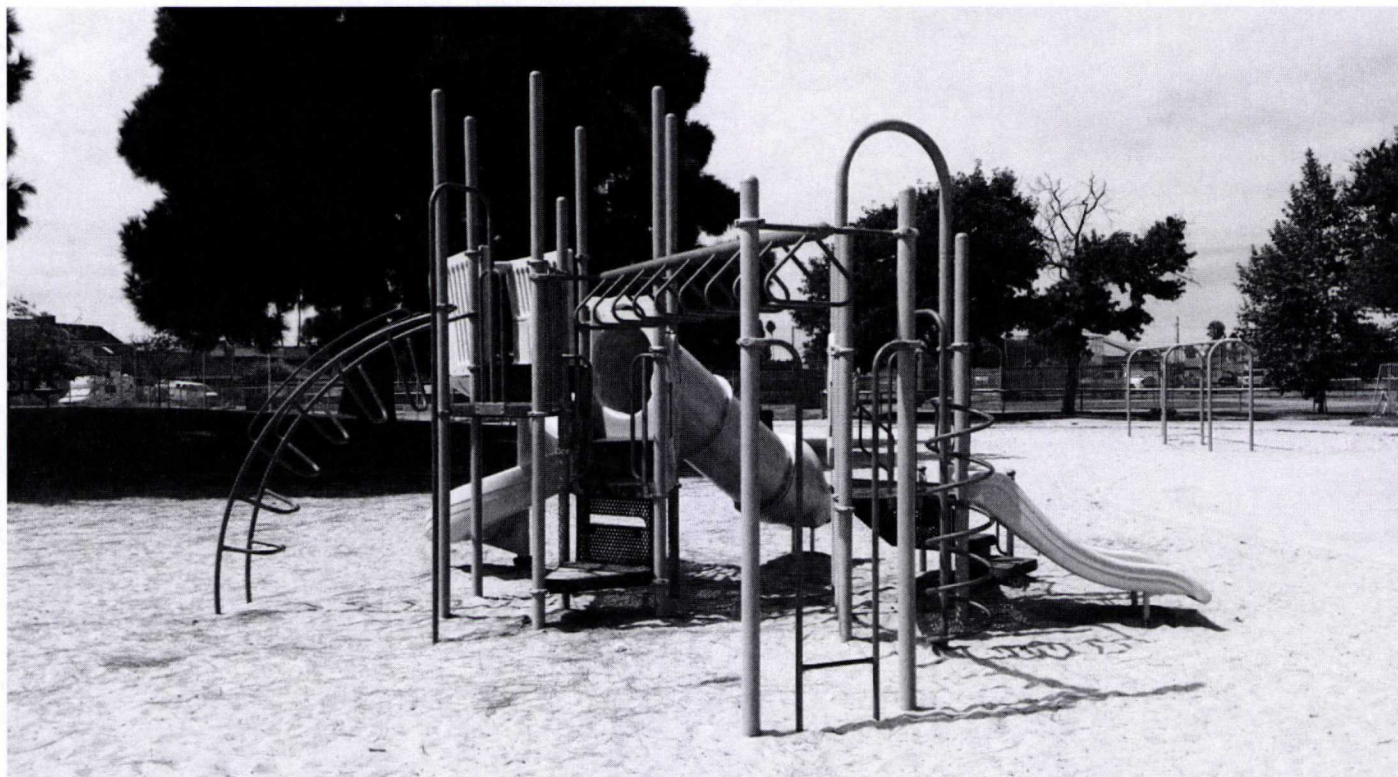
LeBard

Condition: Fair

- ADA: No. Needs rubber surfacing.
- 36" slide, 48" slide cracked.
- Transfer stations, slide pole railing and climber rusted and corroded.

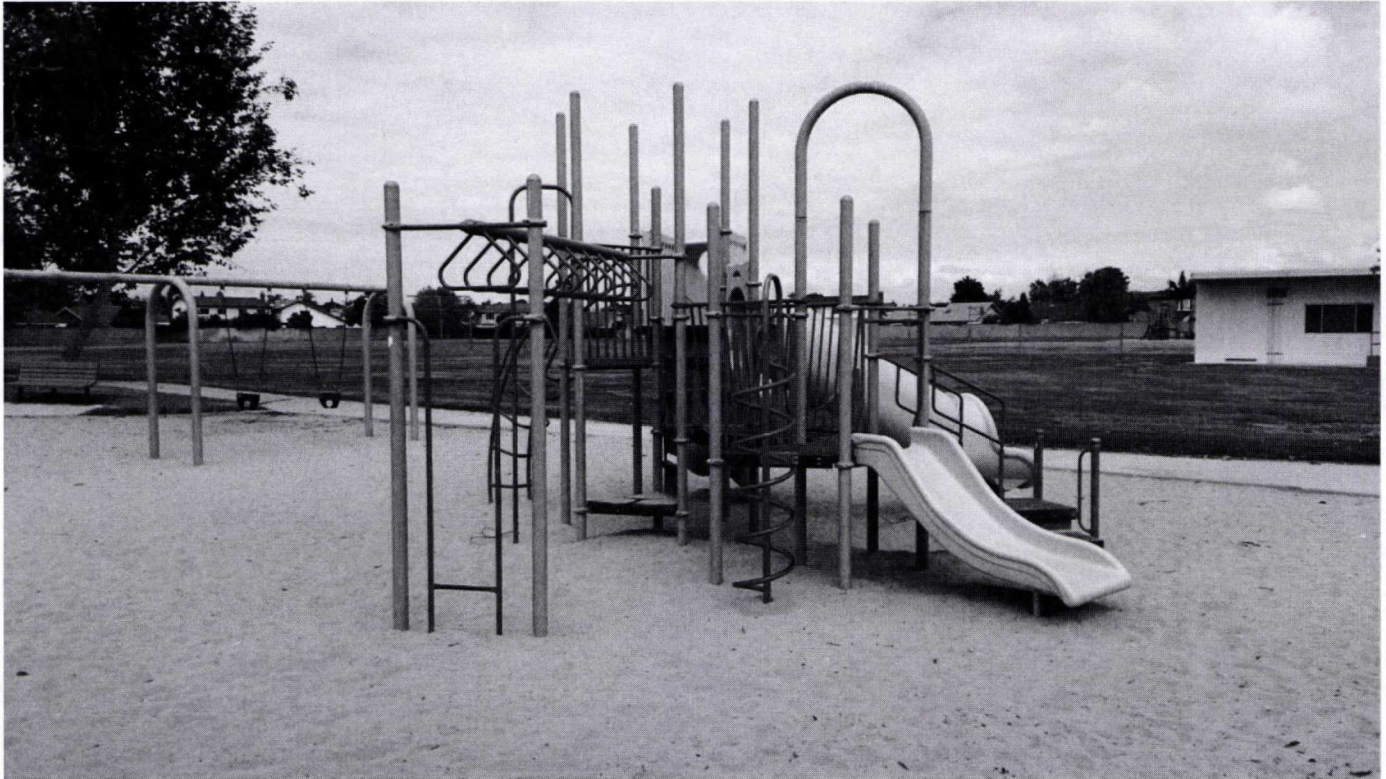
Newland East

Condition: Fair

- ADA: No. Needs rubber surfacing.
- 36" slide cracked and rusted.
- Transfer station rusted and corroded.

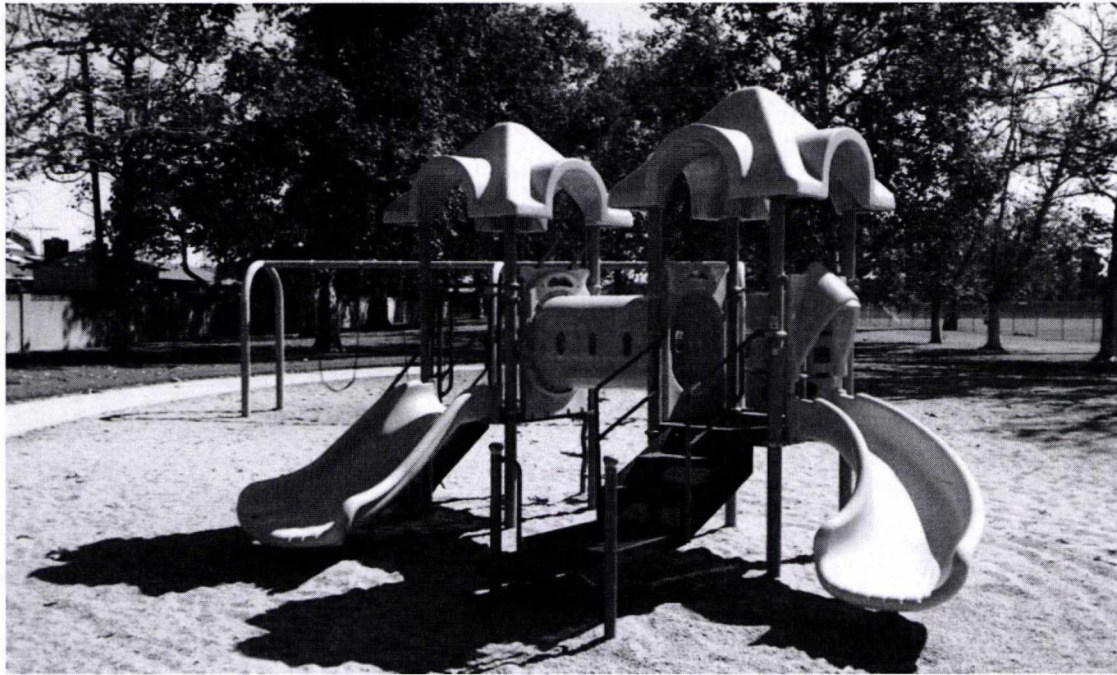
Pleasant View

Condition: Fair

- ADA: No. Needs rubber surfacing.
- 4' oval crawl tube damaged with etching.
- Beanstalk climber bent and rusted.
- Tic tac toe damaged panel.
- 48" and 36" slides cracked.
- Transfer station rusted.

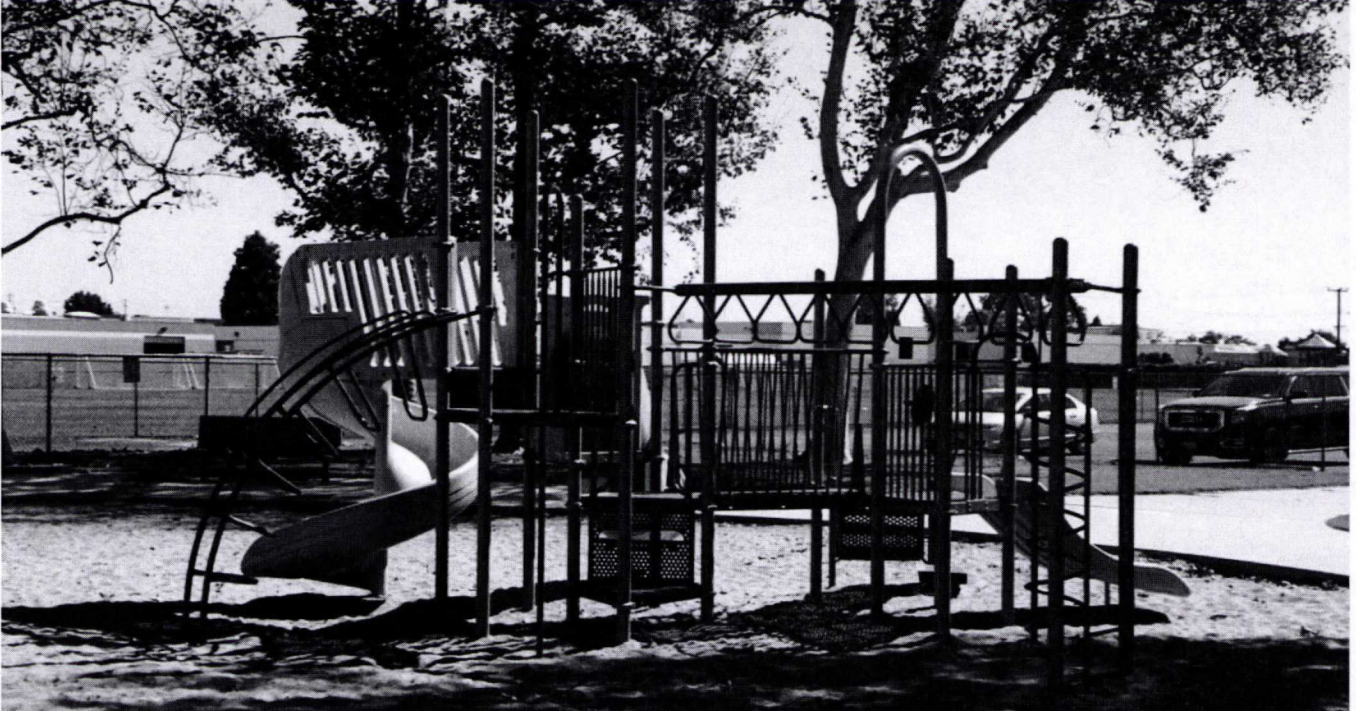
Robinwood

Condition: Fair

- ADA: No. Needs rubber surfacing.
- Transfer station rusted and cracked.
- All hardware on swing set needs to be replaced.

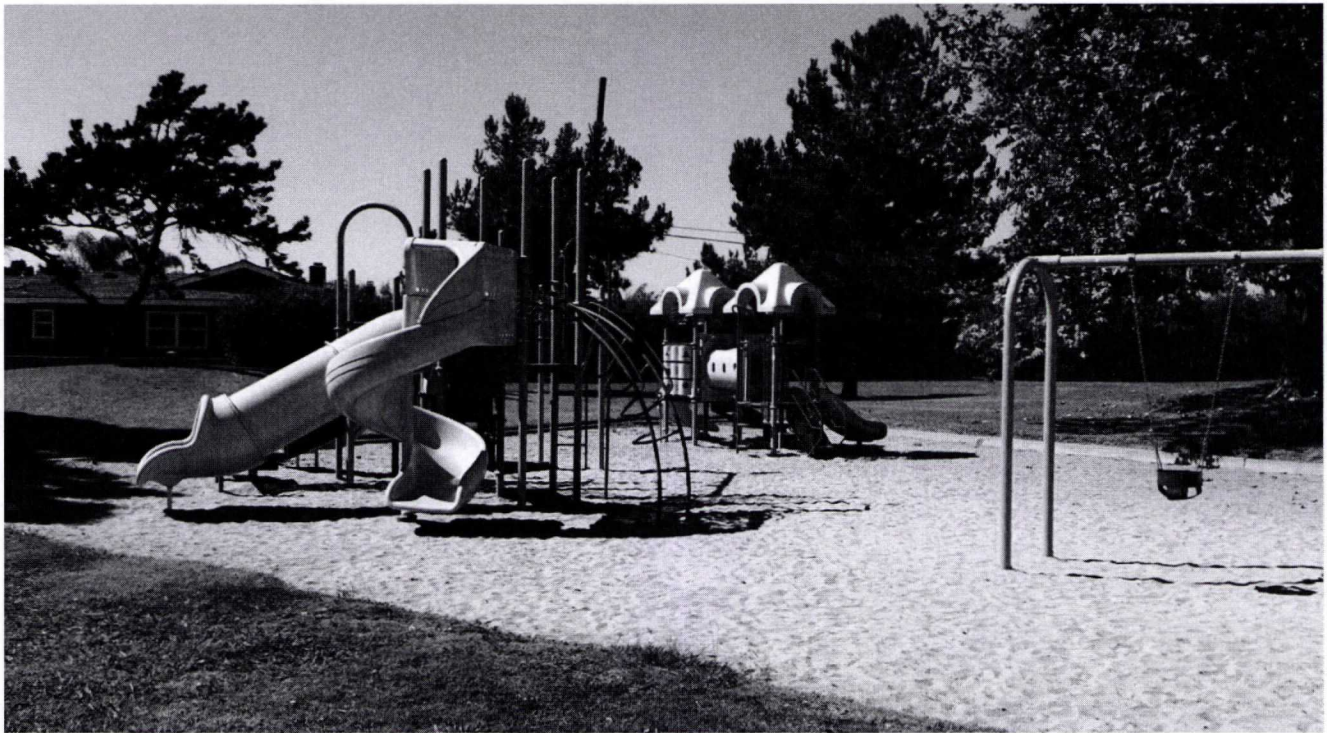
Schroeder

Condition: Fair

- ADA: No. Needs rubber surfacing.
- Deck rusted.
- 36"/48" slides and approach steps cracked.
- All hardware on swing set needs to be replaced.

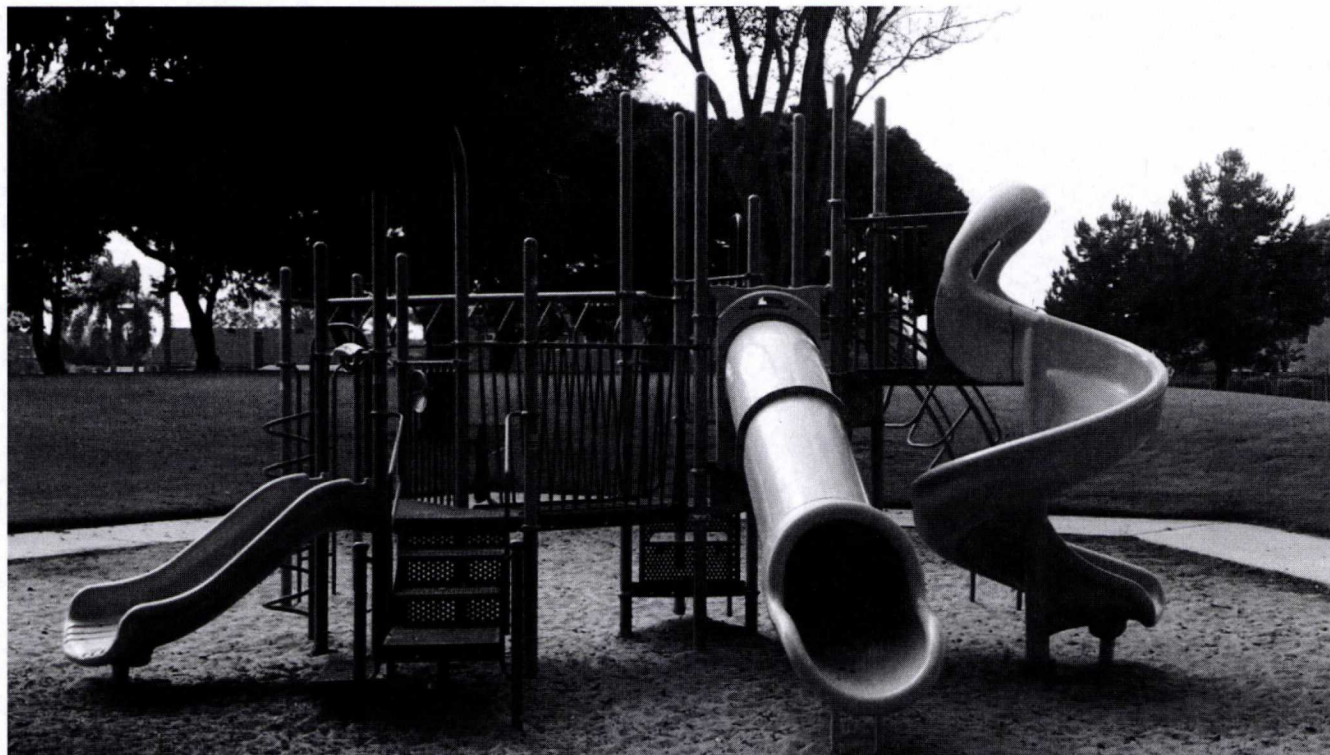
Marine View

Condition: Good

- ADA: No. Needs rubber surfacing.
- 36" slide, 48" slide cracked.
- Transfer stations, slide pole railing and climber rusted and corroded.

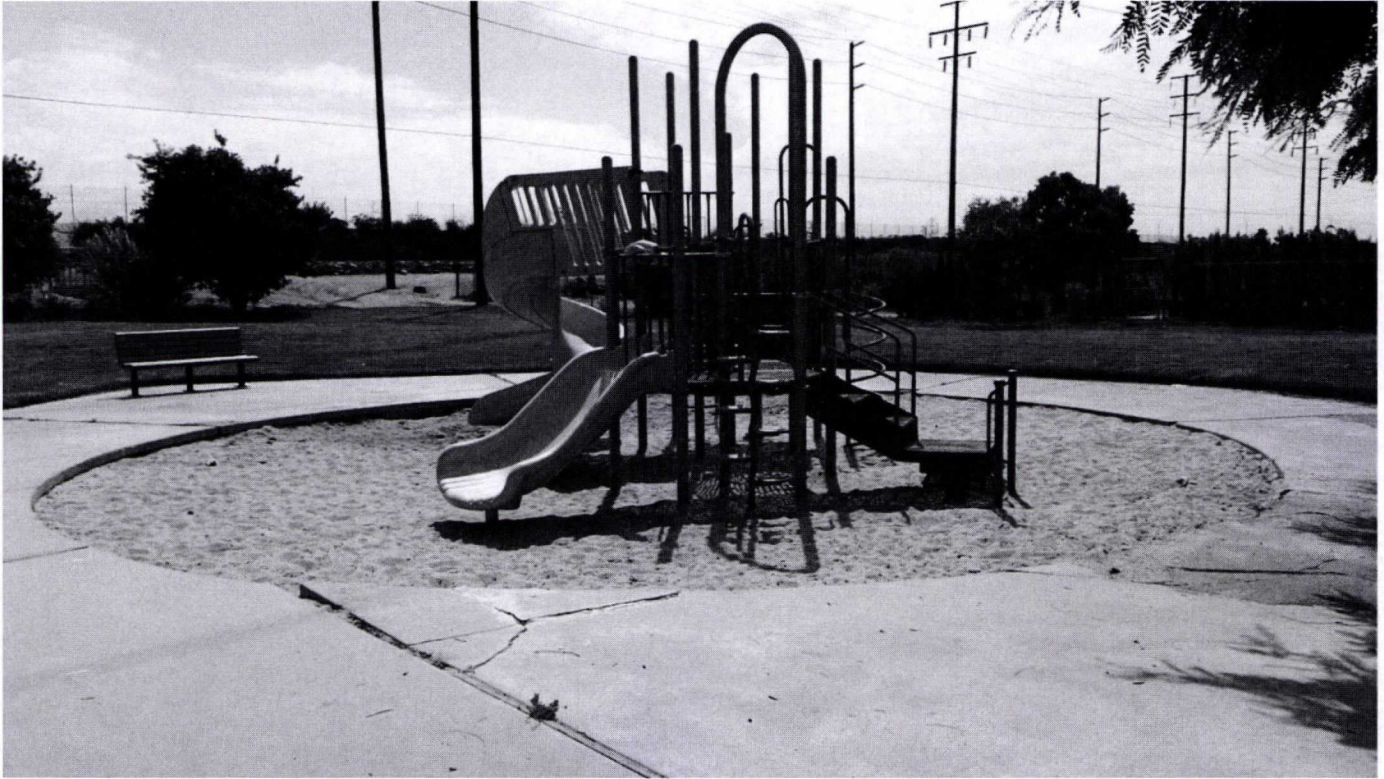
Arevalos

Condition: Fair

- ADA: No. Needs rubber surfacing.
- Transfer stations rusted and corroded.

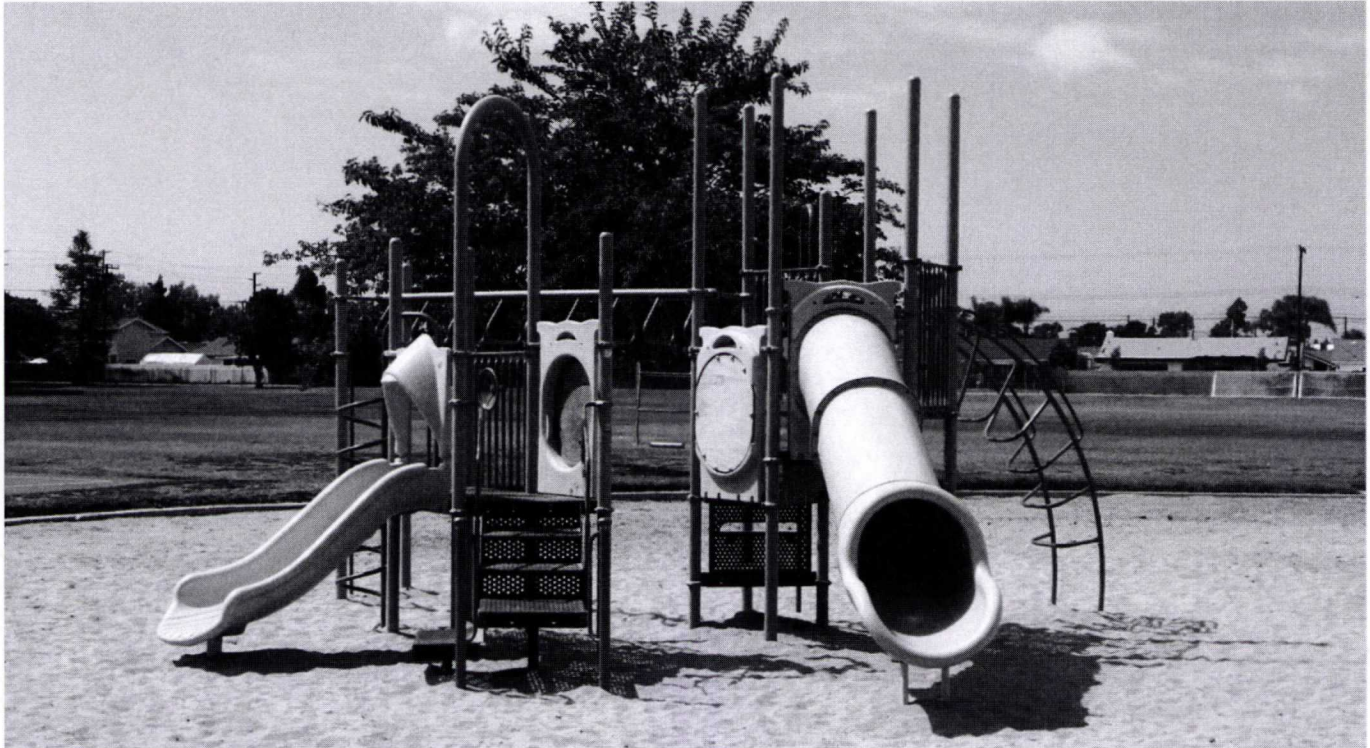
Lake View

Condition: Fair

- Rubber Surfacing: Needed at 5-12 unit.
- 36" and 48" slides cracked/damaged.
- Transfer station and stair railing rusted.

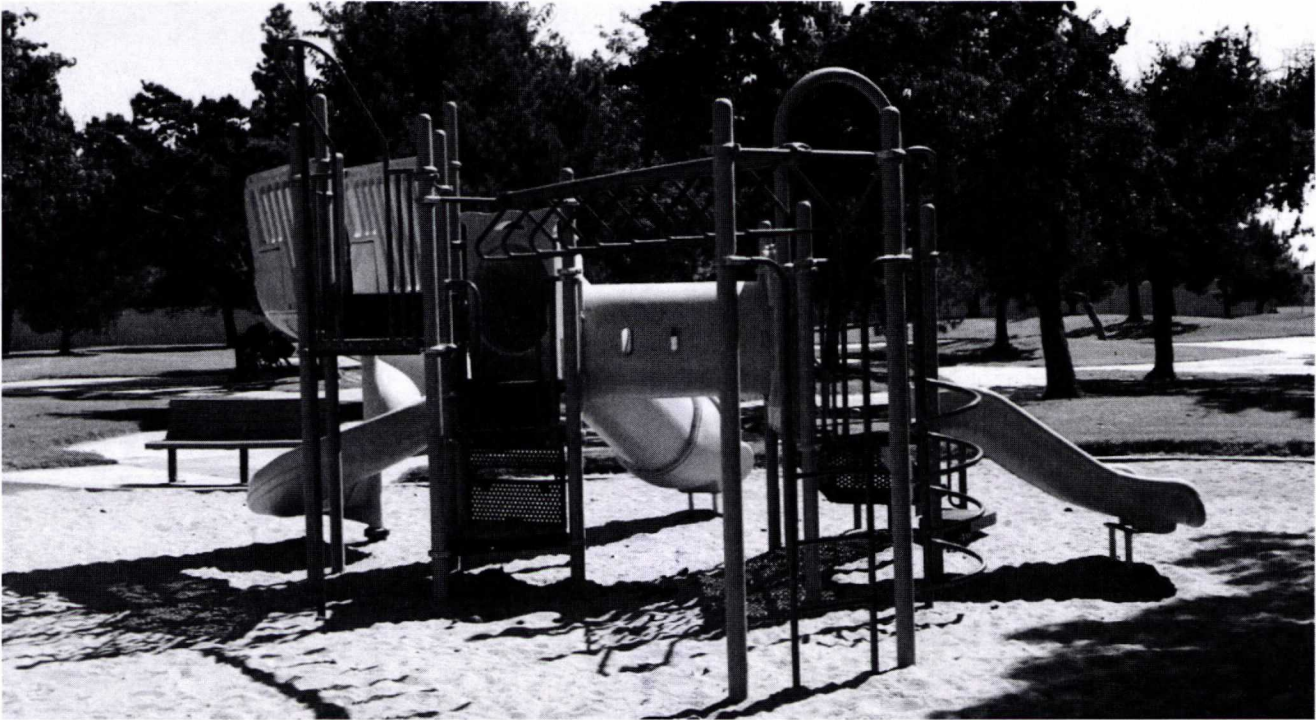
Sun View

Condition: Poor

- Rubber Surfacing: Needed at 5-12 unit.
- 36" and 48" slides burned, cracked and damaged.
- Steps and surfaces are worn, chipped and etched.
- Approach steps rusted.

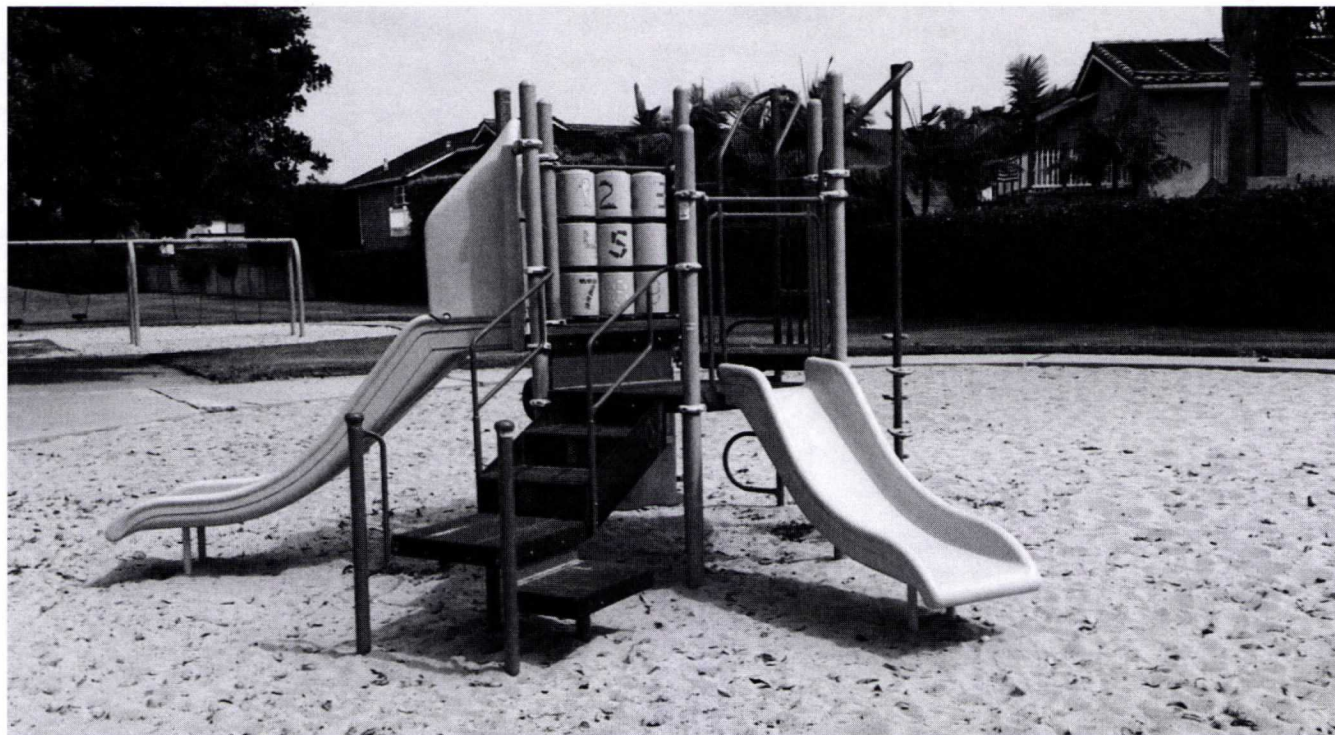
Seely

Condition: Fair

- Rubber Surfacing: Needed at 2-5 unit. 5-12 needs patching.
- Railing rusted.
- 48" slide cracked.

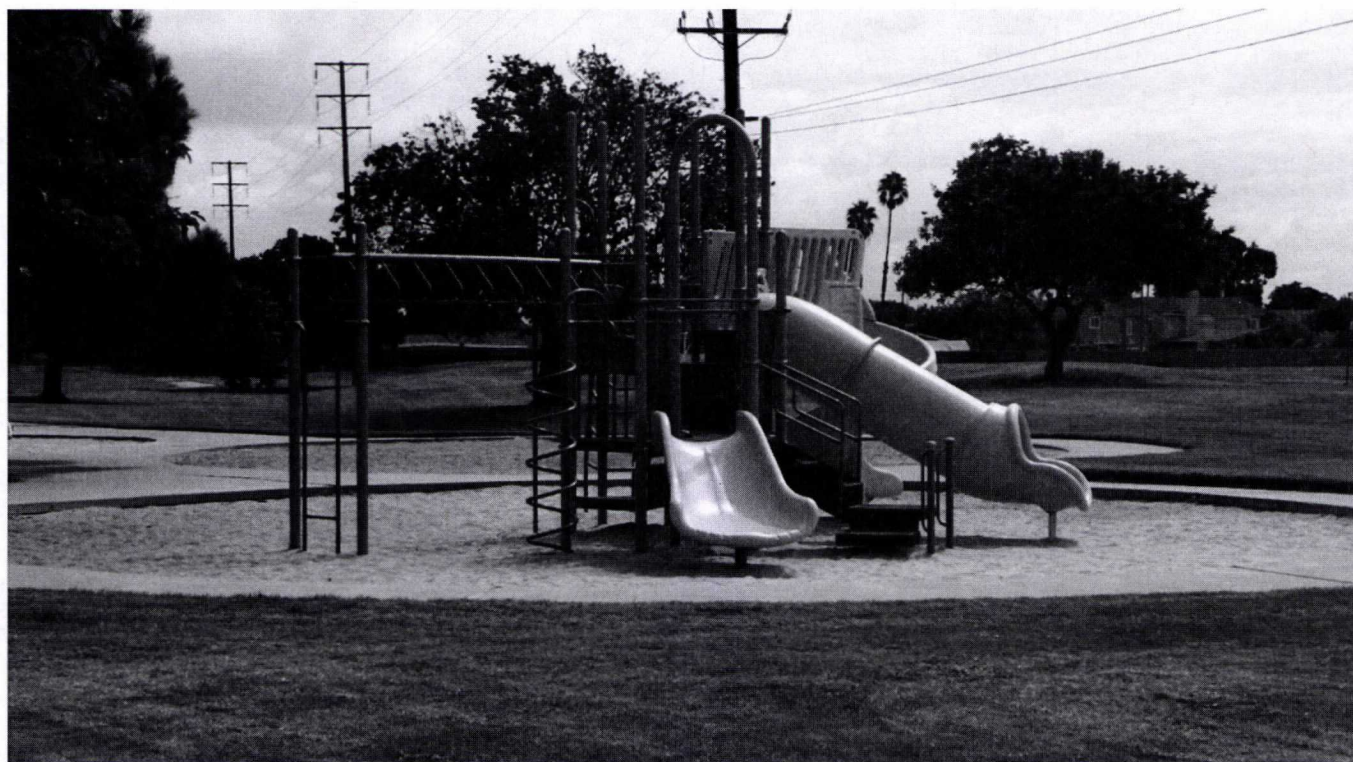
Talbert

Condition: Fair

- Rubber Surfacing: Needed for combo unit.
- 48" tube slide cracked.
- 36" steps, pipe wall barriers and transfer stations rusted.
