City of Huntington Beach

File #: 18-488

Approve the City's Park Playground Equipment Replacement Priority List

STAFF RECOMMENDED PARK PLAYGROUND & EQUIPMENT REPLACEMENT PRIORITY LIST

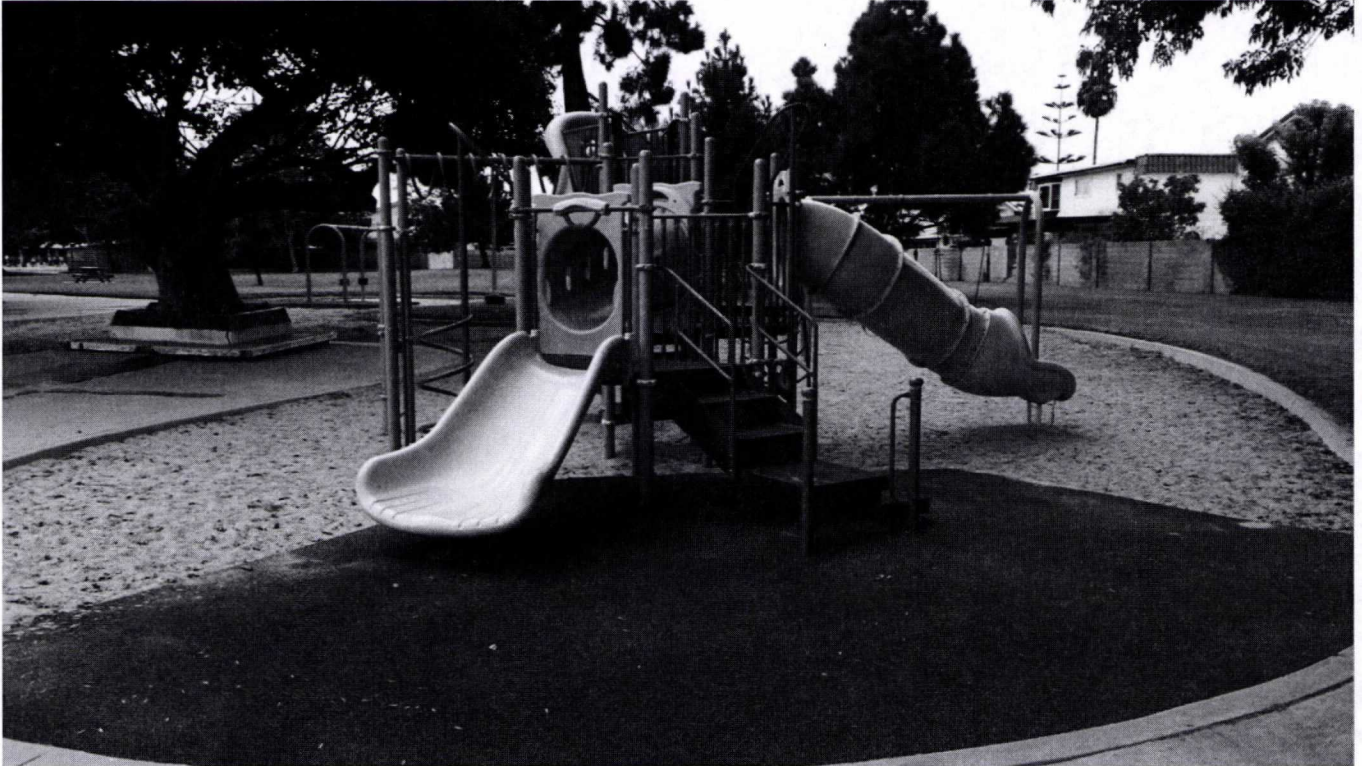
Perry

Condition: Fair

- Rubber Surfacing: Needed for swings.
- Transfer station rusted and broken coating.
- 36" and 48" slides cracked and damaged.

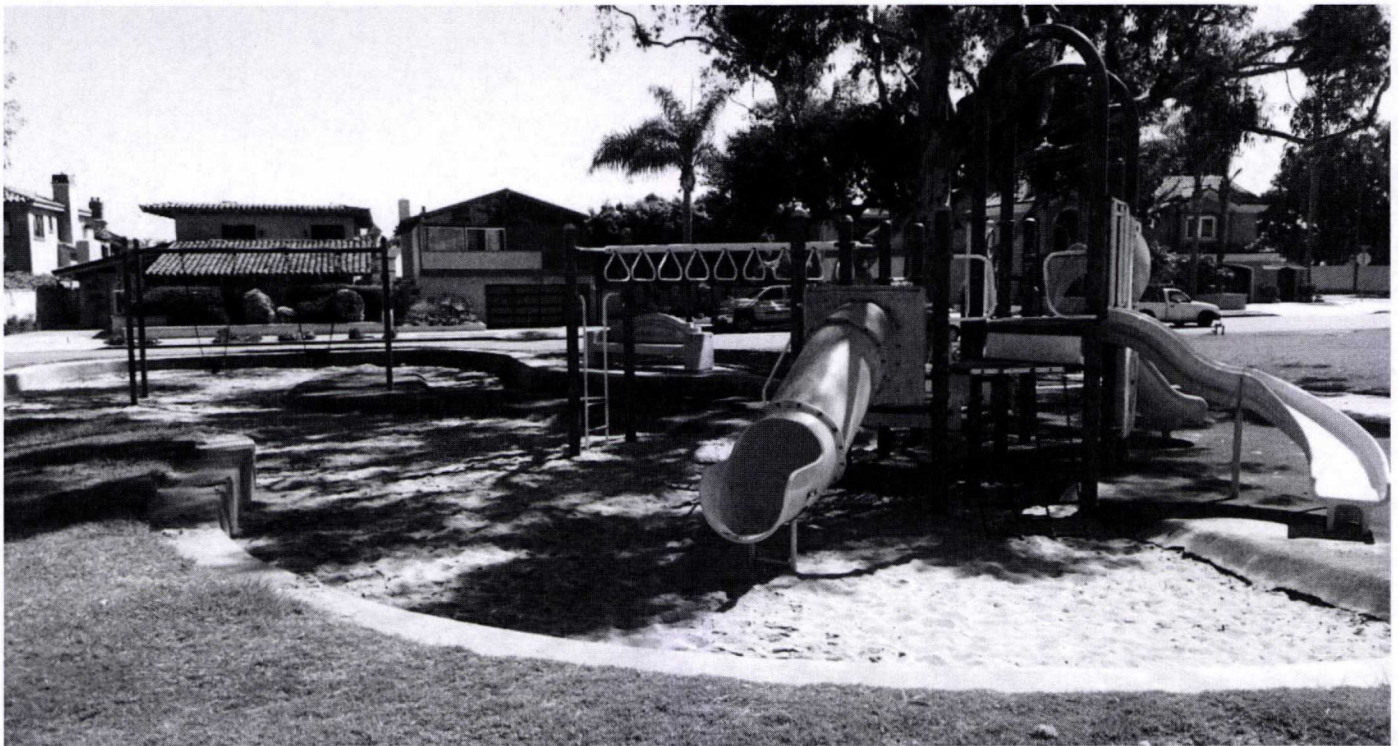
Booster

Condition: POOR

- Rubber Surfacing: Cracked and uneven from tree roots.
- Transfer station and chain climber rusted and broken coating.
- 36" and 60" slides cracked and damaged.
- Hardware (nuts and bolts) rusted and corroded.

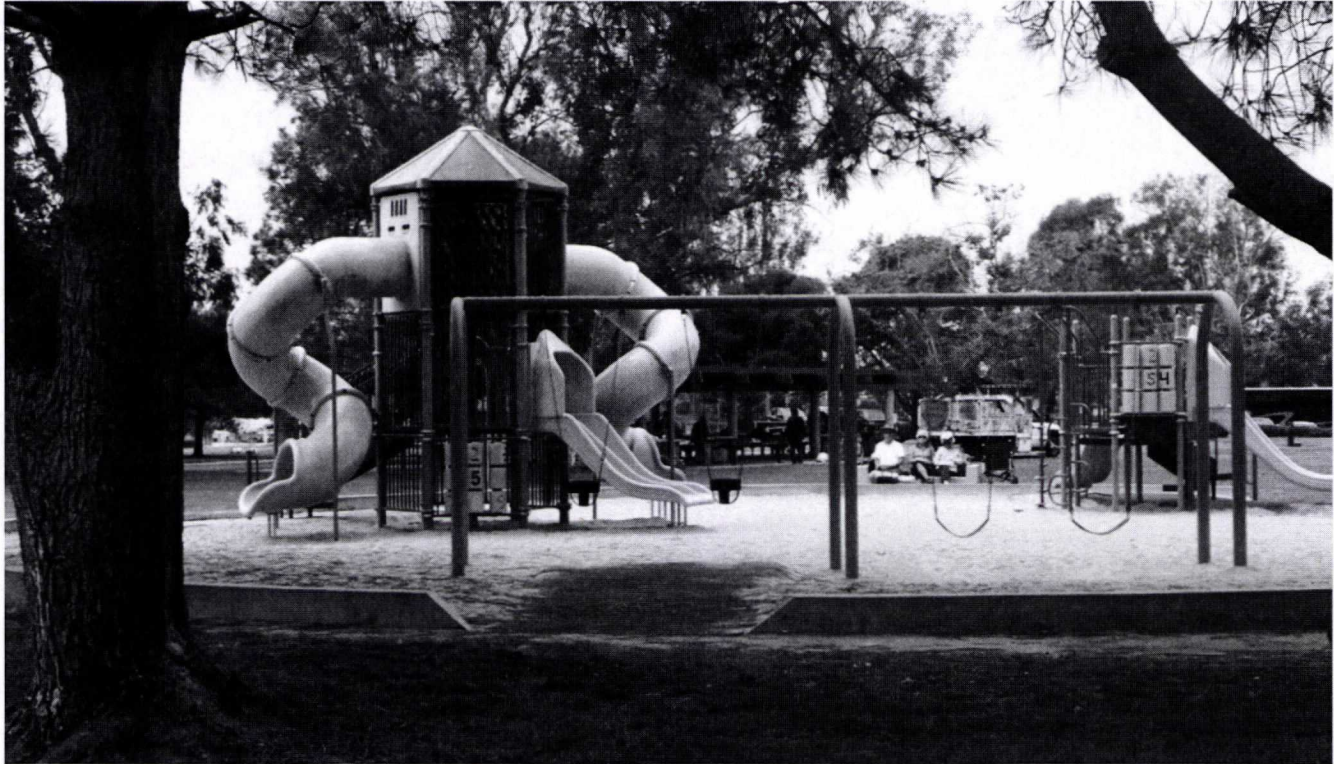
HCP Picnic Shelters

Condition: POOR

- Leaf climber chipped.
- Platform, hand rails transfer station, approach step, barrier railings rusted.
- 9', 36" and 48" slides rusted.

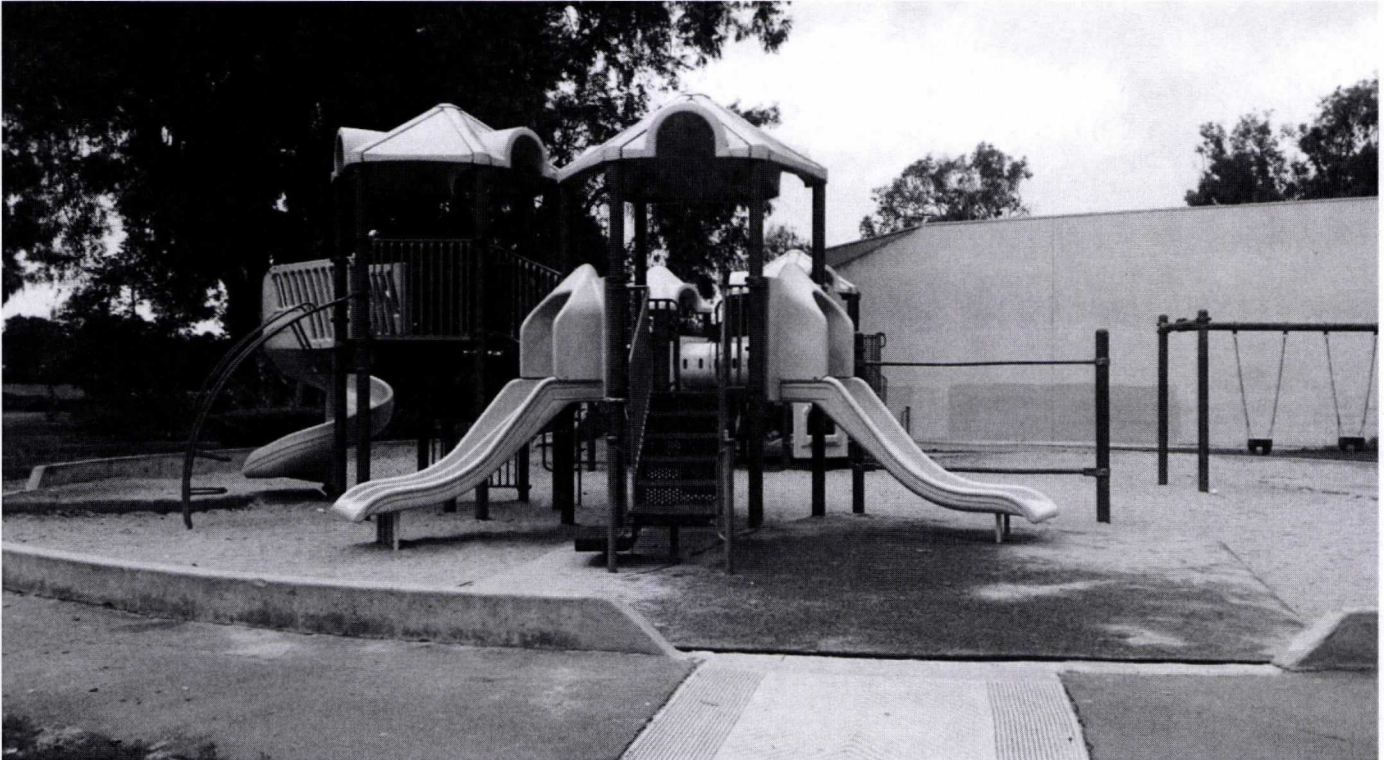
HCP Slater

Condition: POOR

- Steps, 48" and double slides cracked.
- Stair railing, transfer station and approach steps rusted.

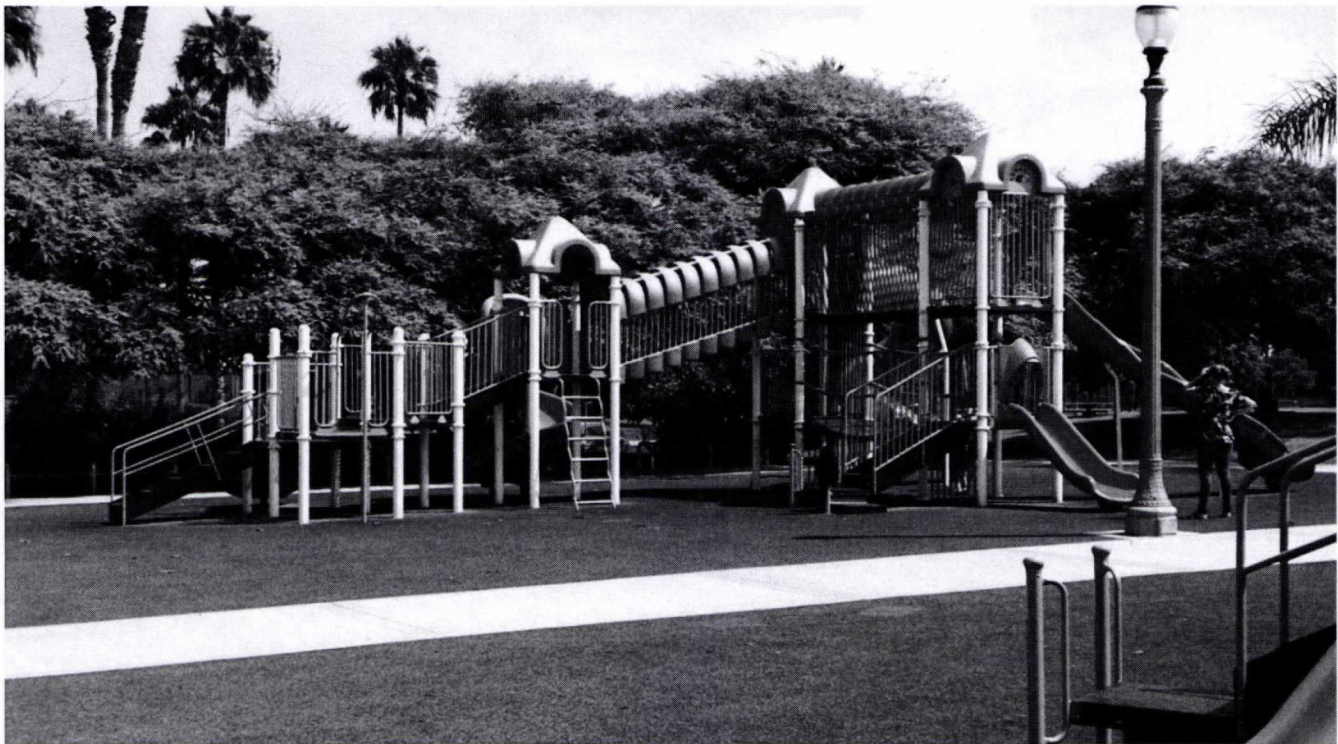
Pattinson

Condition: POOR

- Rubber Surfacing: Needs patching throughout
- Platforms, 36" deck, chains and attachment points rusted.
- Plastic steps needs to be replaced.
- Large tube slide cracked.
