STORM WATER PUMP STATION FACILITY IMPROVEMENTS

Public Works Commission
10/20/2021

STORM WATER PUMP STATIONS – CURRENT CONDITION

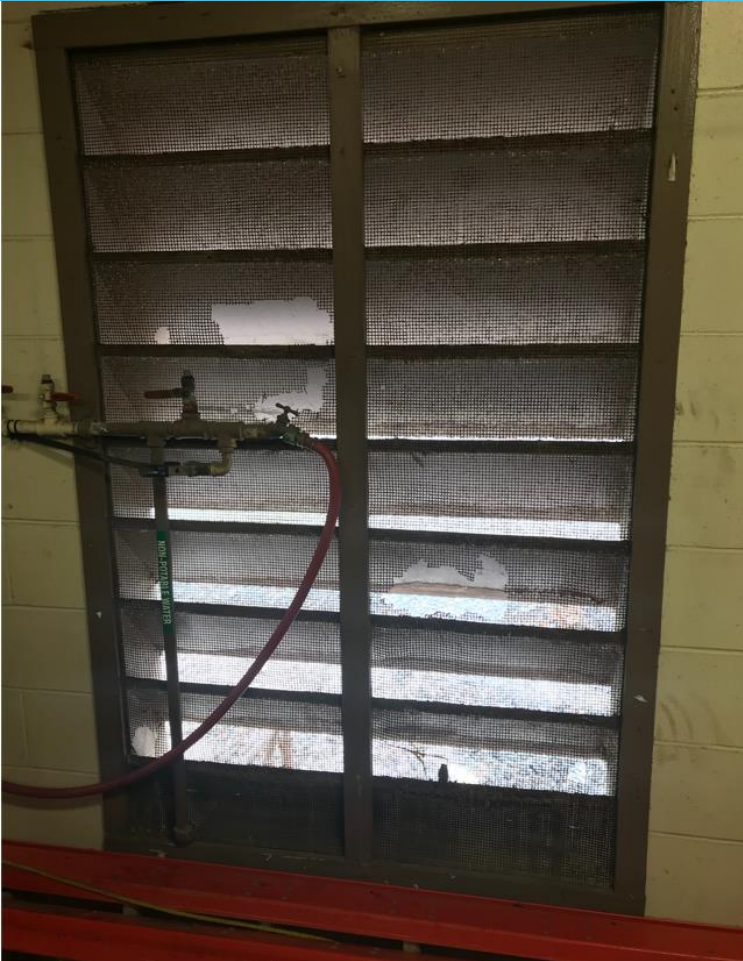
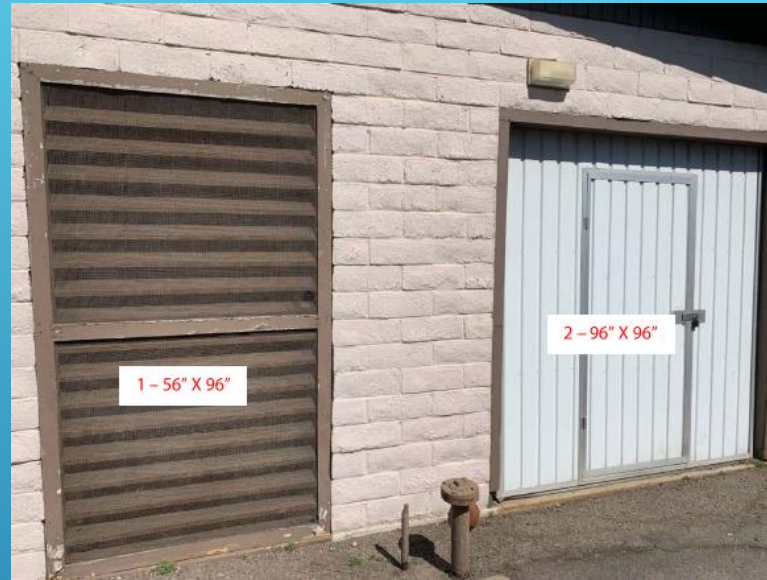
- ▶ Station louvers (left photo and above left) are wooden, original, and deteriorating. They will be upgraded to coated steel to improve durability and sound attenuation.
- ▶ Some station doors are thin corrugated metal (above right). These present a security risk and will be replaced with heavy gage steel doors.

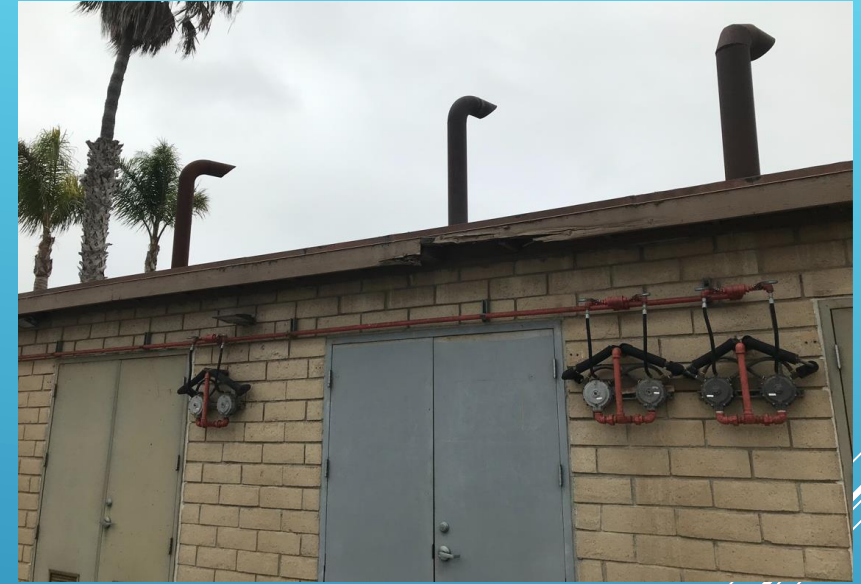
- ▶ Station roofs are nearly 30 years old and require replacement. Roof leaks have been reported at some stations.
- ▶ Fascia boards are deteriorated and will also be replaced and coated.
