# Site Visit Report

## **Meadowlark Golf Club** Huntington Beach, California

Visit Date: March 20, 2026

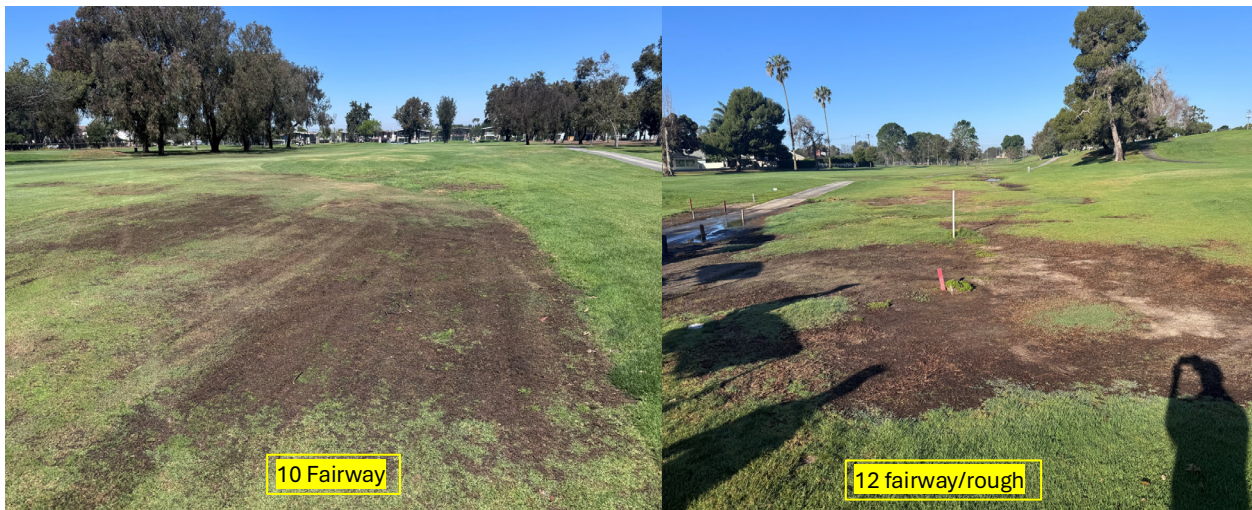
- Where there are low areas across the golf course (Nos. 10, 12 and 14 are good examples), water accumulates, sometimes 3 or 4 feet deep. Water must be pumped through a labor-intensive effort to move water off turf areas, off cart paths, and into storm drains.

- In addition to bare and thin turf in low areas, the same was found in localized depressions in fairways. With no surface fall, water impounds in localized depressions and is very slow to drain. The turf suffers from lack of oxygen and, once dry, continues to struggle from high salinity after the water evaporates.

The bare turf in these low areas on No. 10 (left) and No. 12 (right) are just a few examples where turf has thinned due to suffocation while under water and subsequent struggle with elevated salinity.

Perhaps the most important capital improvement project for this golf course is a comprehensive drainage system.

- None of the USGA Green Section team are civil engineers and therefore we are not equipped to design a system for you. However, in working with many other golf courses, it is clear from our experience at Meadowlark that drainage is needed throughout the property, not just in strategic areas. Furthermore, it is likely that the drainage design should include infrastructure such as large hurricane holes or even onsite retention basins where you're able to move and store water.
- With the above in mind, it is recommended to work with a local civil engineering company and golf course drainage contractor that can design and install a course-wide system. It is recommended to meet with several drainage companies to discuss designing a comprehensive golf course drainage system.

- I would like to be clear that this is absolutely not a drainage system that should be installed with in-house labor. Installing a herringbone drainage network in low-lying areas will not fix the problem. This golf course needs a comprehensive drainage system that will capture water as it moves downslope from areas adjacent to fairways and roughs, as well as a consistent network of subsurface drainage and surface drainage across fairways, roughs, and green surrounds. I am afraid this is an expensive endeavor, but one that is sorely needed for this property. As previously mentioned, I am confident that this project will have a tremendous positive impact on the golf experience at Meadowlark Golf Club.

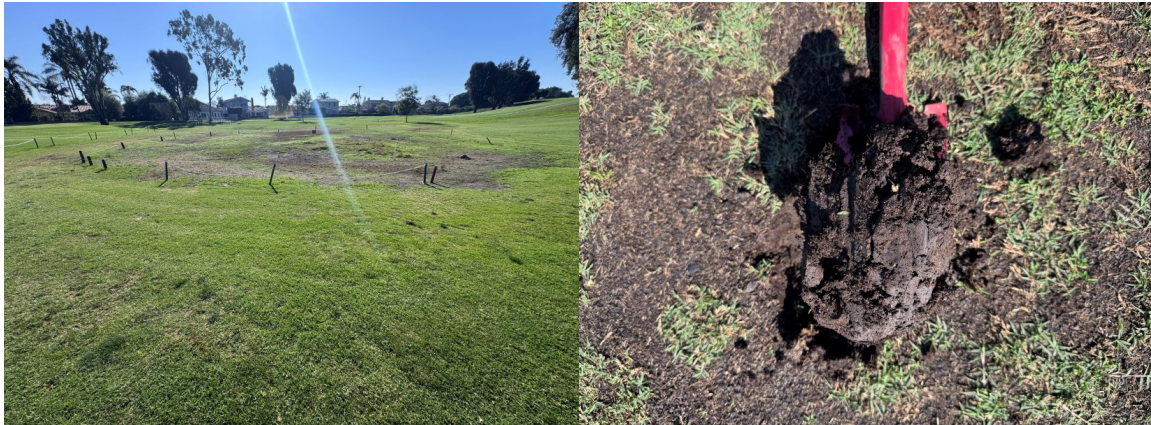
This low area on No. 14 is just 20 yards in front of the green, making this area unplayable. The soil (right) consists of heavy clay which is very slow to drain.

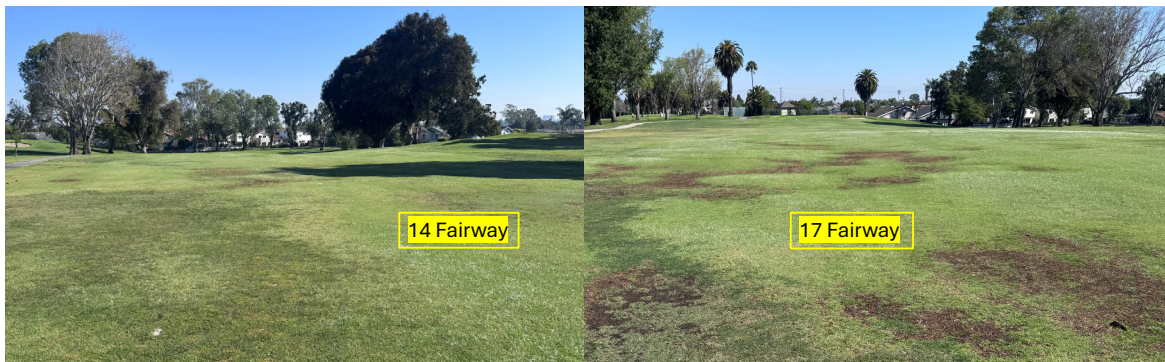
There are bare turf areas on flat ground in addition to low areas. These bare/thin areas are also a result of extended ponding and isolated high salinity.

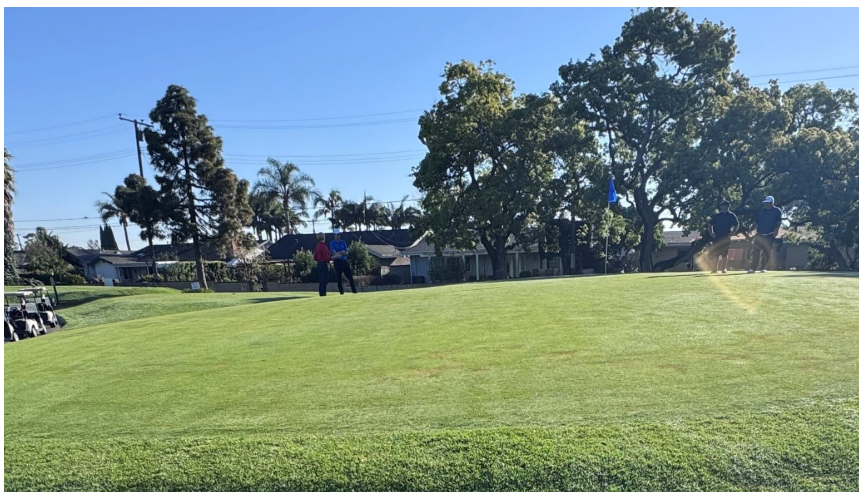
The putting greens consist of a combination of *Poa annua*. There is some creeping bentgrass, but the primary population is *Poa annua*. The *Poa annua* performs well in this climate so close to the ocean.

The turfgrass composition on greens consists primarily of *Poa annua* with some creeping bentgrass.

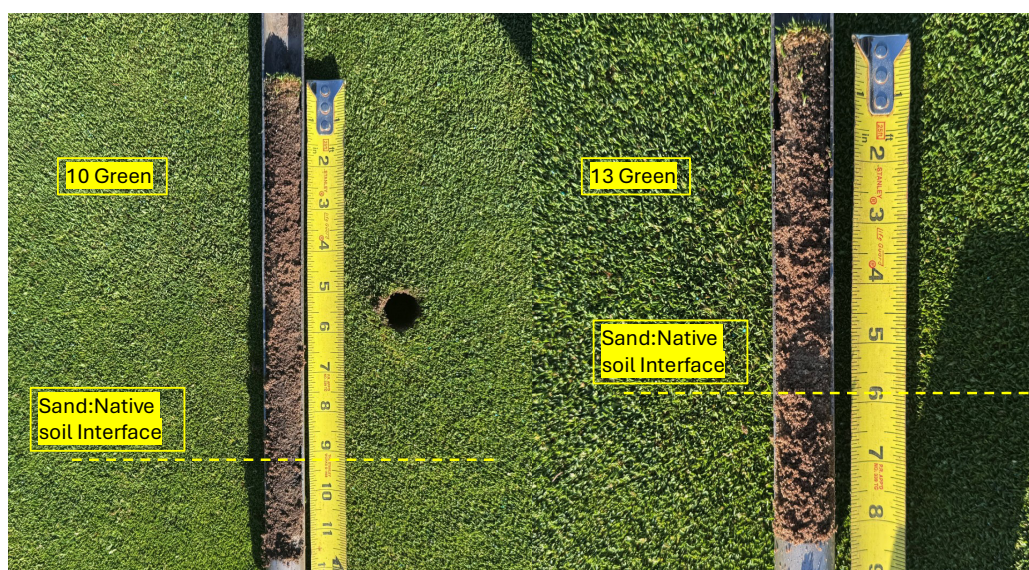
- On some greens, the depth of the improved soil is approximately 8 inches (such as observed on No. 10) while on other greens, the depth is only about 6 inches. It is on the shallower greens (such as on No. 13) where water will at times accumulate in the hole (cup). There is no subsurface drainage. However, the greens are sloped and therefore surface drainage is good – other than where there are raised collars.
- While these are not modern-built greens with 12 inches of rootzone mix, gravel and subsurface drainage, they generally perform well, meaning turf is healthy and the surface performance meets expectations.
- Most greens have a raised collar that impedes proper water flow off the surface.

The improved profile with sand and organic matter is deep on No. 10 green (left) at 9 inches but much shallower on No. 13 green (right) at about 6 inches.

With regard to making recommendations for the long-term needs assessment for these greens, I do not foresee the need to rebuild despite the push-up style greens. This climate is favorable and the water quality is acceptable, thus the greens have been healthy for many years, and I expect them to continue in that fashion. We did recommend utilizing a Drill & Fill® machine on greens, ideally once per year, which I believe will help with drainage.

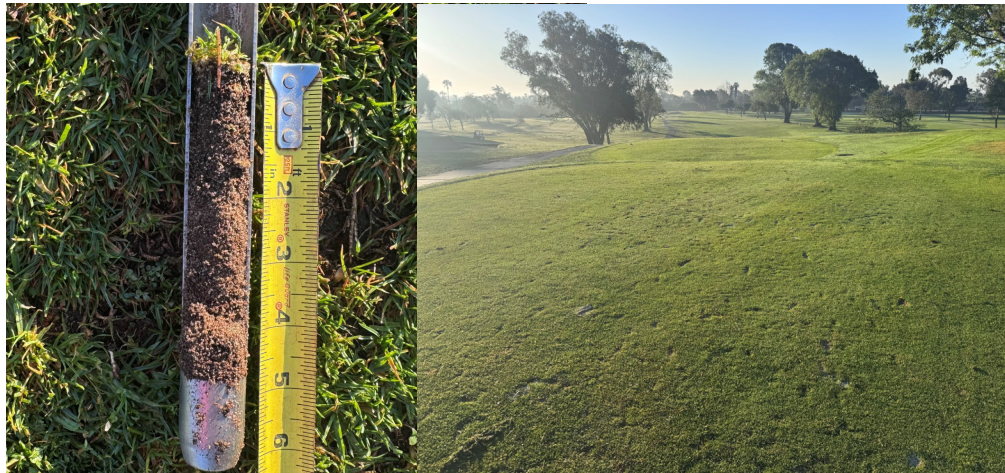
The tees were constructed with 5 to 6 inches of sand on top of native soil. A considerable amount of thatch has accumulated on top of the sand.

The rootzone in tees is comprised of about 5 inches of sand and organic material on top of the native soil (No. 10 tee rootzone and tee surface shown here).

For the long-term golf course experience at Meadowlark, a tee renovation is highly recommended. More specifically, teeing areas should be enlarged, especially for the white tees on many holes, and all the tees need to be releveled and resurfaced. As a guideline moving forward, tees should be leveled about every ten years.

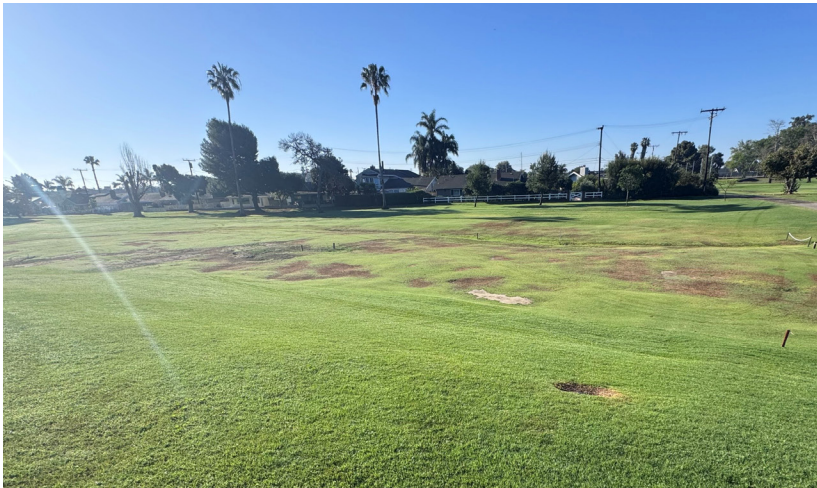
The kikuyugrass has poor turf density on No. 12 fairway as a result of anoxic conditions and elevated salinity due to flooding.

I will refer back to the drainage section of this report. The primary recommendation for the long-term health of this golf course and to significantly improve the golfer experience throughout the year will be to install a course-wide drainage system designed by a qualified engineer and drainage designer. Given that kikuyugrass is so successful on this golf course, I do not see the need to change turf varieties.

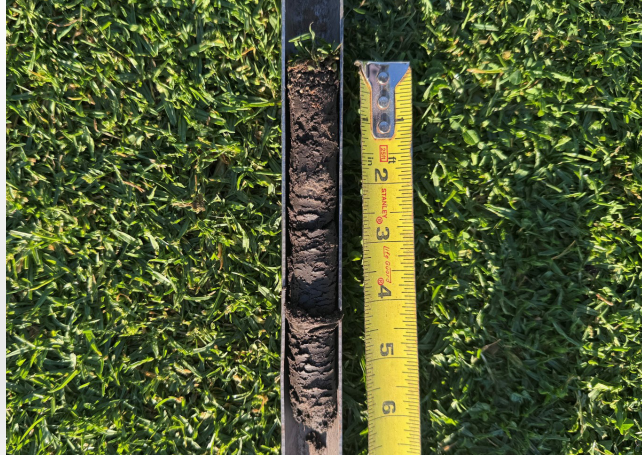
The soil is dominated by clay. This soil drains very slowly, likely only 1/10 inch per hour or less. The soil texture appears to be consistent from the surface to several feet deep. Where there is moisture, the kikuyugrass roots are deep and healthy. Where there are dry areas, the clay becomes extremely hard and compacted. The soil type makes for difficult irrigation management given the very slow infiltration rate.

Clay dominates the soil texture in fairways, and it appears to be several feet deep or more. Where there is adequate moisture, roots are deep in this soil, but it is extremely slow to drain.

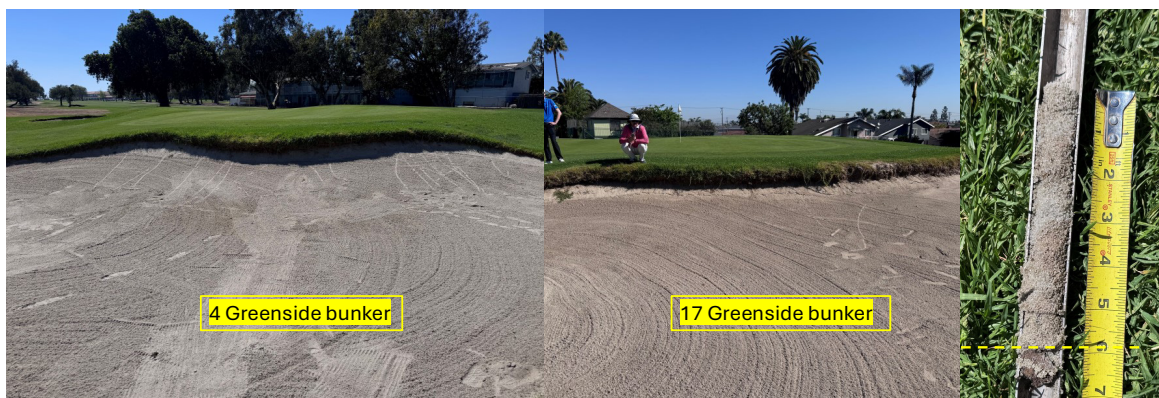
- In general, the sand is free of rocks. Sand depth was measured at 5 to 6 inches, which is generally sufficient to provide good playability. It was noted that the agronomy team have been routinely adding sand to improve playability.
- The bunkers drain poorly. When there are rain events or heavy irrigation, it is common to see water standing in bunkers.
- The bunker edges have grown in elevation, and the original perimeters have been lost. There is a significant amount of thatch and organic matter and sand splash that has accumulated in bunker surrounds.

The bunker lips are likely 2 to 3 feet higher than their original elevation. Sand depth was measured at approximately 6 inches (right).

It is recommended to consider renovating all of the bunkers on the golf course. There are only 20 bunkers, which is excellent, but some bunkers are quite large.

- You may consider reducing the size of some of the bunkers simply to reduce maintenance costs and the costs of sand replacement.
- It will also be critical to lower the elevation of the bunker lips to try and recapture the original design.
- Finally, the drainage should be audited and fixed to improve the ability of the bunkers to exit water from the system.

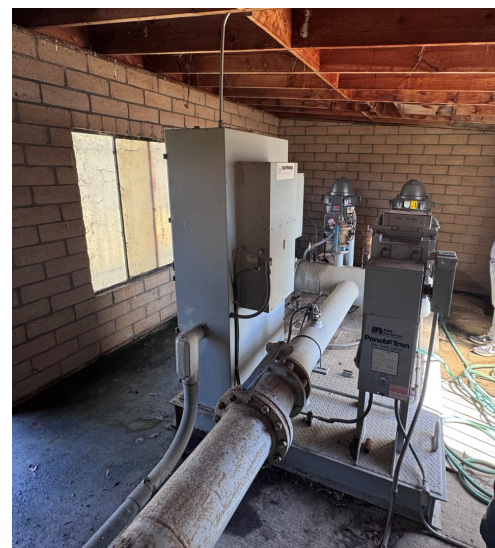
The pump station is original, and it is good to report that it is in good shape and is routinely maintained. The team have replaced motors as needed. The skid and the pump station are in decent to good condition. The pump station is enclosed in a protective building with adequate air circulation.

The pump station is in good working condition and is in an acceptable enclosure.
