GEOTECHNICAL REPORT
PROPOSED IMPROVEMENTS
EDISON PARK
HUNTINGTON BEACH, CALIFORNIA

Project Number: SC1369

November 30, 2023

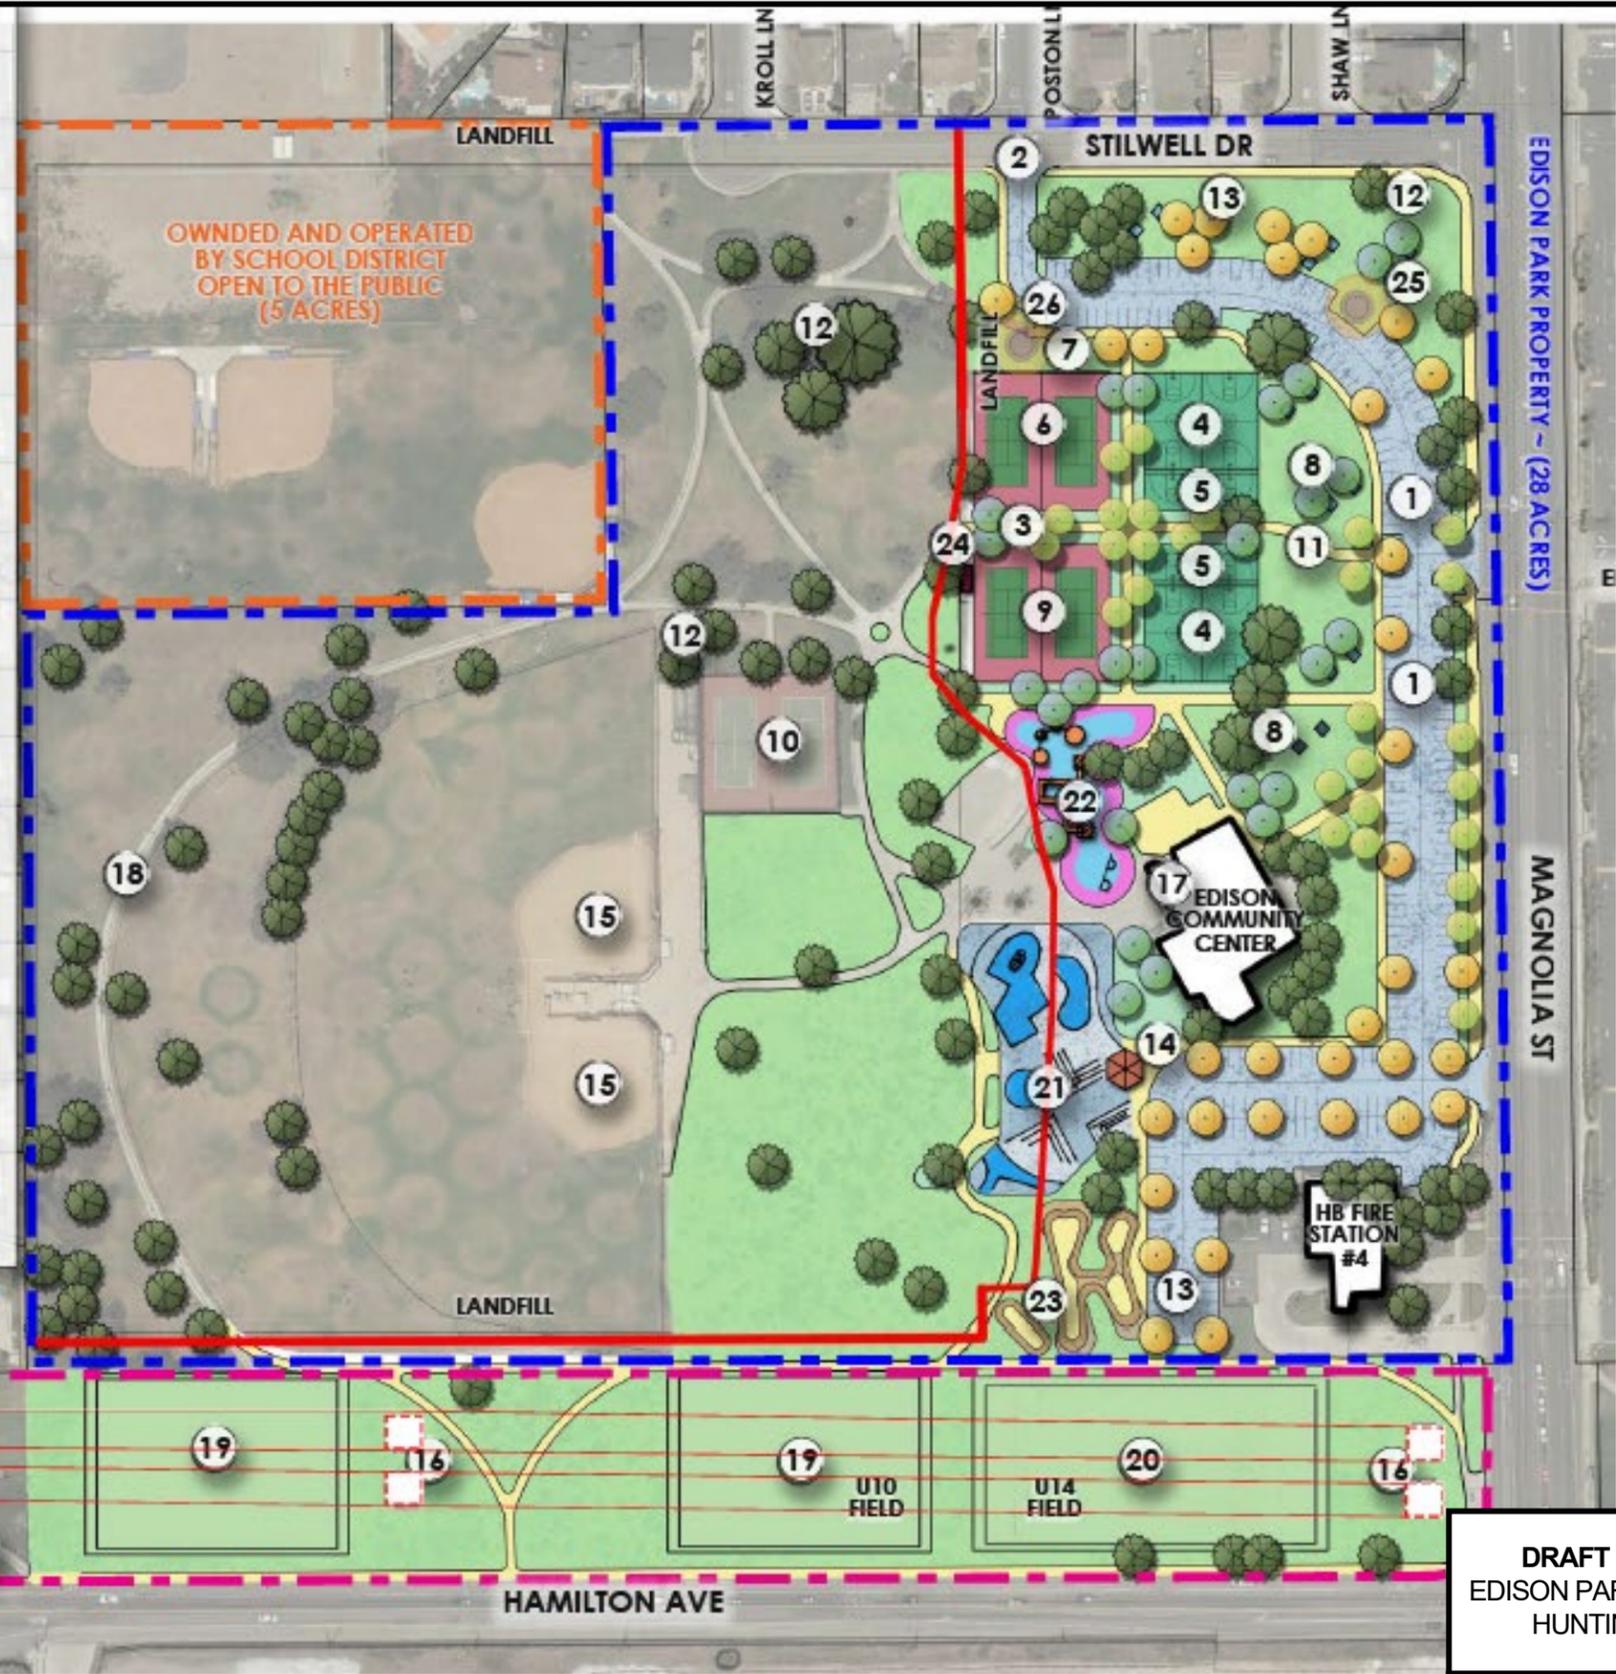
FIGURE
	2
PROJECT NO: SC1369	NOVEMBER 2023

DRAFT CONCEPTUAL PLAN BY RJM
 EDISON PARK - PROPOSED IMPROVEMENTS
 HUNTINGTON BEACH, CALIFORNIA

07/25/2023

Geosyntec performed a review of the Draft Conceptual Plan prepared by RJM dated 25 July 2023 (Figure 2) to assess the compatibility and feasibility of the proposed park improvements. Geosyntec's review findings and preliminary recommendations related to RJM's draft conceptual plan are presented in Table 1.

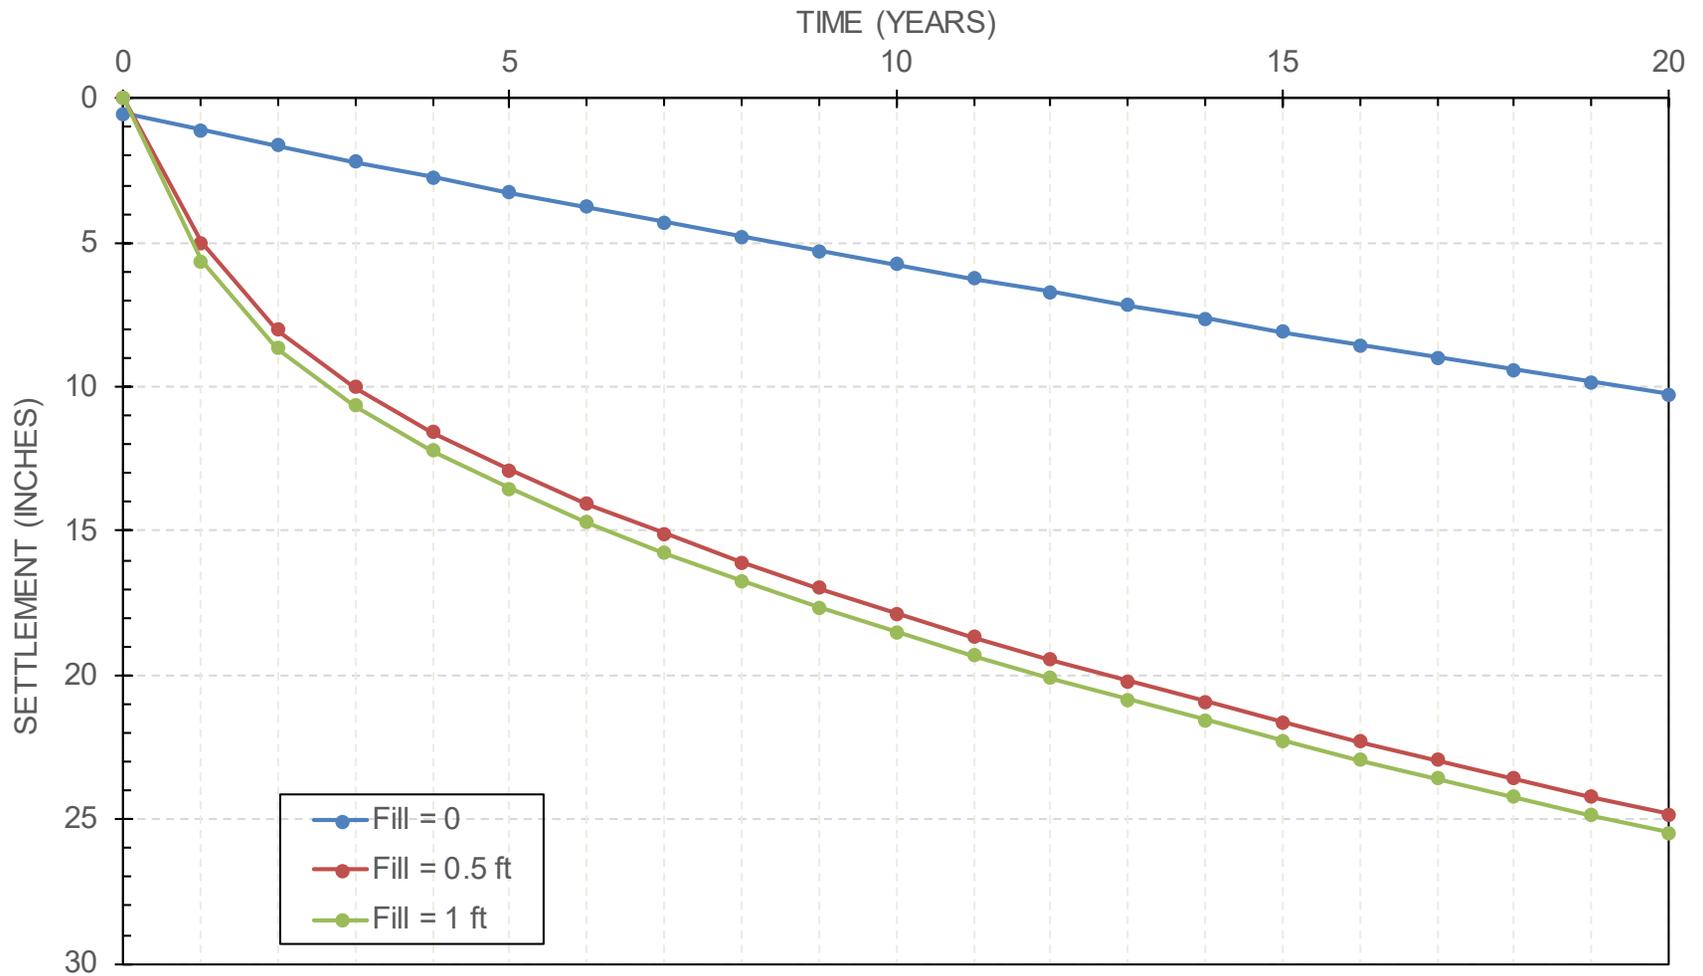
Note:
Waste settlement estimates from Geosyntec (2018) Feasibility Study for Edison Park Settlement Related Damage Repair

WASTE SETTLEMENT ESTIMATES EDISON PARK – PROPOSED IMPROVEMENTS HUNTINGTON BEACH, CALIFORNIA	
PROJECT NO: SC1369	NOVEMBER 2023
FIGURE 3

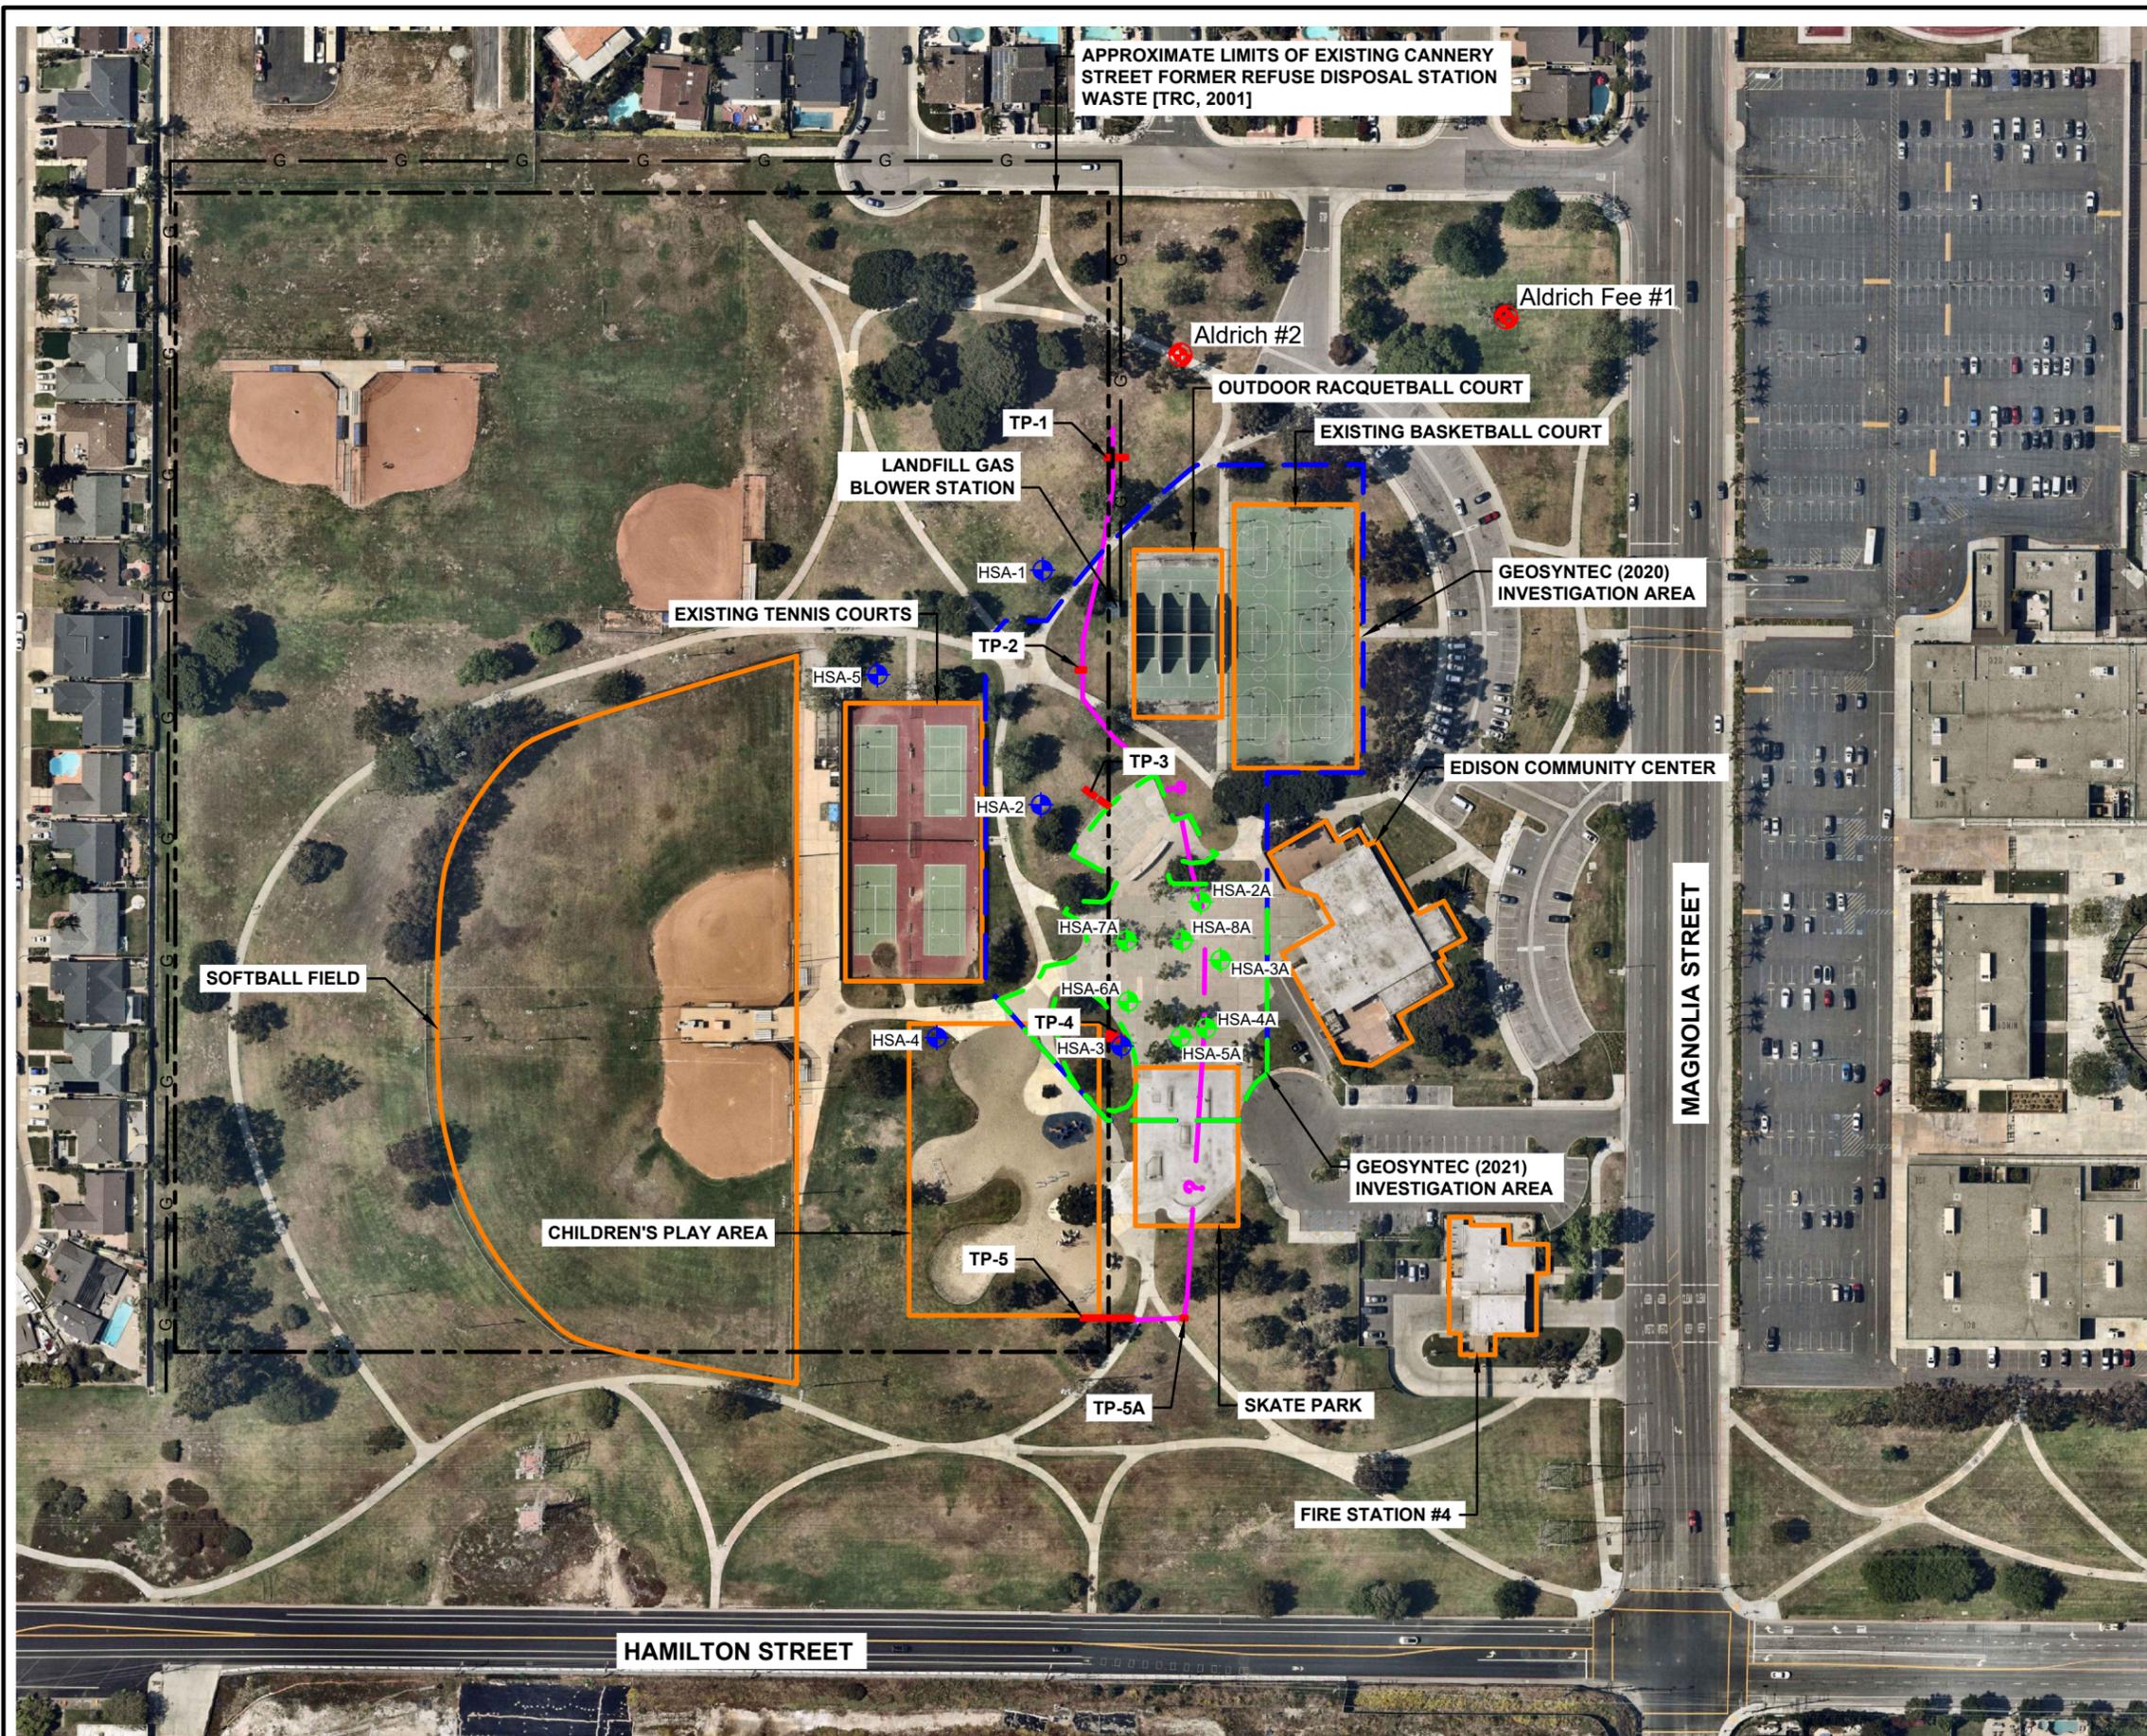
EXISTING CONDITIONS AND FIELD INVESTIGATION LOCATIONS EDISON PARK PROPOSED IMPROVEMNTS HUNTINGTON BEACH, CALIFORNIA

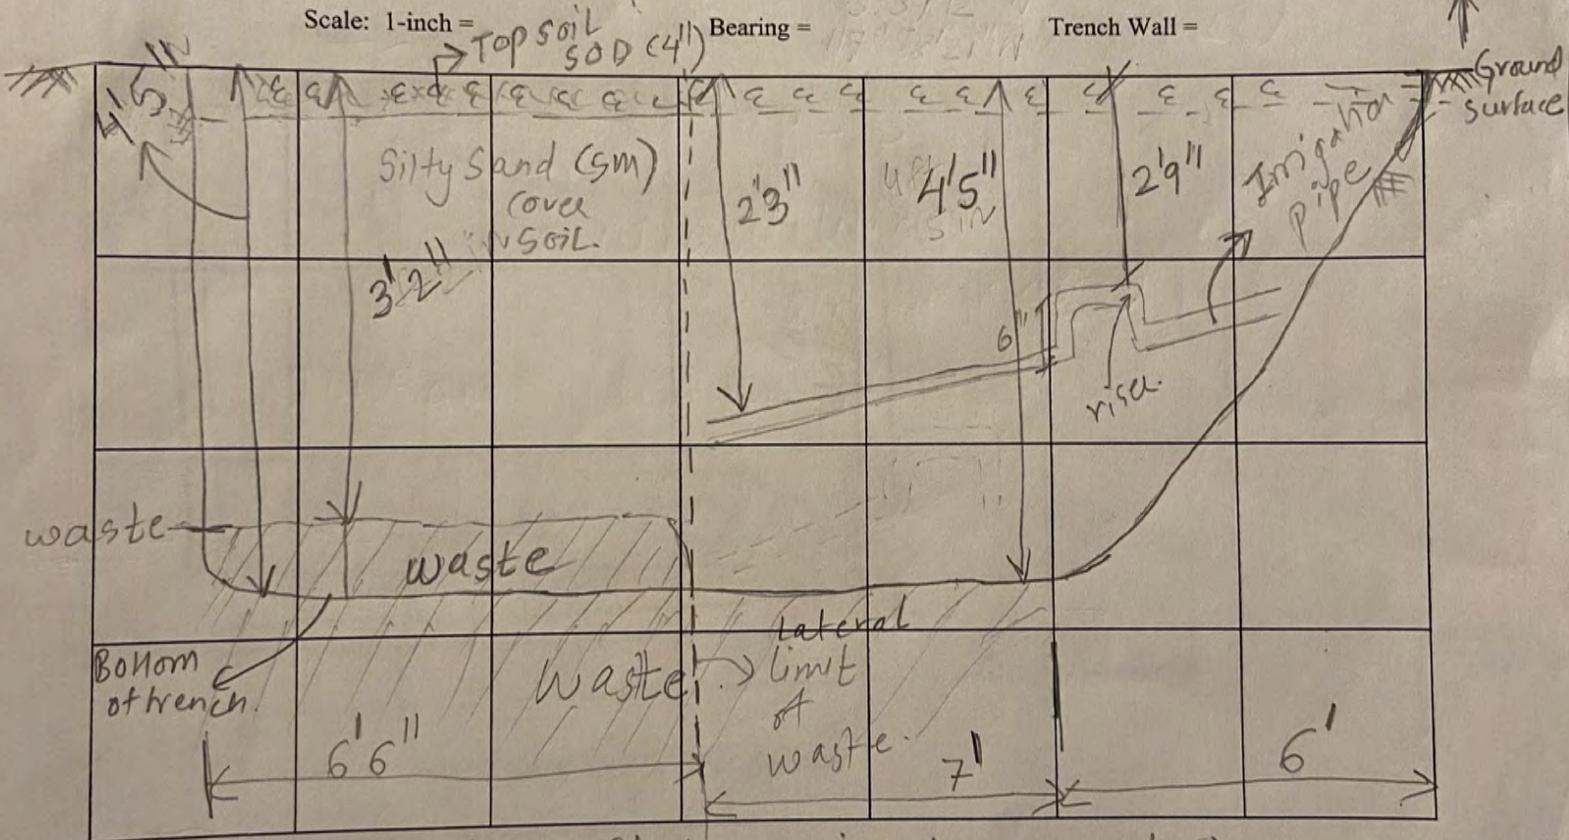
Test Pit Number: TP-1

Waste: mostly AC debris (dark grey in color, no odor)

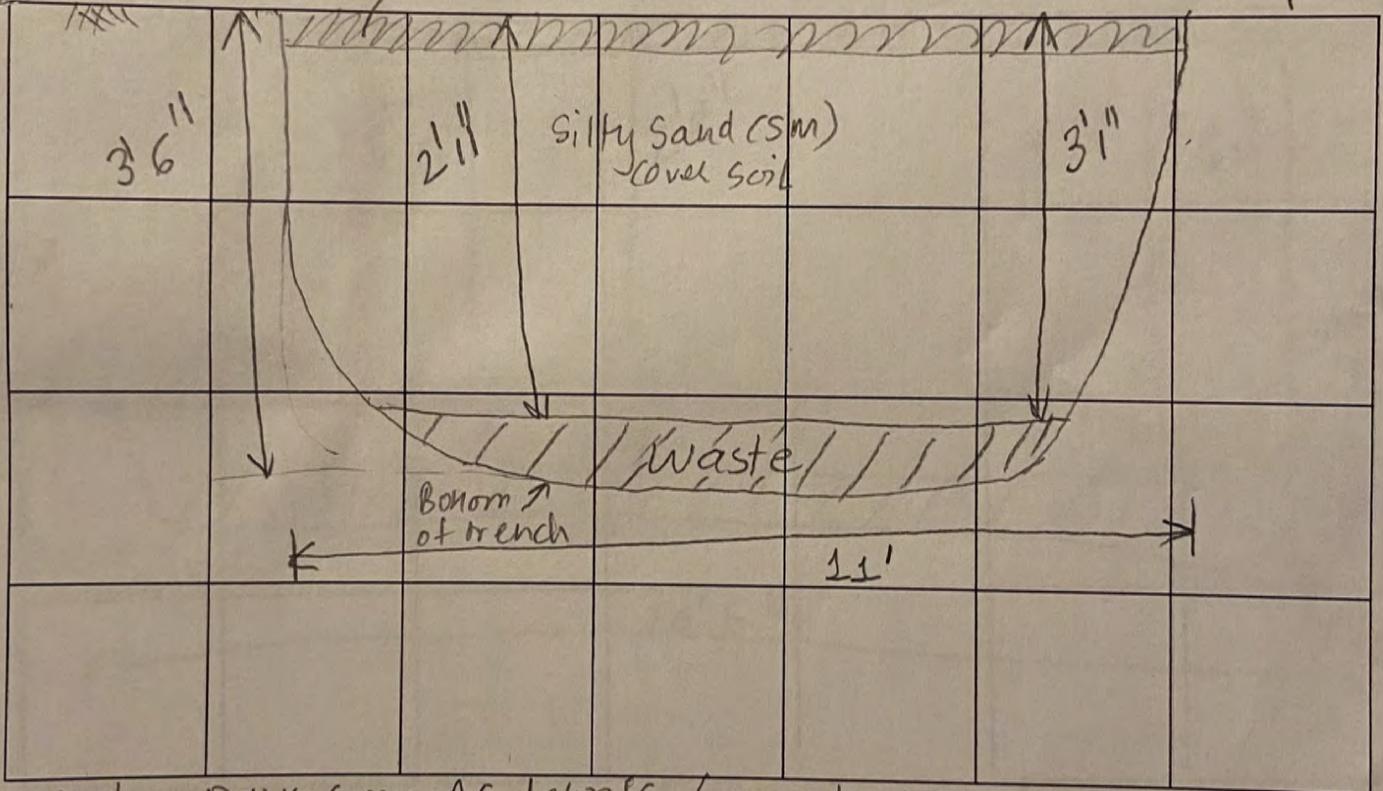
Test Pit Number: TP-3

waste: Dark Grey, AC debris (no odor)

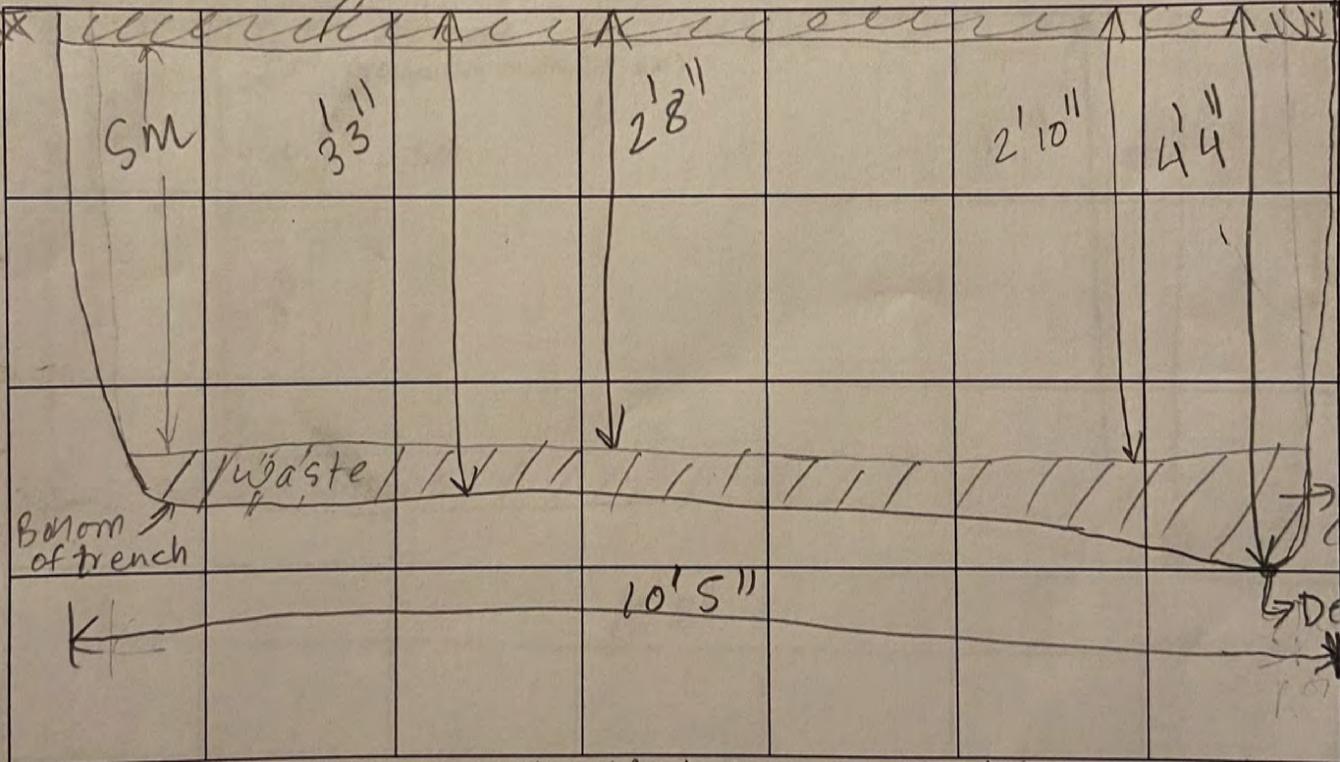
Test Pit Number: TP-3 (cont..) Date: 9/25/2020

waste: Dark grey, mostly Asphalt-concrete debris, no odor.

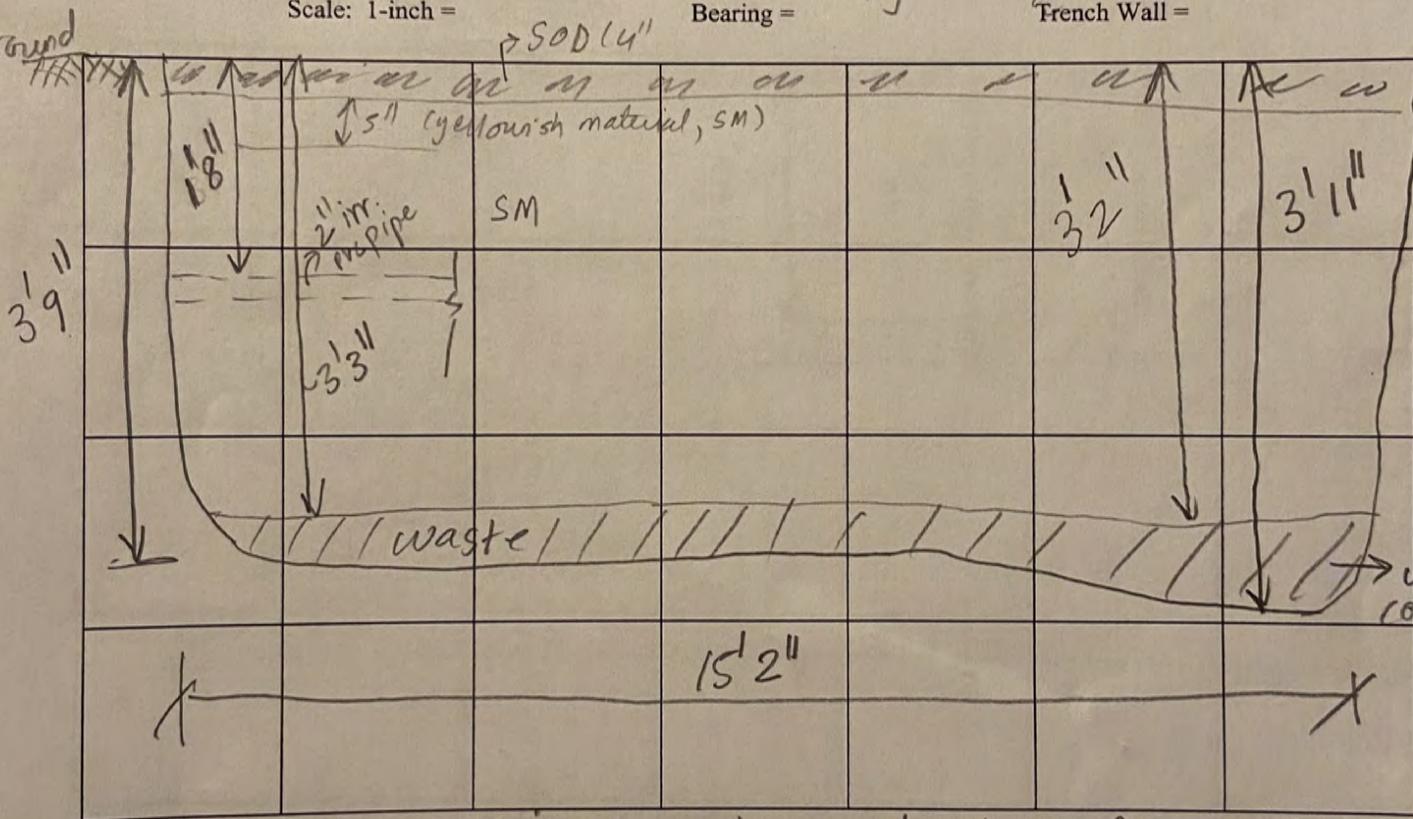
Test Pit Number: TP-4

Notes: lateral limit of waste could not be found (reached close to concrete slab and utility lines)

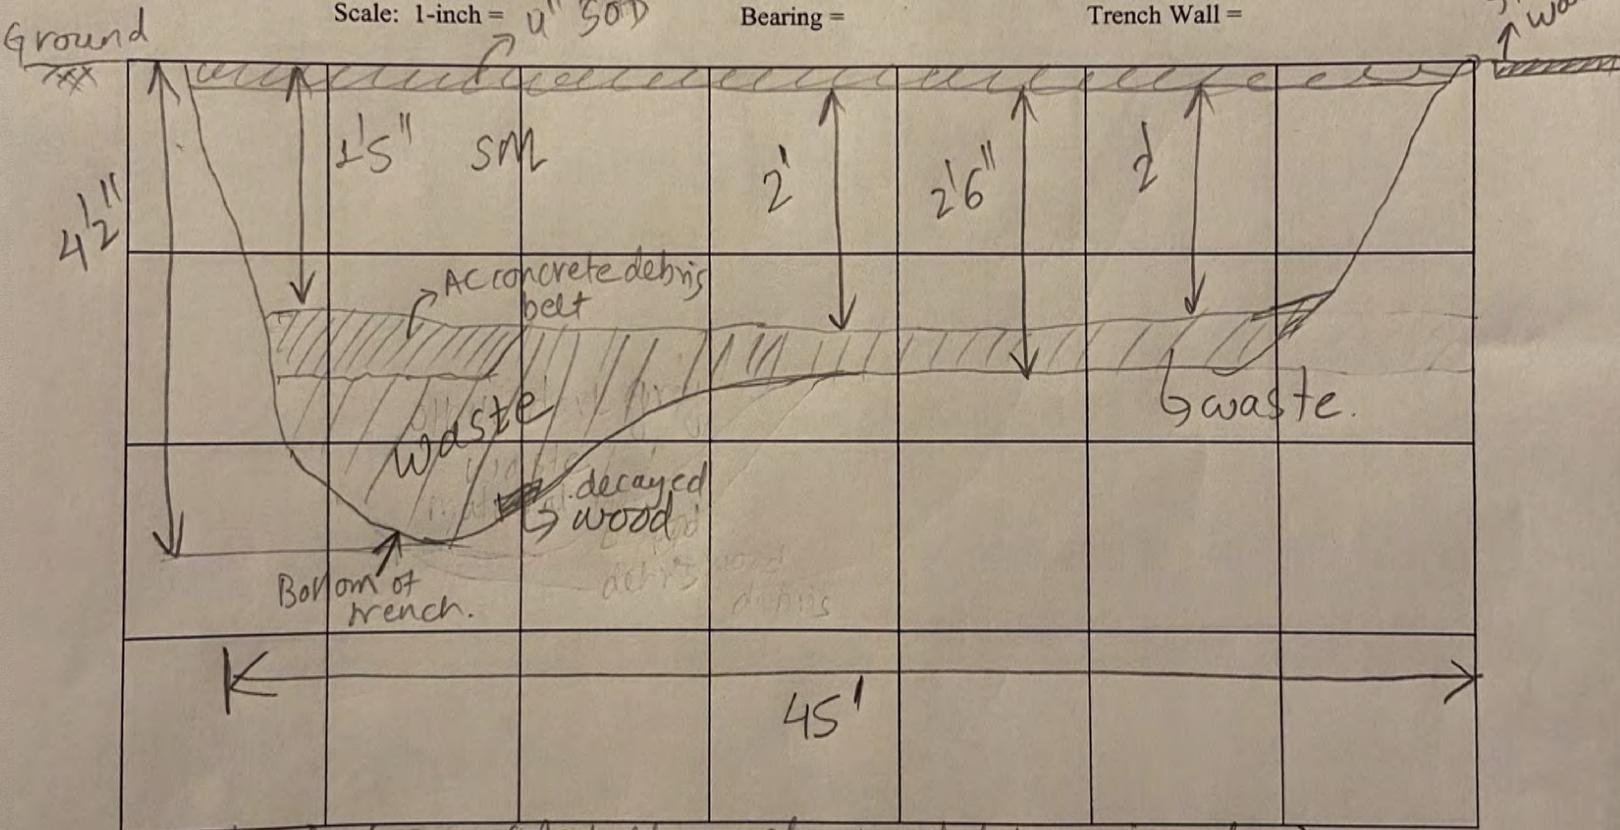
Test Pit Number: TP-5

Waste: Dark grey CA asphalt concrete, wood debris (with odor)

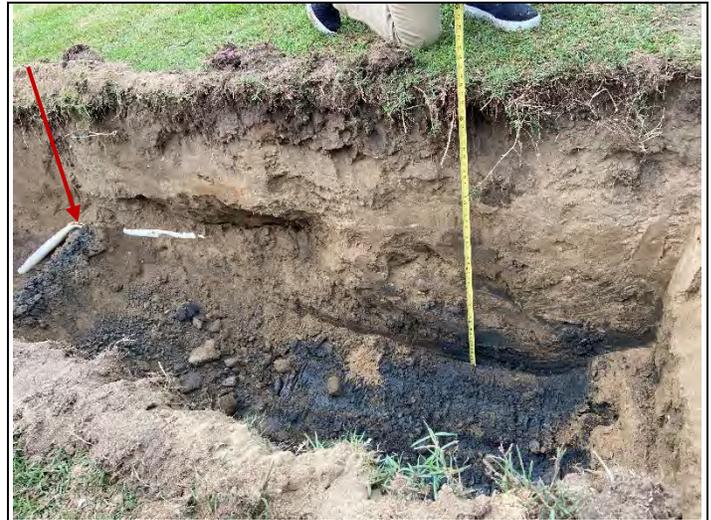
Waste encountered at TP-1. Also indicated is the exposed underground irrigation pipeline (looking southeast).

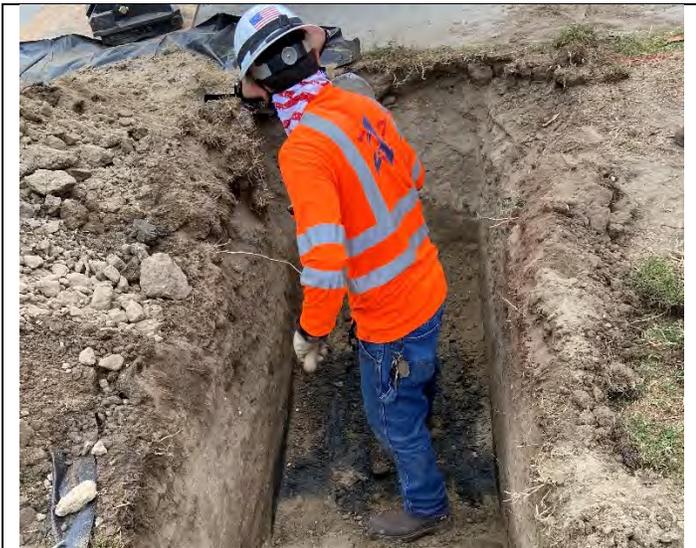
Waste encountered at TP-3, waste continues underneath the concrete slab (looking east)

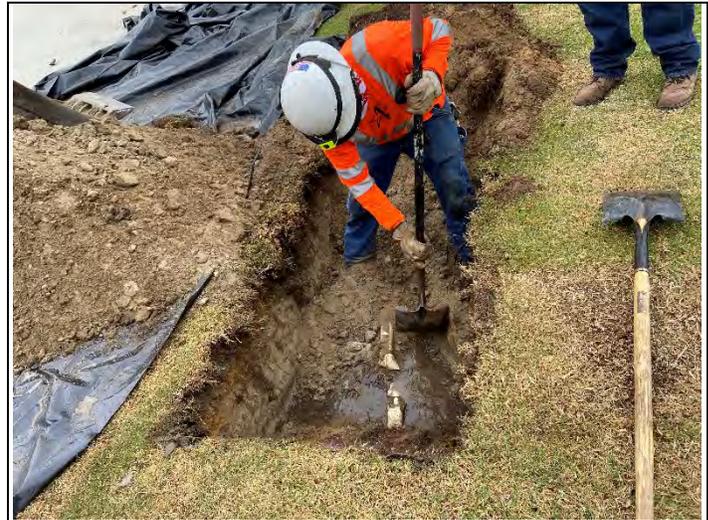
Damaged irrigation pipe at TP-4 (looking northeast).

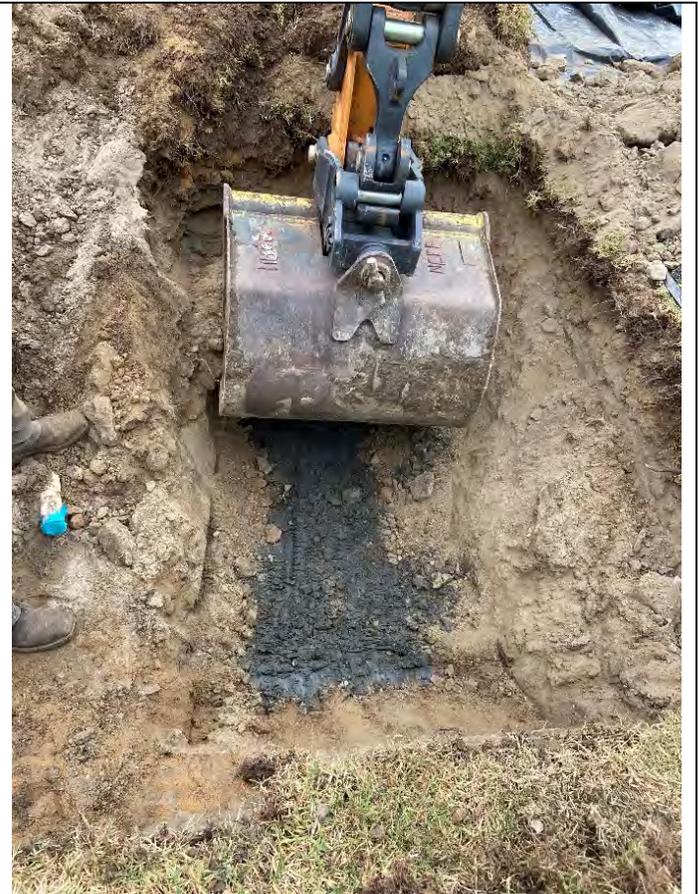
Waste encountered at TP-4 (looking east).

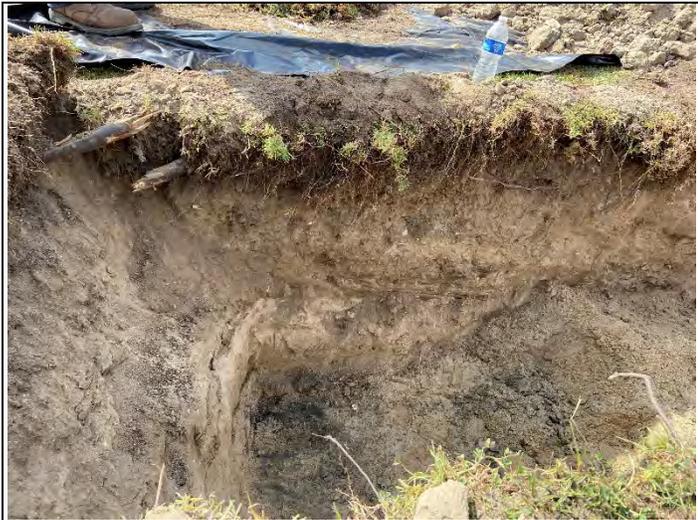
Waste observed to continue underneath the concrete slab at TP-4 (looking south).

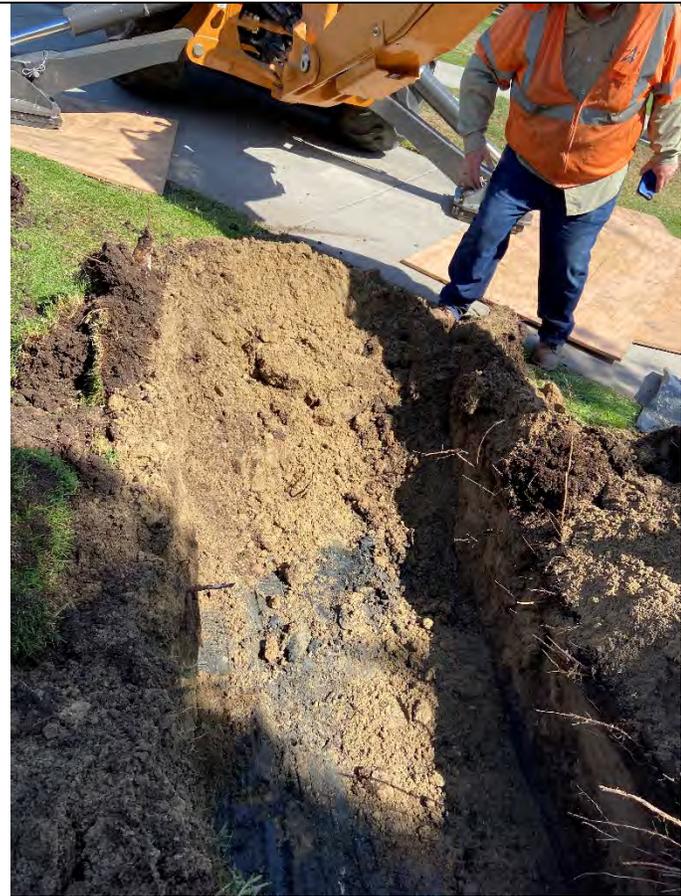
Waste material encountered at TP-5 (looking south).

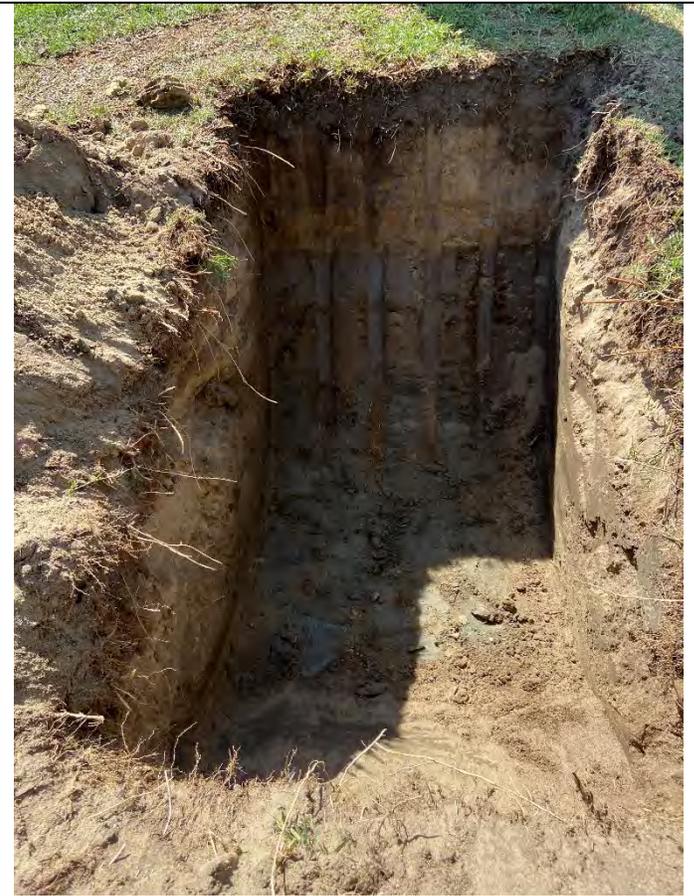
Pothole 35 ft east of excavated trench at TP-5 and observation of waste (looking west).

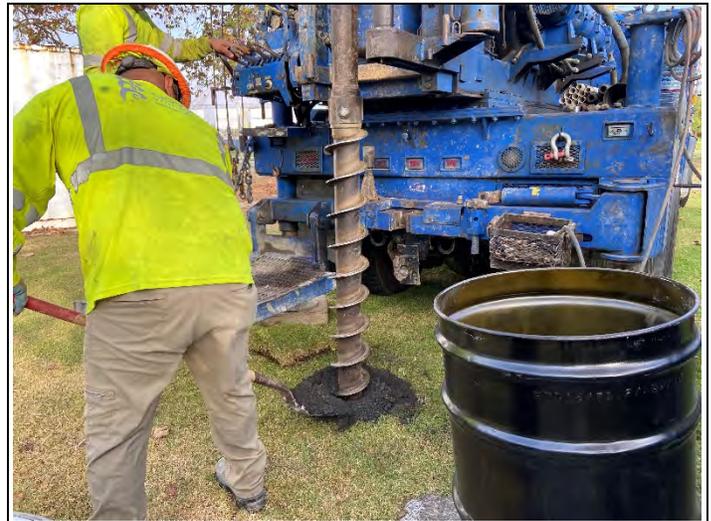
Waste encountered at HSA-5 (looking northwest).

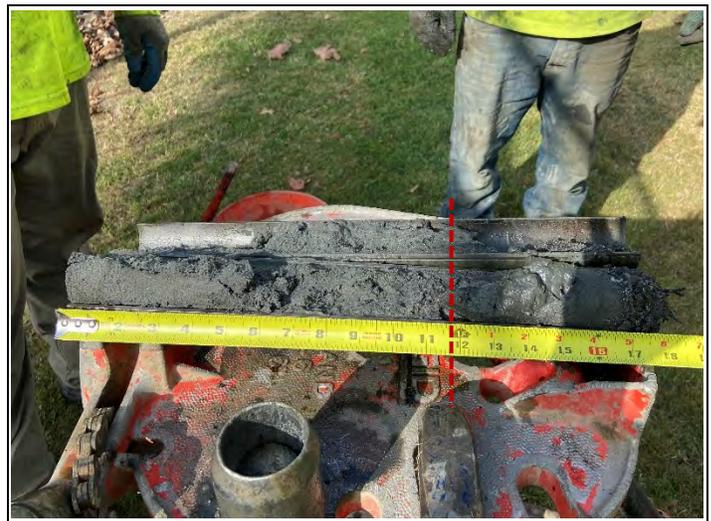
Split spoon sample collected at 40 – 41.5 ft bgs at HSA-5. The interface between the waste and native soil is indicated.

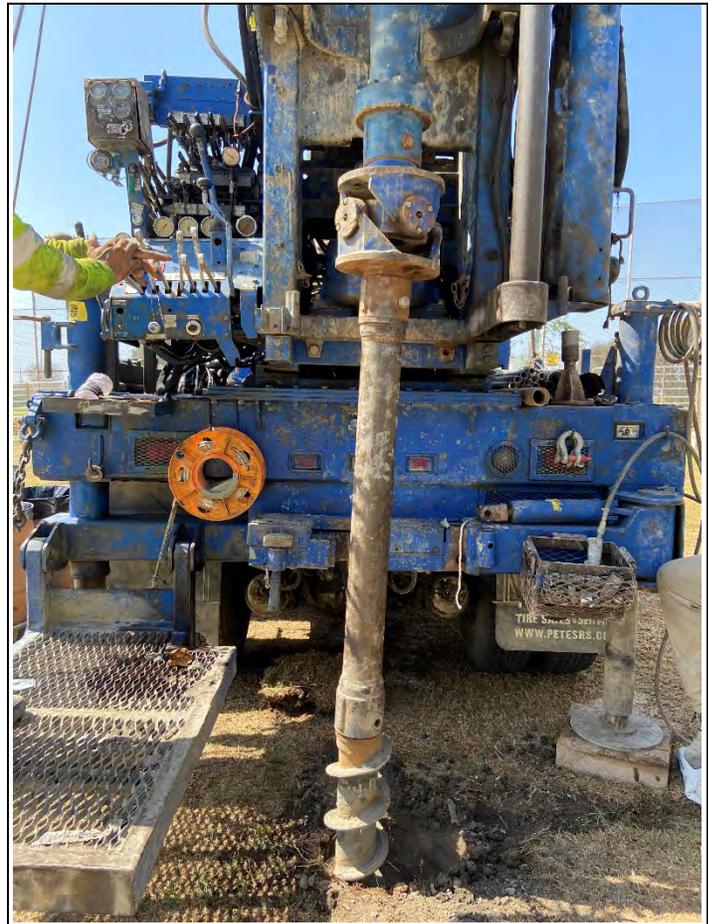
Tilting of auger at HSA-4 (looking west).

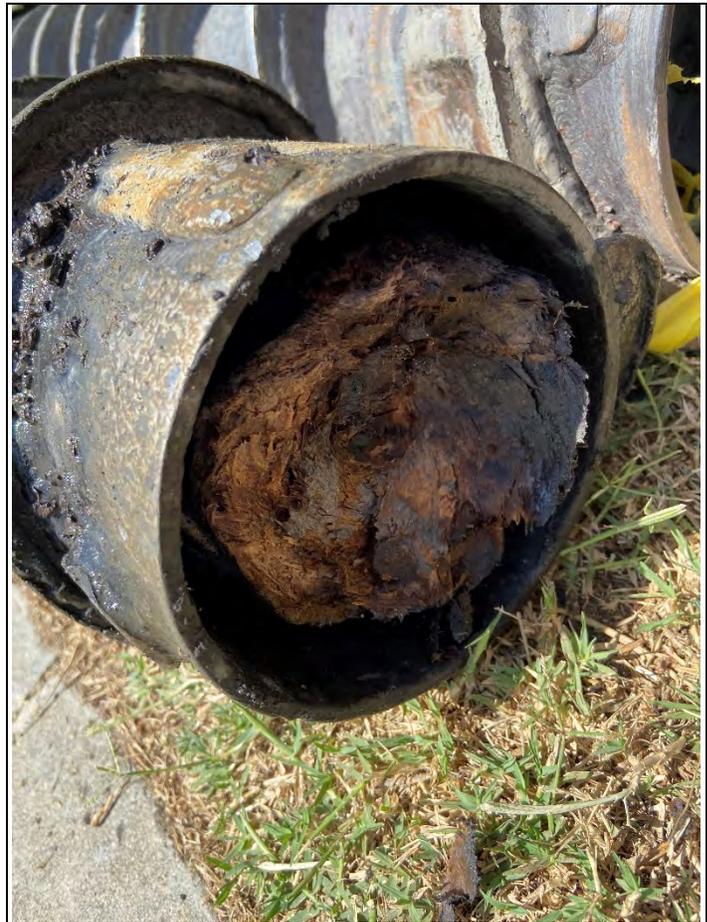
Wood plugged in the lead auger at HSA-4.

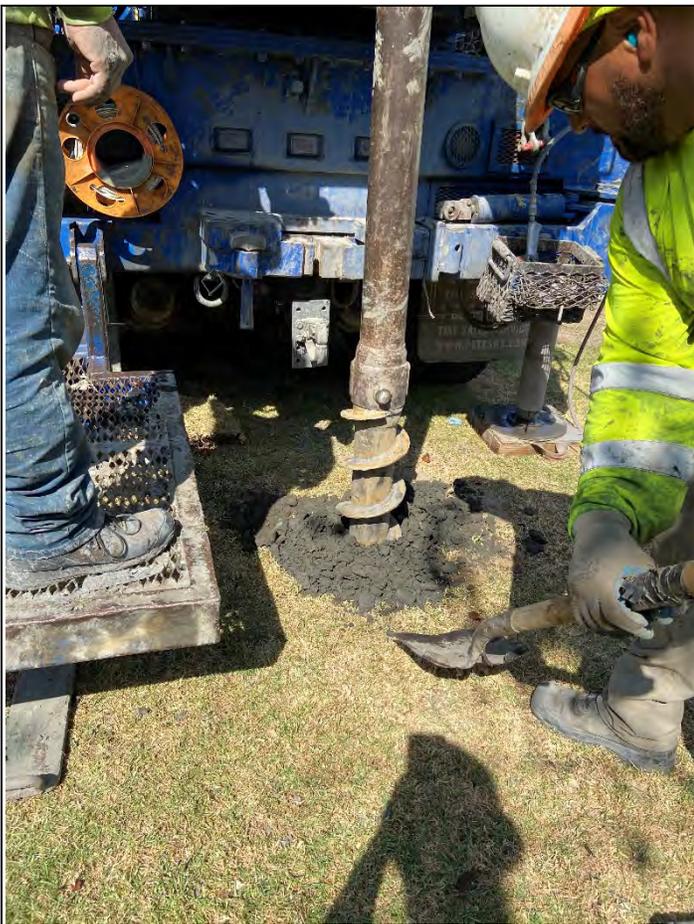
Waste observed in the soil cuttings at HSA-3 (looking northeast).

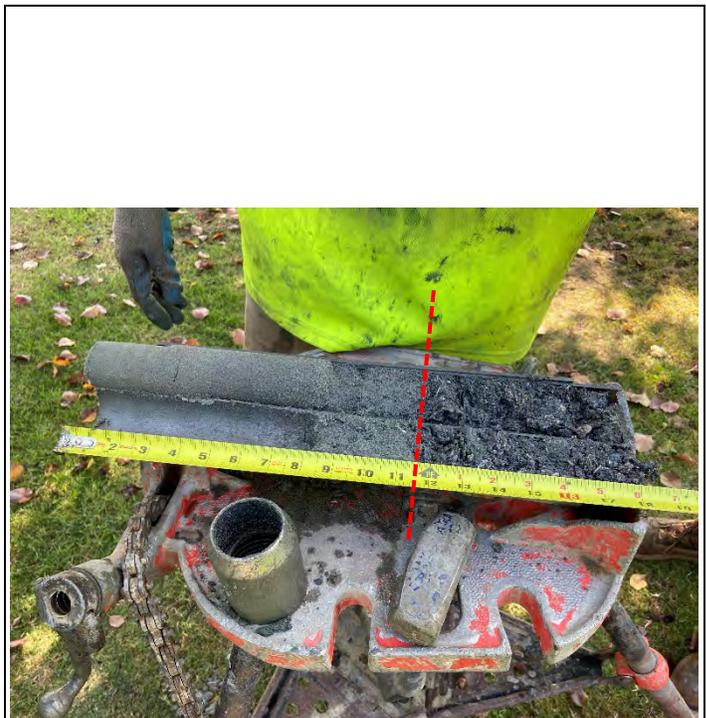
Split spoon sample collected at 20 to 21.5 ft bgs at HSA-3. The interface between the waste and native soil is indicated.

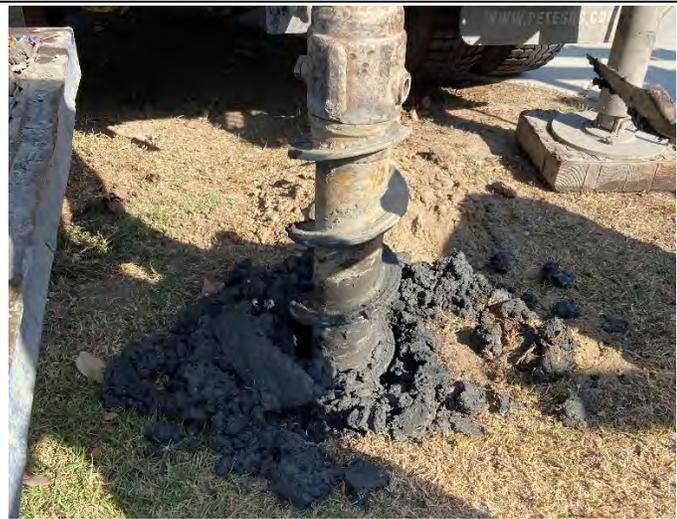
Waste material observed in the spoil at HSA-2 (looking northeast).

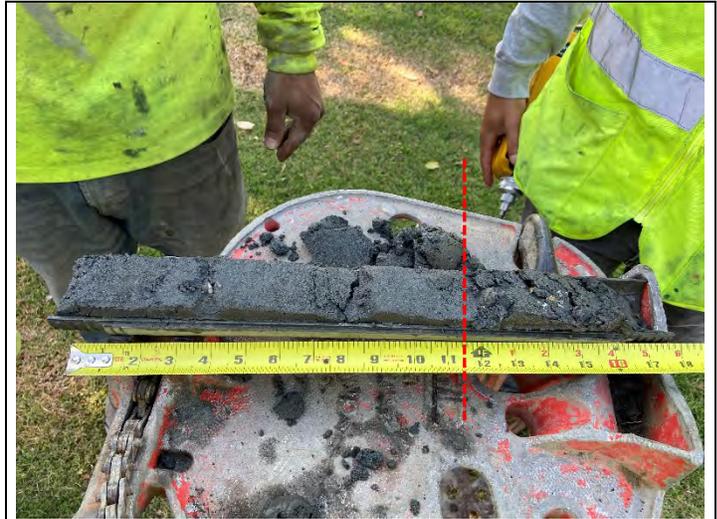
Split spoon sample collected at 15 – 16.5 ft bgs at HSA-2. The interface between the waste and native soil is indicated.

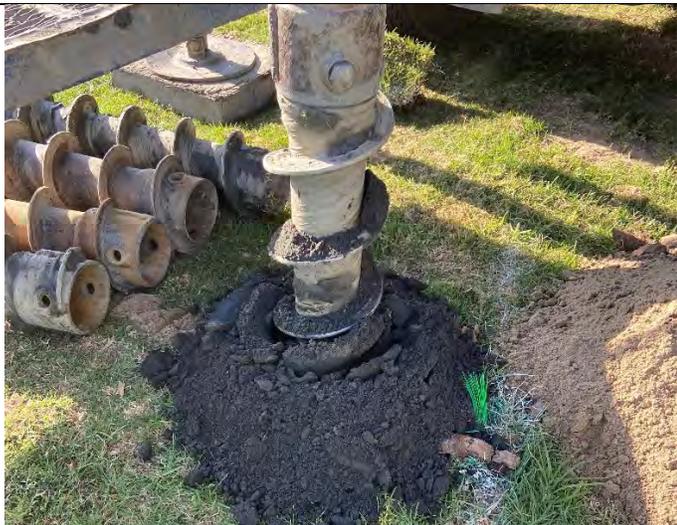
Waste material observed at HSA-1 (looking northwest).

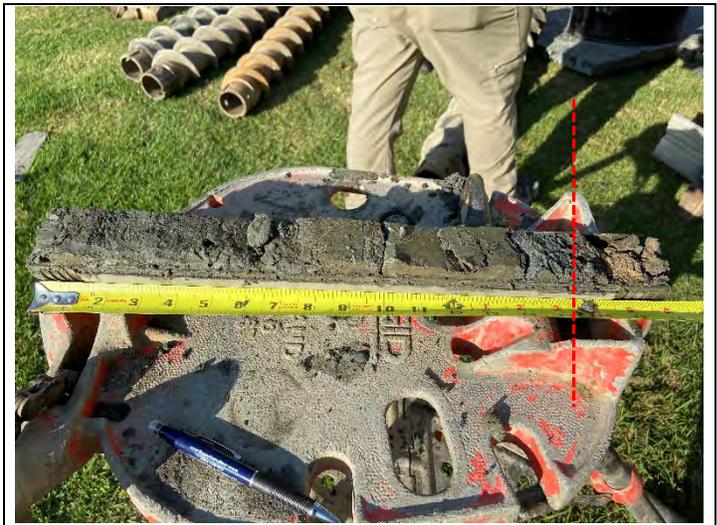
Split spoon sample collected at 10 – 11.5 ft bgs at HSA-1. The interface between the waste and native soil is indicated.

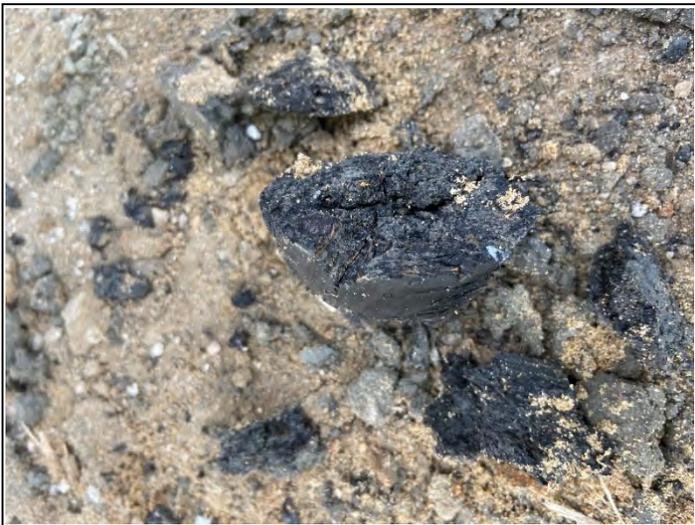
Wood debris observed in the drill cuttings at HSA-4A
