GEOTECHNICAL REPORT
PROPOSED IMPROVEMENTS
EDISON PARK
HUNTINGTON BEACH, CALIFORNIA

Project Number: SC1369

November 30, 2023

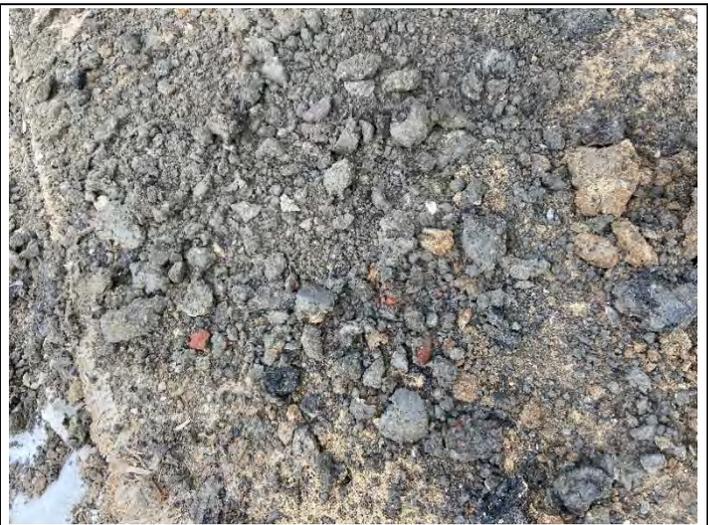
Brick pieces observed in the drill cuttings at HSA-4A

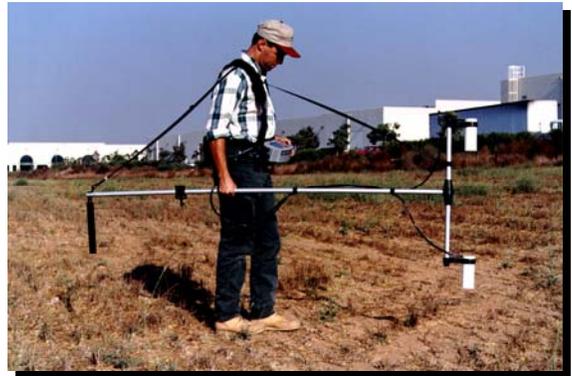
Geometrics G-858 Magnetometer

Anomalies in the earth's magnetic field are caused by induced or remanent magnetism. Induced magnetic anomalies are the result of secondary magnetization induced in a ferrous body by the earth's magnetic field. The shape, dimensions, and amplitude of an induced magnetic anomaly is a function of the orientation, geometry, size, depth, and magnetic susceptibility of the body as well as the intensity and inclination of the earth's magnetic field in the survey area. Buried ferrous metallic objects, such as pipes, drums, tanks, and debris generally give rise to dipolar anomalies with a positive response south and a negative response north of the object. The magnetic method is an effective way to search for small metallic objects because magnetic anomalies have spatial dimensions much larger than those of the objects. An oil well typically gives rise to a monopolar anomaly with a very high amplitude, positive peak several feet south of the well and a low amplitude, broad negative response to the north. The magnetic anomaly over a buried oil well often has a diameter of over 50 feet and amplitude of several thousand nanoteslas, depending on depth and casing characteristics. Magnetometers can typically locate an abandoned oil well to depths of over 20 feet providing that background noise levels are not too high and the well casing is not significantly corroded. Magnetometers are not able to detect nonferrous metals such as aluminum and brass.

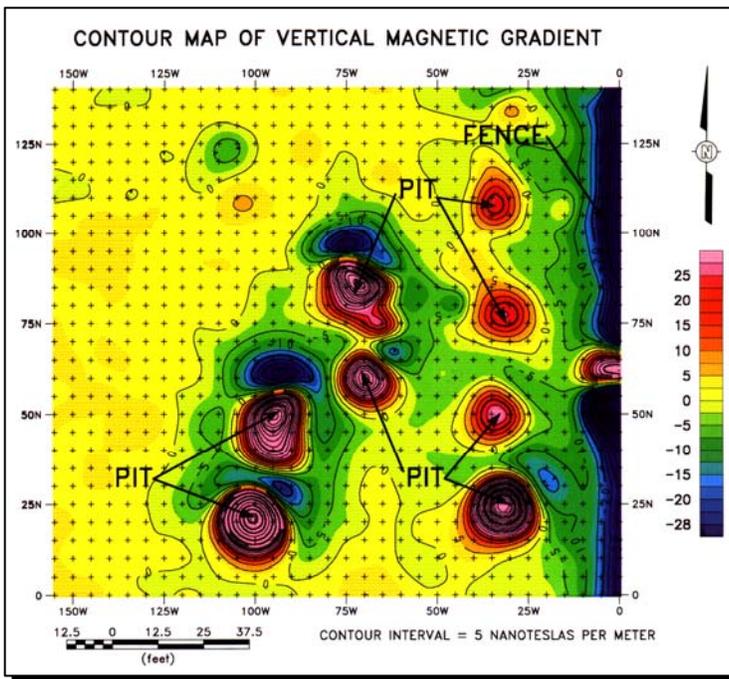
Magnetic Survey to Locate Pits Containing Buried Metallic Containers
